# **Failure of an Earth Dam**

*An analysis of earth dam break – Årbogen dam, Nedre Eiker municipality, Norway*

Master Thesis in Geosciences

**June 2011**

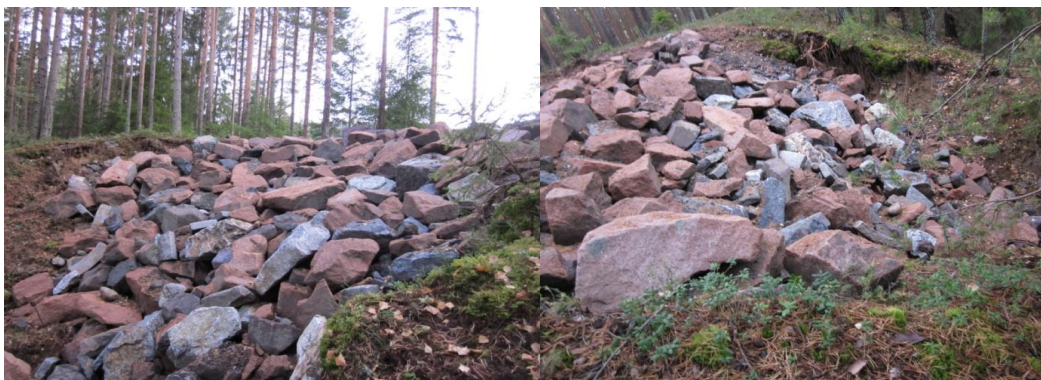
*Figure 1.1: Two main slides happened at the Årbogen Dam site.(Captured during the field visit on 28th October 2010)*

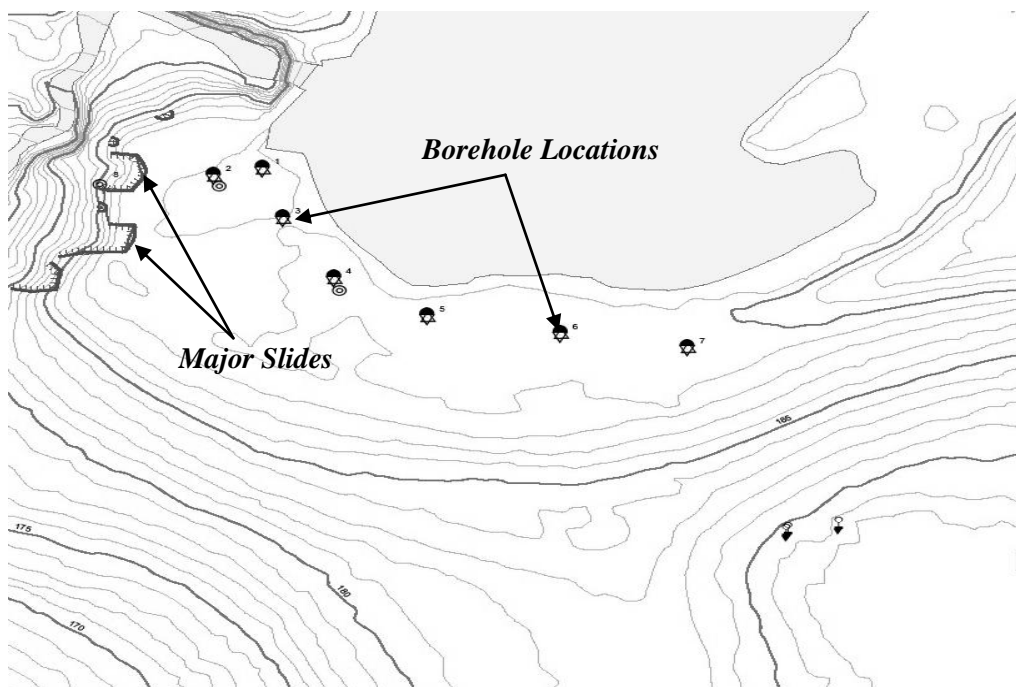
*Figure 1.2: Major slides and borehole locations*

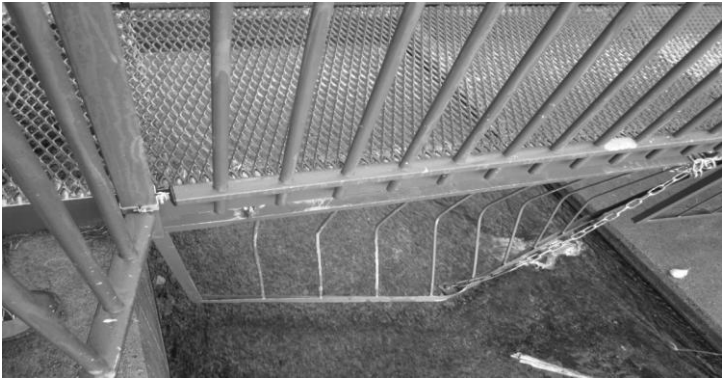
*Figure 2.15: Damaged spillway of Årbogen dam, Norway (Pictures from site visit with NGI on 28<sup>th</sup> October 2010)*

The figure 2.15 shows the damaged spillway of a small embankment dam (Årbogen dam) in Norway. When an intense rainfall occurred, the spillway was partly blocked by suspended particles causes the increase of water level higher than the estimated probable maximum flood (PMF) level and overtopping.

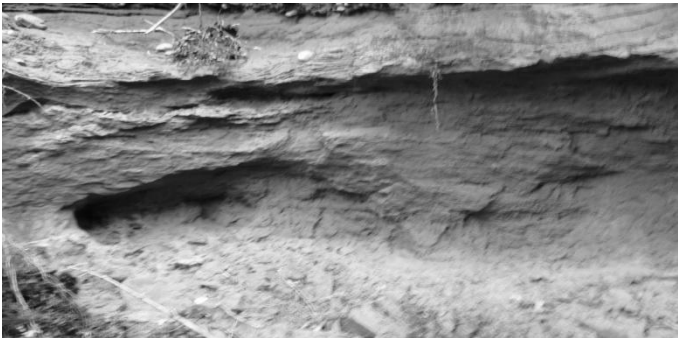
Incase of Årbogen dam, the direct overflow (causes the external erosion) and the seepage water (causes the internal erosion) are the main causes of failure.

*Figure 2.16: Traces of internal erosion at downstream side of the Årbogen dam (Pictures from site visit with NGI on 28<sup>th</sup> October 2010)*

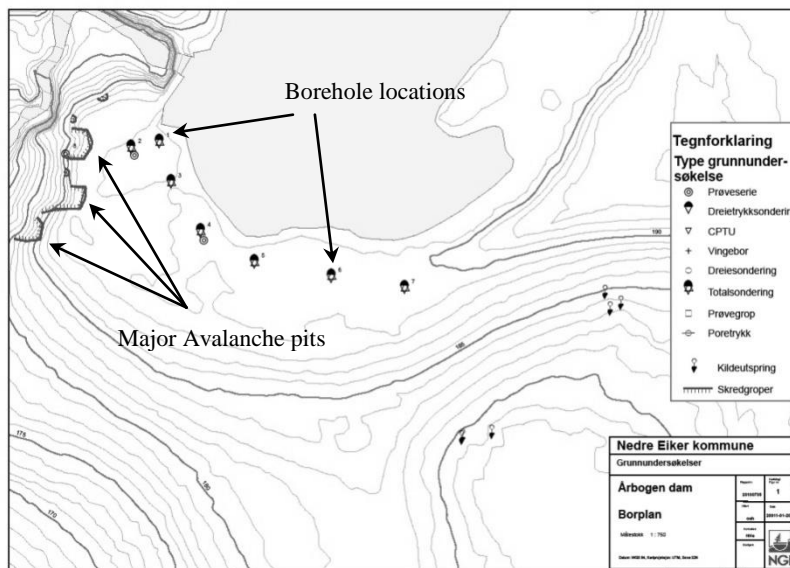
On Friday 13<sup>th</sup> August 2010, there was a series of intense rainfall (62mm between 7<sup>th</sup> and 13<sup>th</sup> of August) occurred in the upstream side of the Krogstadelva, in Nedre Eiker area resulted the small old industrial dam Årbogen was overflowed (0.5m above the top). The seepage water through the deposits combined with the direct overflow caused three major and several small slides along the glaci fluvial sand deposit.

Figure 3.1 Major avalanche pits and the locations of the boreholes

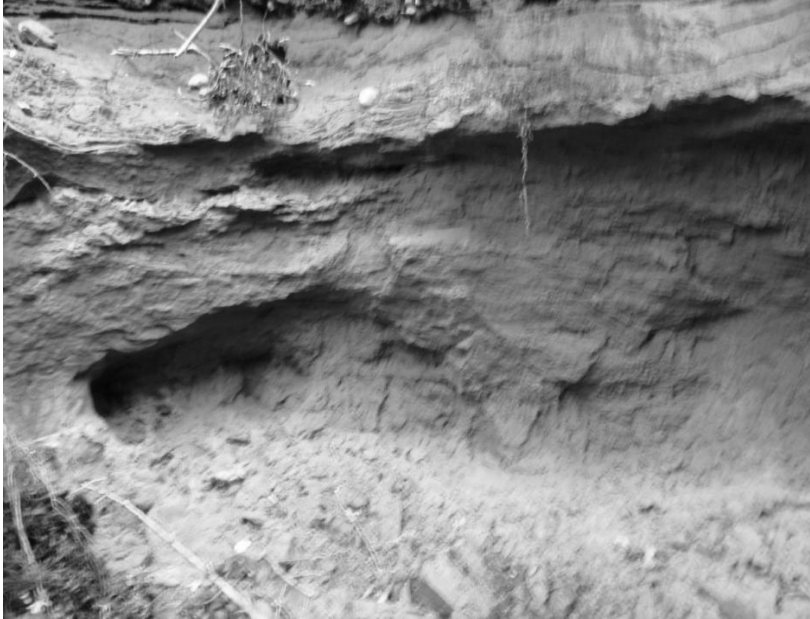
Pit 1 is the largest pit and is about 4 m depth in the back, 10 meters wide and has cut about 8 m into the soil. The pit has sloping bottom of the river and consists of ~ 2 m of gravel and stony clayed silt and fine sand (see Figure 3.2). In the lower part of the slope there are some exposed rock (red sandstone). The fine-grained layer is darker and looks from a distance like a clay layer. At the bottom of the interface occurred, there is a sandy channel. From the observation, the outflow of water continued for a long time from the sandy channel.

*Figure 3.2: Rear part of the avalanche pit 1 with sand layer at the bottom*

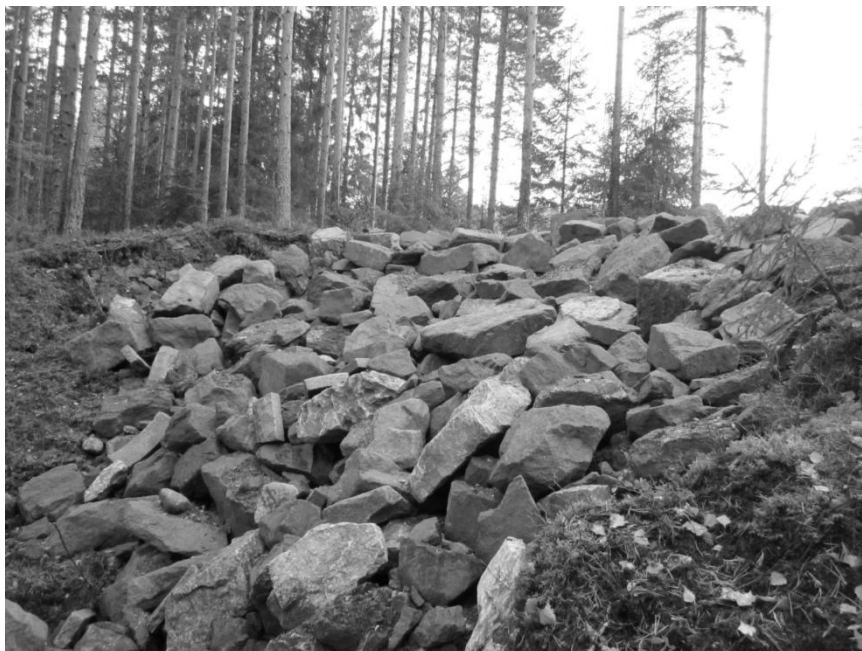
Figure 3.3: Partially filled avalanche pit (Picture captured during the field visit on 28<sup>th</sup> October, 2010)

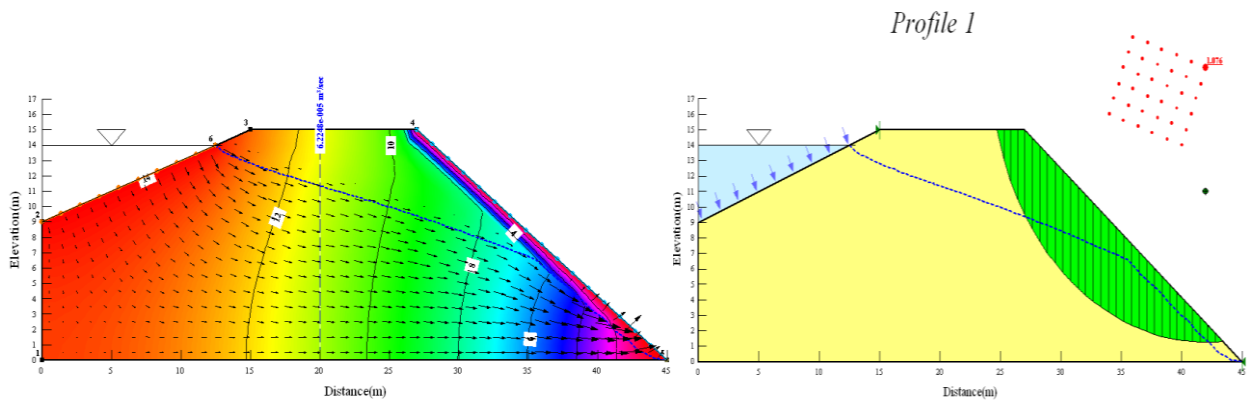
Figure 3.6(a): Steady-State seepage analysis

In the steady-state analysis, the total flux through the cross section is  $6.22 \times 10^{-5} \text{ m}^3/\text{sand}$  the factor of safety is 1.076. From the value of safety it can be concluded that the slope may failure for some extreme flood condition. Let's check in the analysis of flooding condition. Figure 3.6(a) and 3.6(b) show the visual interpretation of the results.

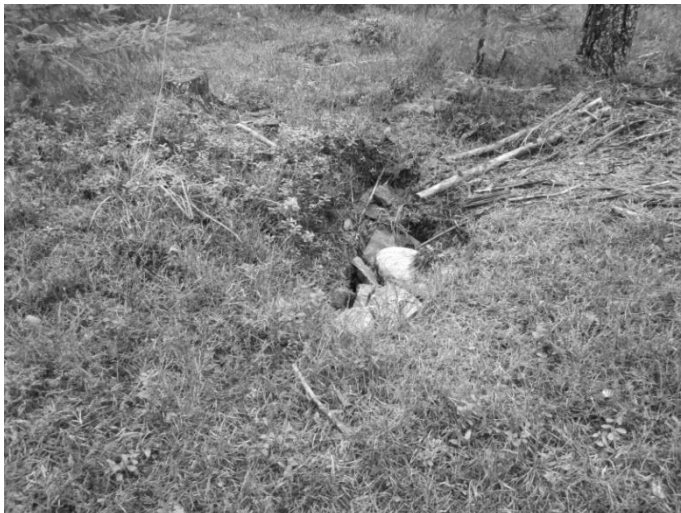
shows a water spring at the field.

*Figure 3.15: A water spring observed around the dam site*
