Master Thesis, Department of Geosciences

# Human activity as a cause for landslides in Norway

*Case study of two man-made debris flows in Otta, Central Southern Norway*

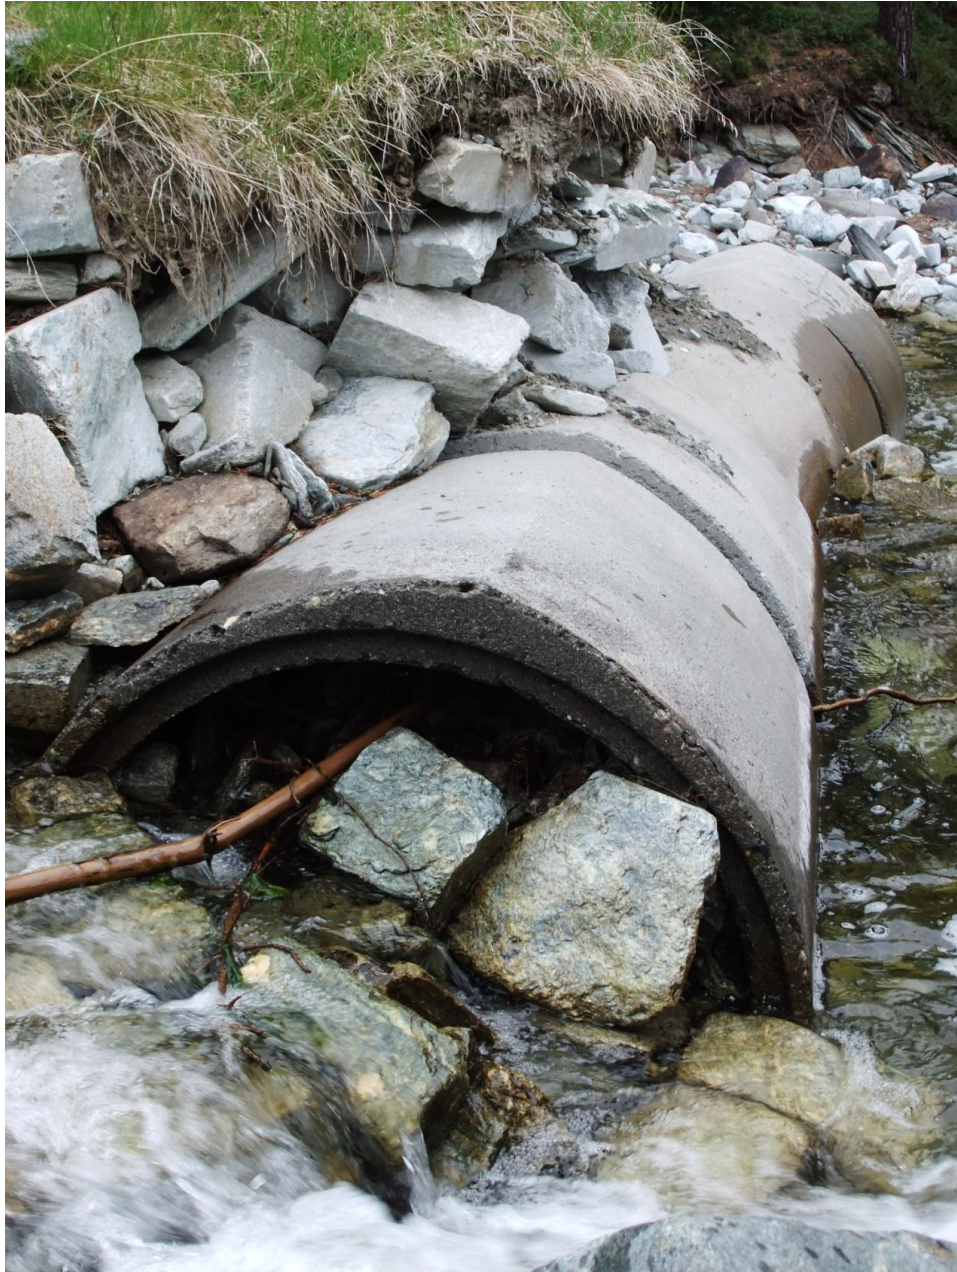
Figure 4.3.3 The totally blocked drainage pipe for the second bridge.

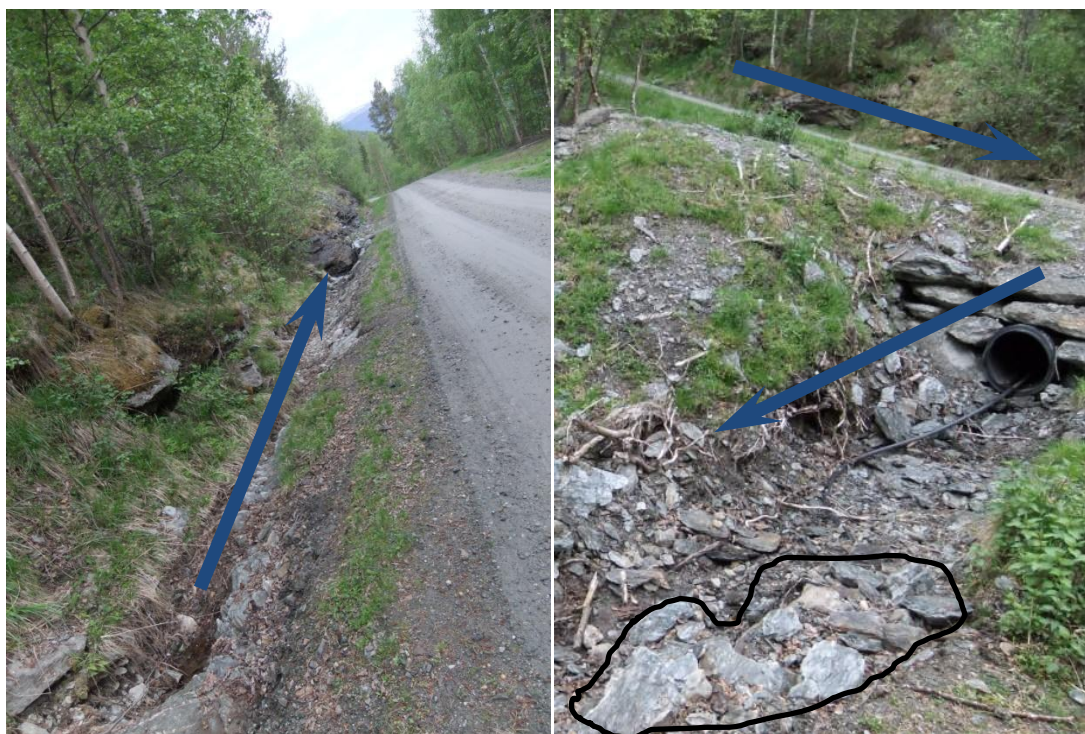
Figure 5.2.2.1 Main road of the location and the drainage pipe in the start point. Blue arrows show the declination of the slope and the flow direction in the channels, and mineral shale showing in the second figure in the black circle.

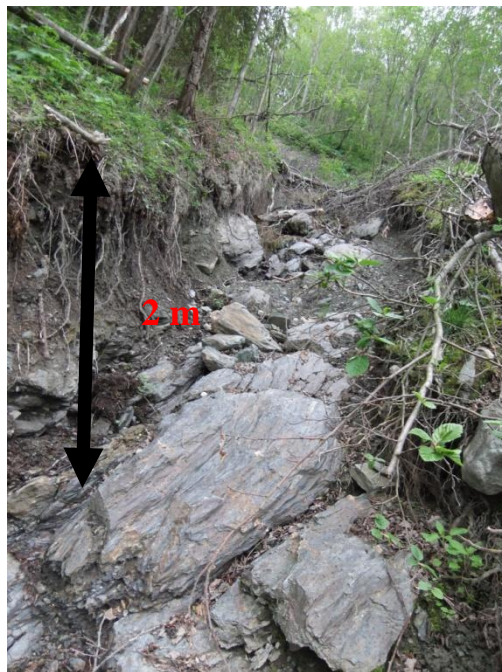
Figure 5.2.2.4 Exposed bedrock in the flowing track.

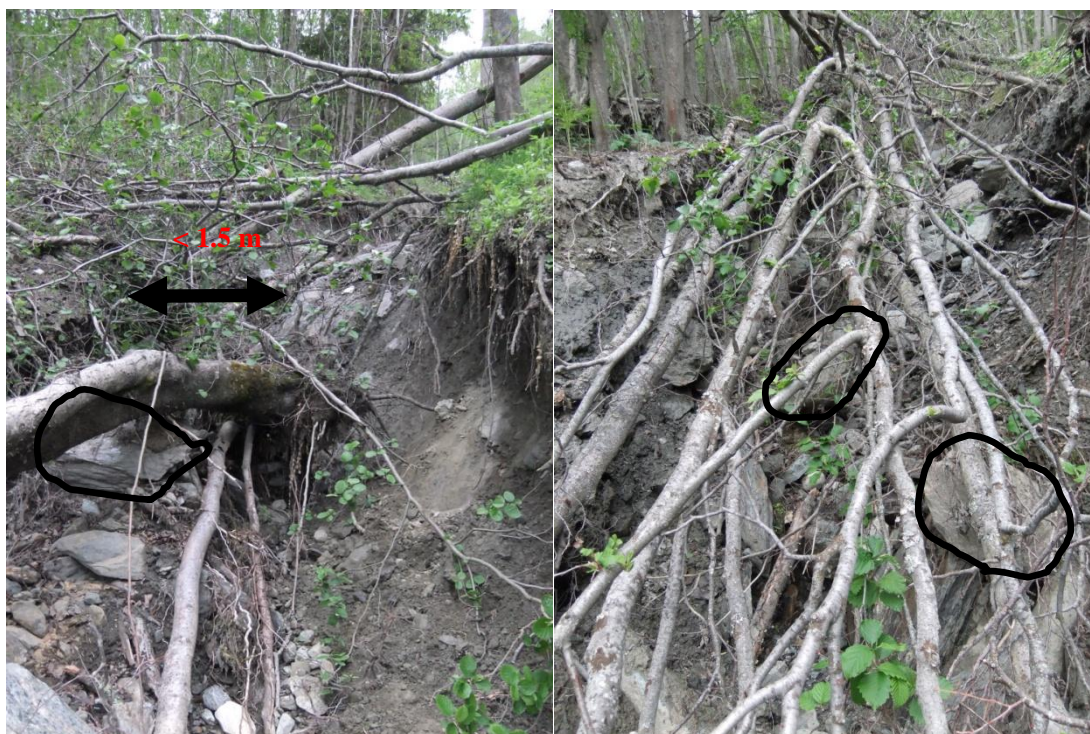
Figure 5.2.2.5 Woods dams in point 132 (left) and point 128 (right).

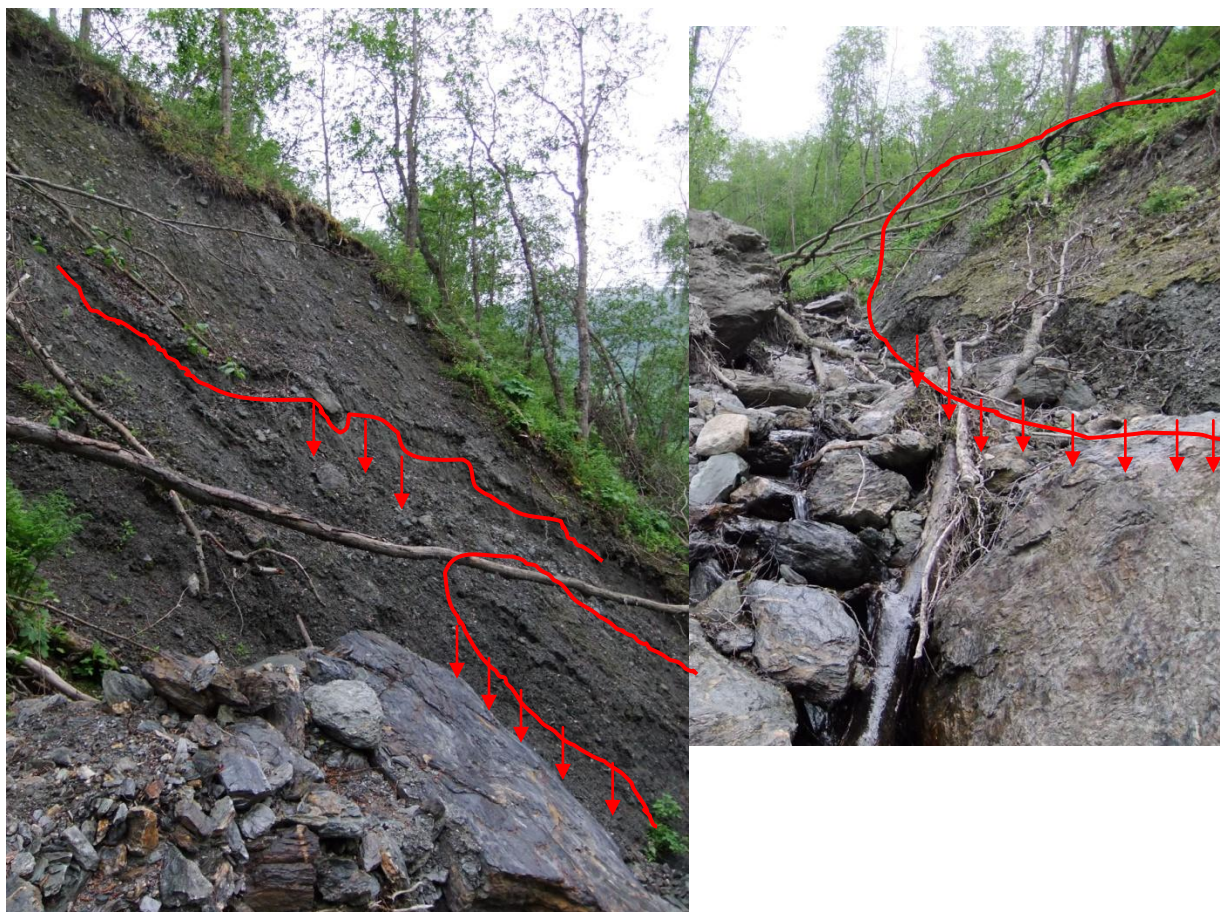
Figure 5.2.2.6 Creep phenomenon observed on the slope along the track.

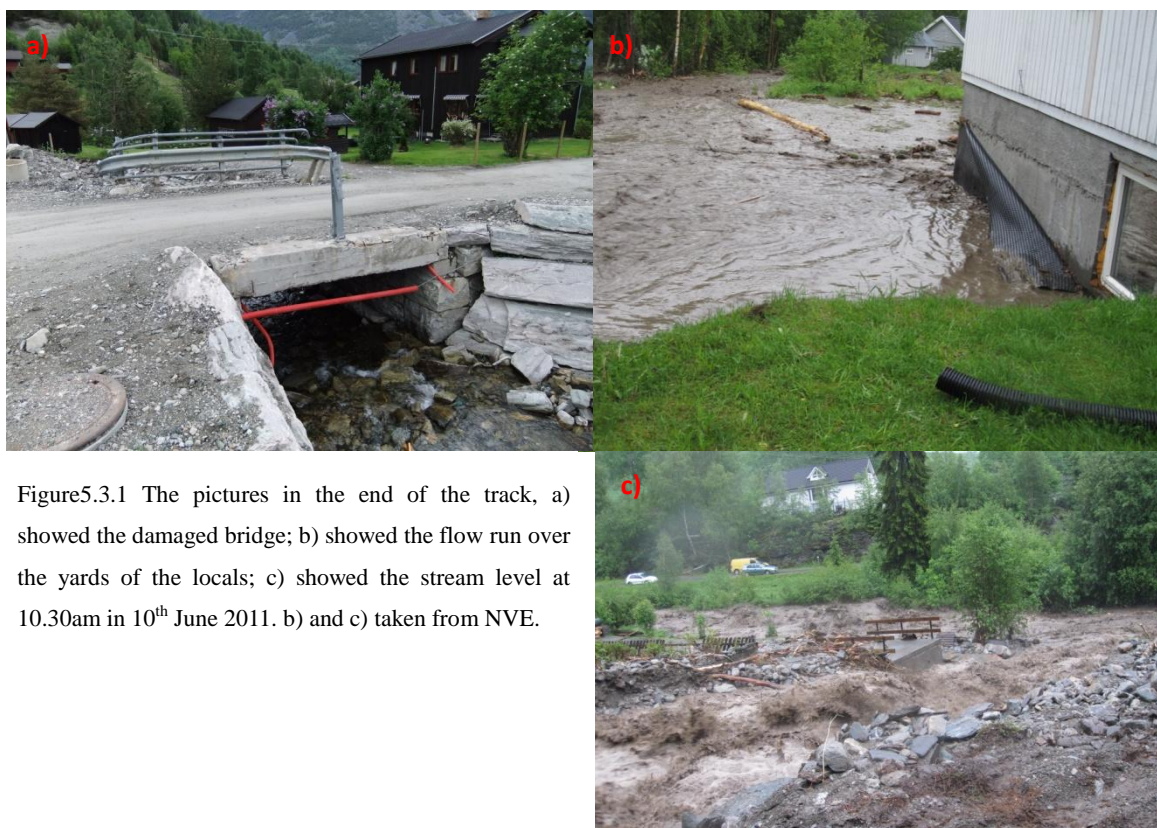
Figure 5.3.1 The pictures in the end of the track, a) showed the damaged bridge; b) showed the flow run over the yards of the locals; c) showed the stream level at 10.30am in 10<sup>th</sup> June 2011. b) and c) taken from NVE.

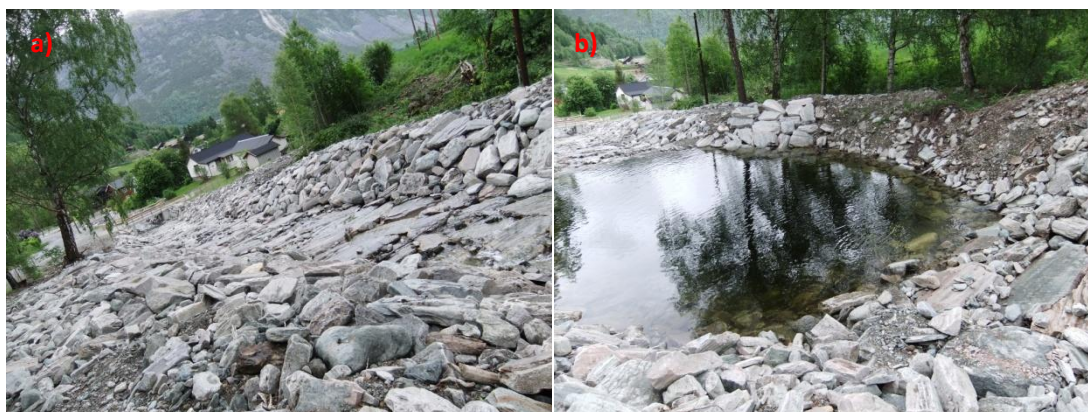
Figure 5.3.2 a) the readjusted channel, b) the built pool for risk mitigation.

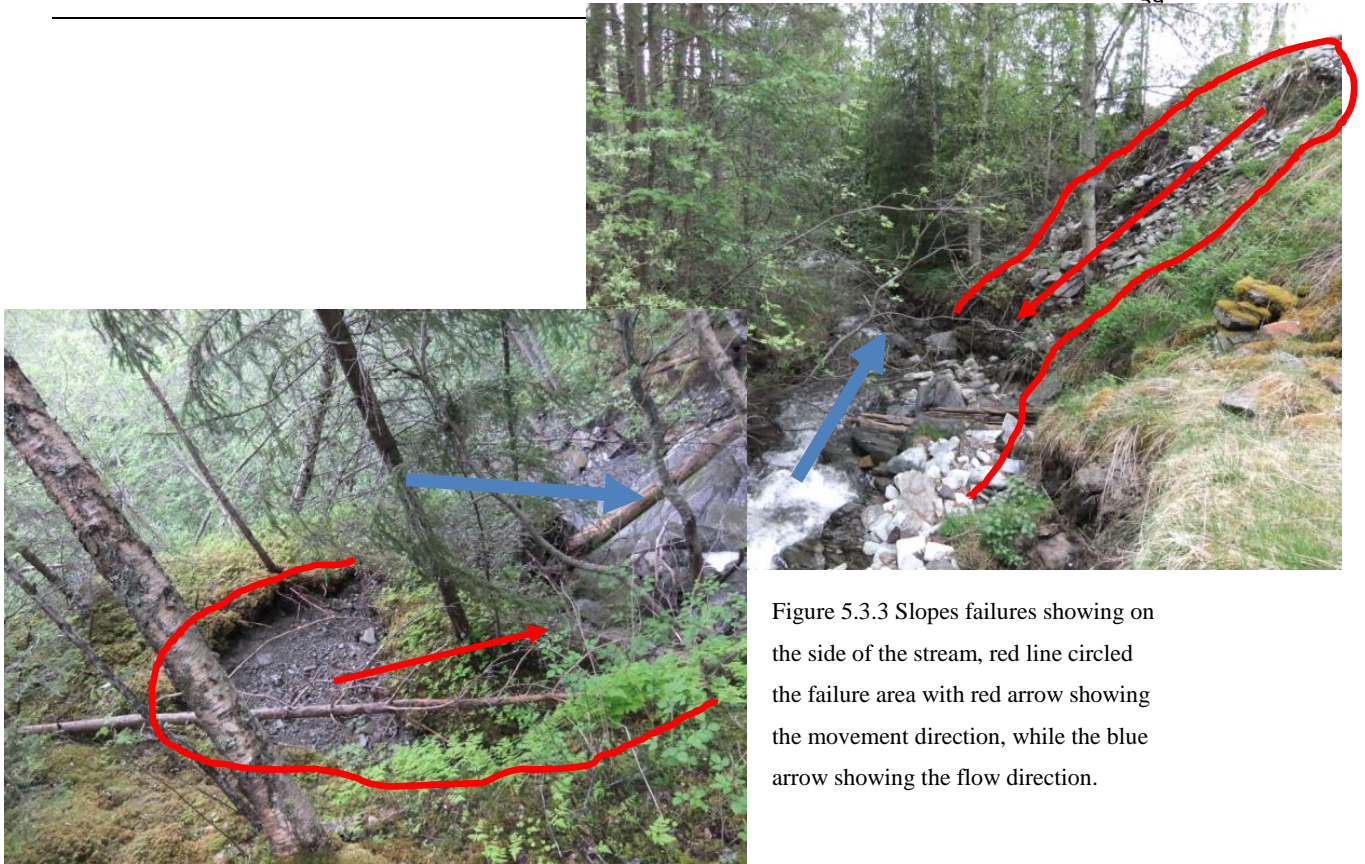
Figure 5.3.3 Slopes failures showing on the side of the stream, red line circled the failure area with red arrow showing the movement direction, while the blue arrow showing the flow direction.

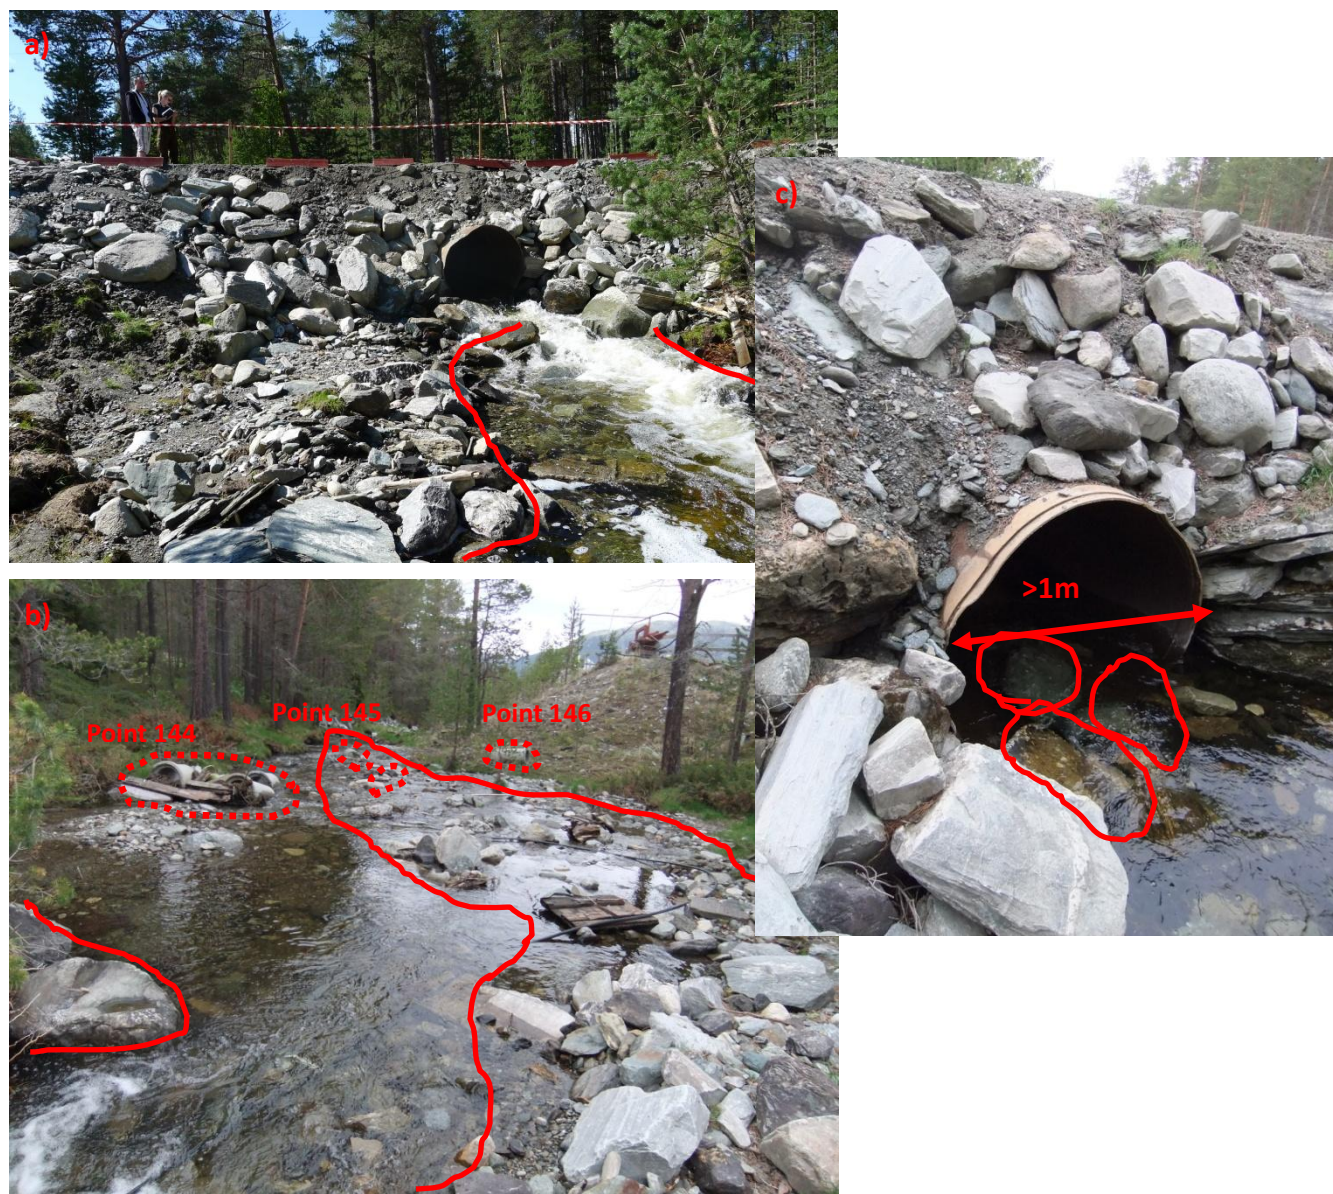
Figure 5.3.2.1 a) the repaired bridge; b) the open field after the failure point, circled by the red dash line showed the flushed concrete pipes. Area circled by the red solid line in a) and b) showed the debris deposits behind the bridge.

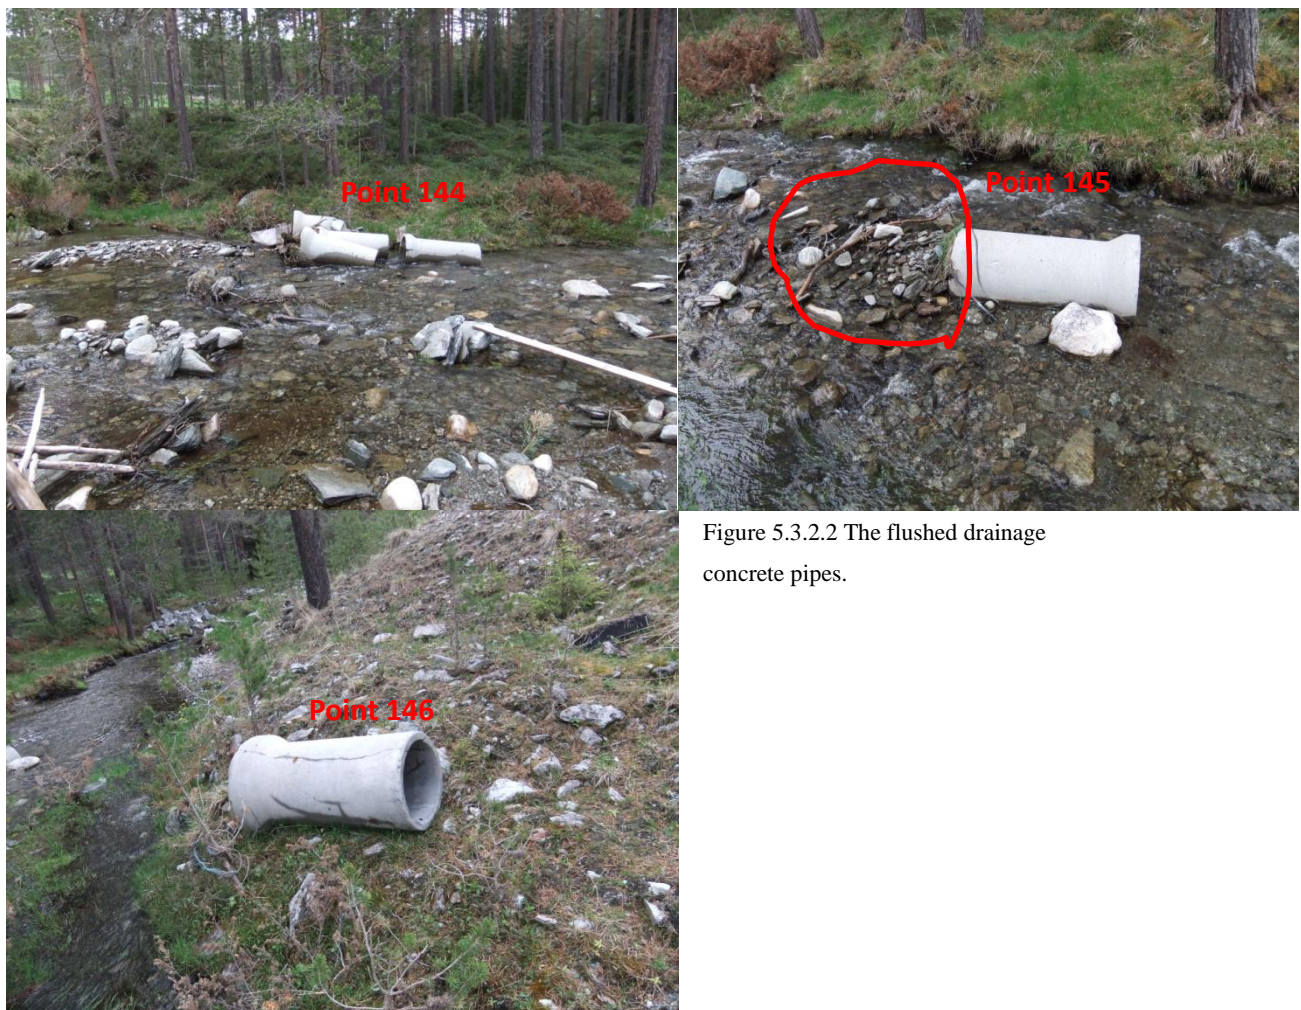
Figure 5.3.2.2 The flushed drainage concrete pipes.

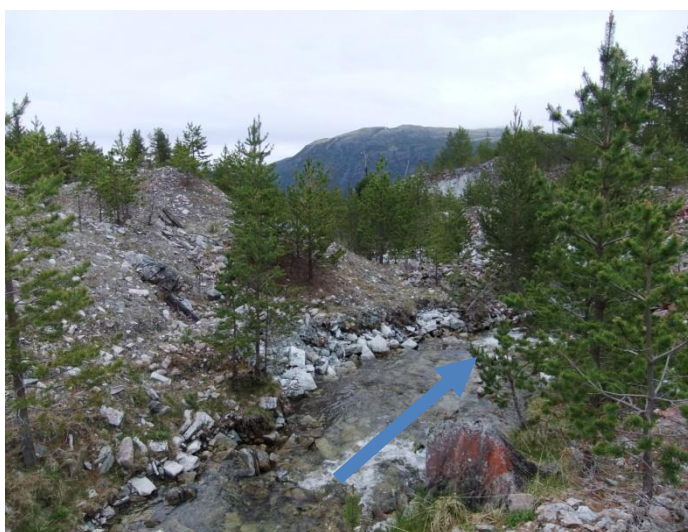
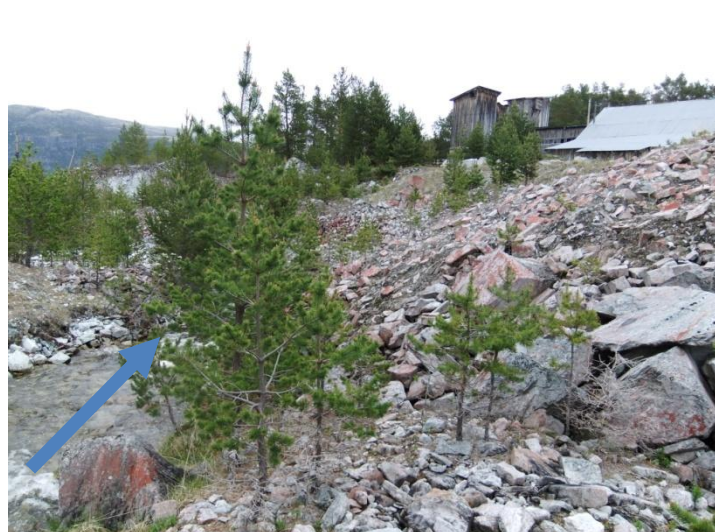
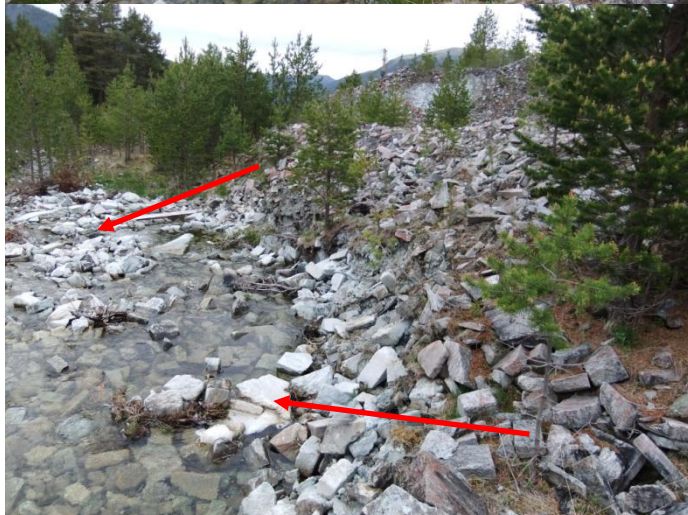
Figure 5.3.2.4 A large amount of waste dumped in Point 150, soap stone on the right bank. The blue arrow showed the flow direction, and the red arrows showed the loose boulders movement direction.

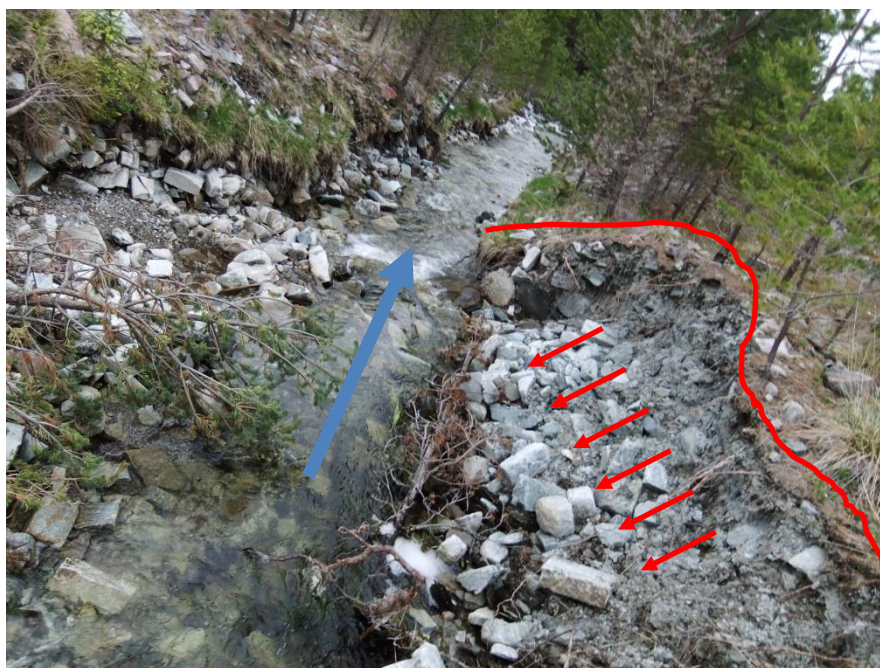
Figure 5.3.2.5 The failure slope in the end of the dumped waste, the blue arrow showed the flow direction.

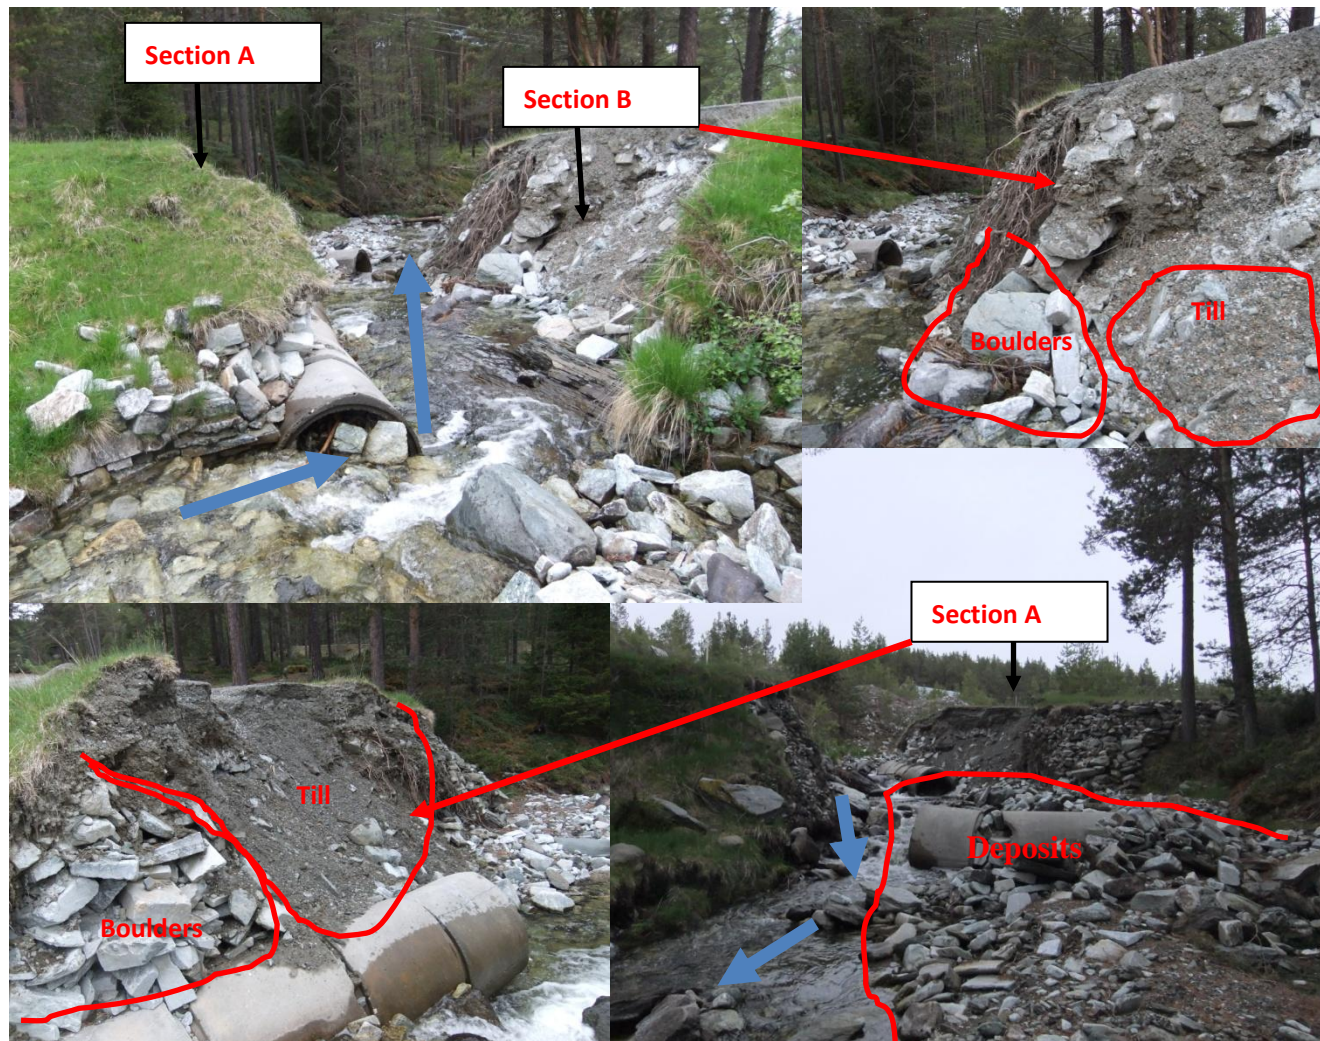
Figure 5.3.2.6 The destroyed bridge in Point 153.

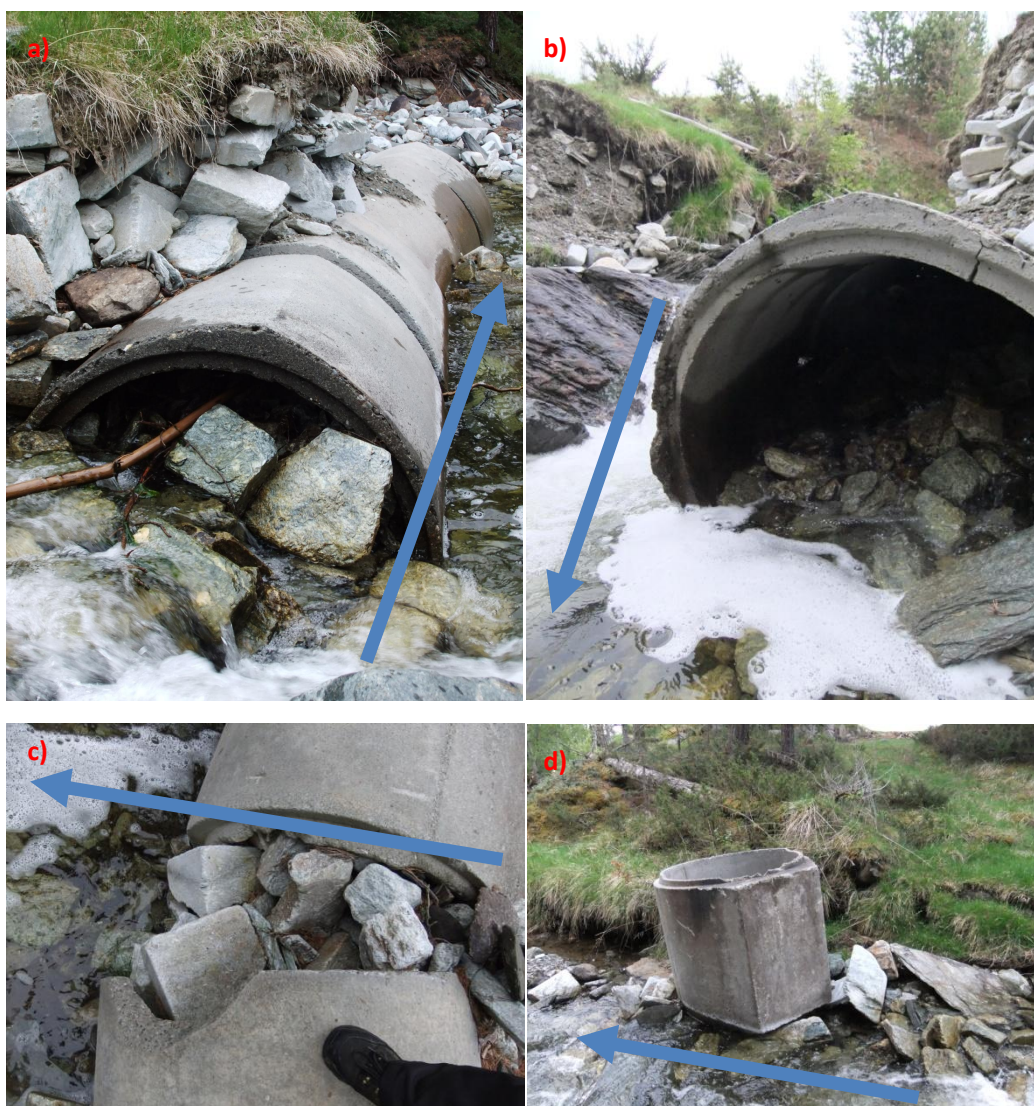
Figure 5.3.2.7 a) the front side of the five tubes; b) the back side of the five tubes; c) the middle of the two tubes being flushed away 4-5m away; d) the furthest tube being flushed away.

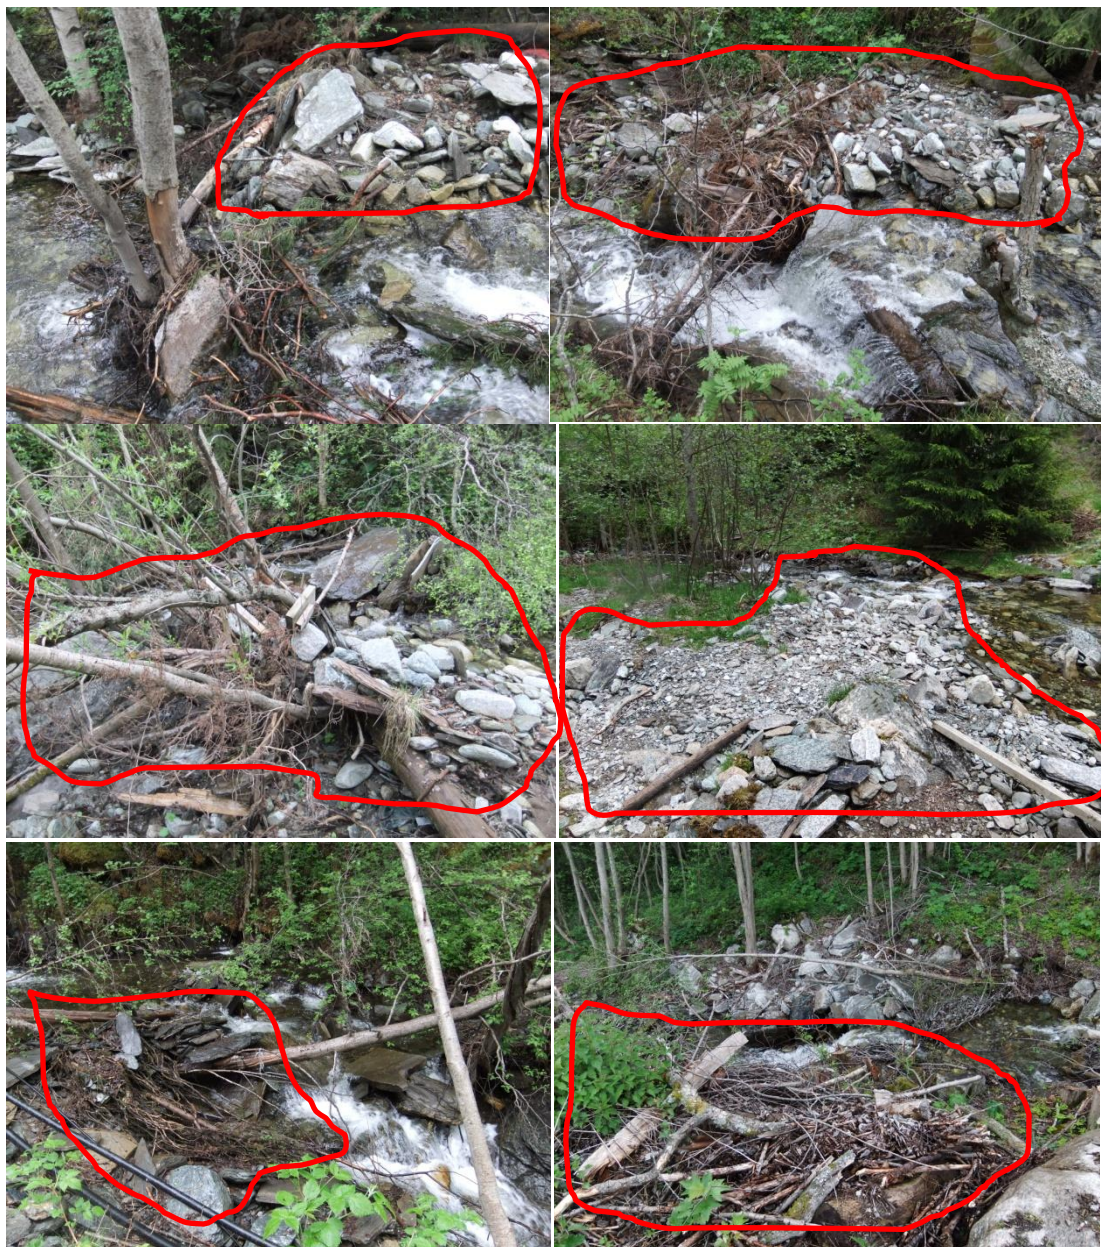
Figure 5.3.2 Debris deposit along the track.
