Salt damage around a bat roost at Urnes stave church

Masters Dissertation
December 2019

Urnes stave church is dated to the 1130s and was inscribed on the UNESCO World Heritage List in 1979. In the south west nave corner, the bearing post and adjoining bressummer (sill beam) of original pine wood suffer from salt deterioration. The area is situated near a bat roost, and this has led to the assumption that the salts derive from bat urine. Examinations and different analytical methods were used to verify the source of the salts and examine the condition of the wood. On site investigations included test strips and portable XRF and X-ray. Samples were taken for analyses in ICP-OES, FTIR, SEM-EDX and light microscopy using lignin staining to answer the research questions. A wildlife camera, ultrasound detectors and climate loggers were part of the investigations at site to investigate present bat activity and assess the preservation climate inside the church.

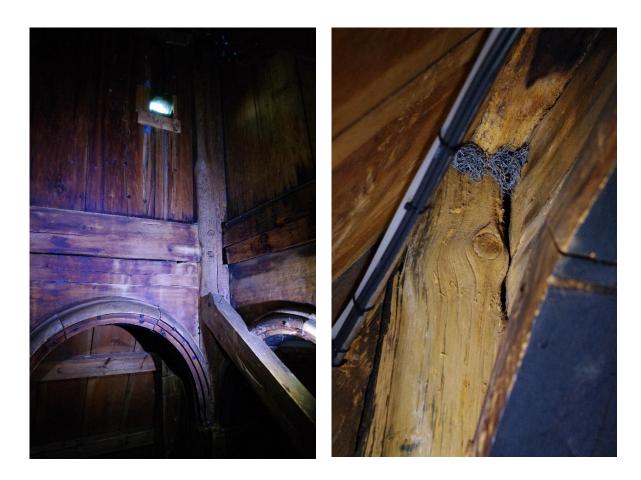
In 1998, degradation of an unknown character was discovered on the southwest (SW) nave corner post and the connecting bressummer (see figure 2, a and b). Since, the wooden surface has been constantly moist and there is evidence of material loss. This wooden surface is light in colour from surface deposits. Analyses have identified these deposits as salts.

Figures 2 a and b. An image of the contaminated area in the SW nave corner seen from the west gallery (a) and from the aisle corner (b). The surface is contaminated by salts. Chicken wire is used to prevent bats from reentering the roost. The SW post, bressummer, arcade moulding and wall planks are seen.

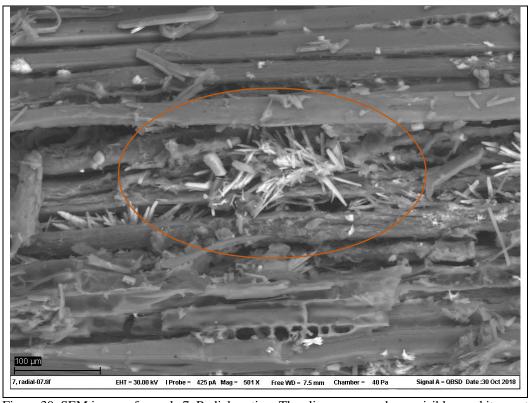
Figure 30. SEM image of sample 7, Radial section. The alien compounds are visible as white crystals with sharp tips in between the wooden matrix, seen here as darker cells with tracheids. Mag. 501x

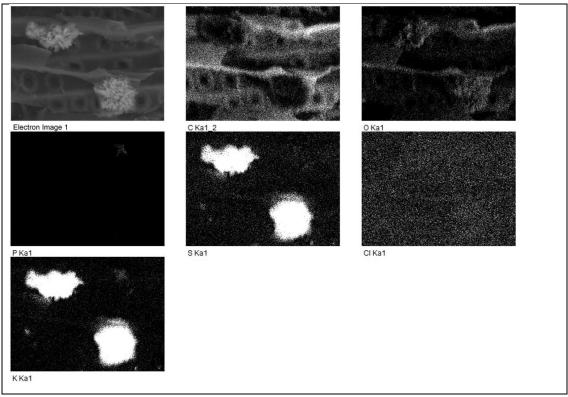
Figure 31. SEM-EDX analysis of sample 6, a wooden sample taken from the bressummer hole (bat roost). The mapping of the elements in the salt molecule show high atomic percent of Potassium (K), Sulphur (S) and some Oxygen (O), and the salt is most likely potassium sulphate (K_2SO_4) .

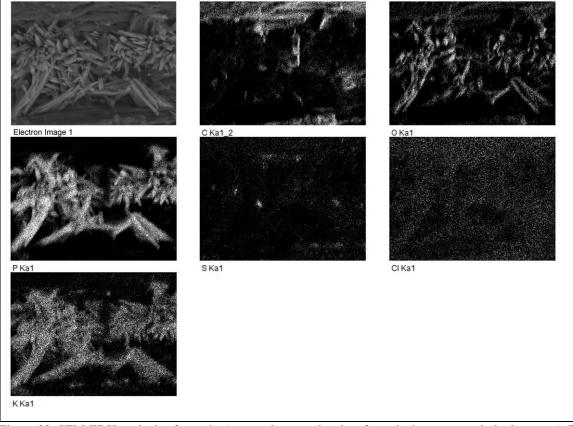
Figure 32. SEM-EDX analysis of sample 6, a wooden sample taken from the bressummer hole (bat roost). The mapping of the elements in the salt molecule show high atomic percent of Potassium (K) and Phosphorus (P) and Oxygen (O).

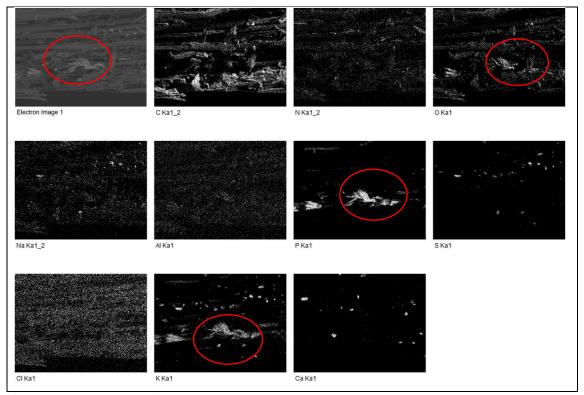
Figure 33. Sample 7, taken from the hole under the bressummer on the gallery side (bat roost). The mapping of the elements in this image show that the salt crystal contains potassium and phosphorus, and some oxygen. It is likely that the salt molecule is K_3PO_4 , potassium phosphate. The image show crystals mostly at the surface but also within tracheid cells (circled).

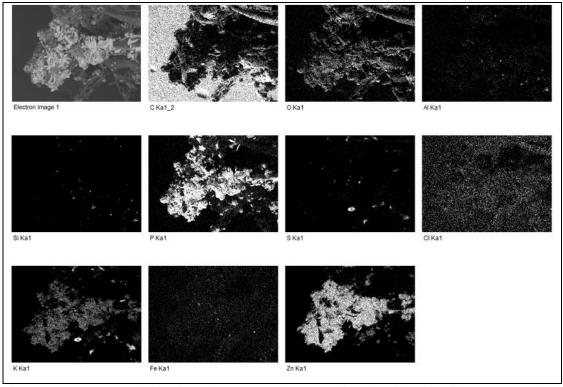
Figure 34. SEM-EDX analysis of sample 14, a wooden sample from the aisle side of the SW post. The mapping of elements shows a compound containing mainly zinc and phosphorus. It also contains some potassium and oxygen. The compound could be $Zn_3(PO_4)_2$, zinc phosphate or $Z_{n_3}P_2$, zinc phosphide.

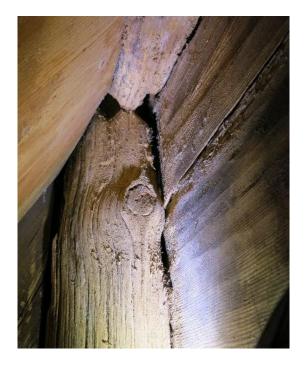
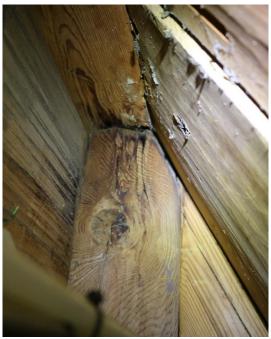
Figure 36. The vertical construction part is the SW nave corner post, the part resting on top of the post is the bressummer. The salt damage is seen as a fuzzy and light-colored surface. The joint between the post and bressummer is losing contact, and the opening enable bats to enter the hollow bressummer. The twig in the post is protruding.

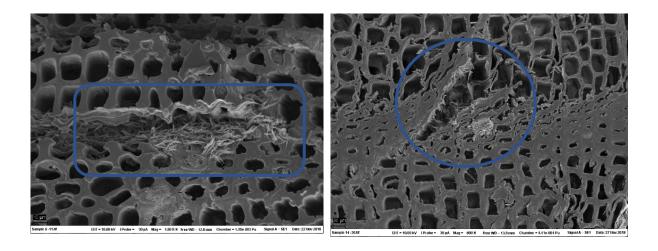
Figure 41 and Figure 42. SEM images. Images of samples 6 (Mag. 1500x) and 14 (Mag. 600x) in transverse section, showing areas where the wood cells have suffered a severe damage due to salt crystal formation.

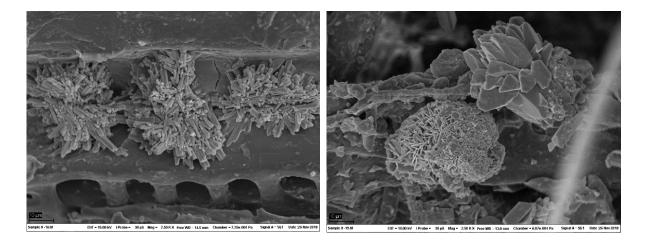
Figure 43 and Figure 44. SEM images. Images of sample 8 (Mag. 2500x), showing two different salt crystal topographies. As seen in the results from the elemental mapping, the different crystals showed different molecular composition.

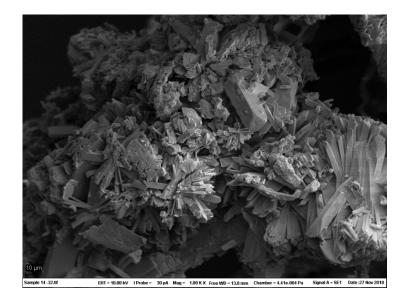
Figure 46. The coarser crystals contain more phosphorus.

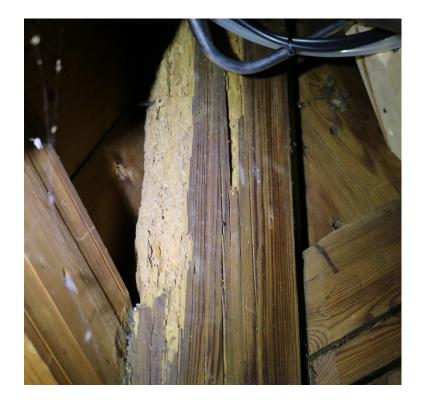
Figure 51. The aisle rafter connecting the SW nave corner post and the aisle wall plate, and carrying the aisle roof, has old insect attacks. This area will most probable have been treated with pesticides in the past but shows no sign of salt contamination.

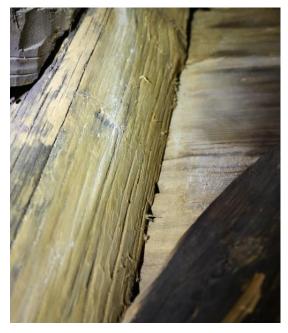
Figure 54. White salt efflorescence on the SW post at Urnes during rainy weather. October 2019.

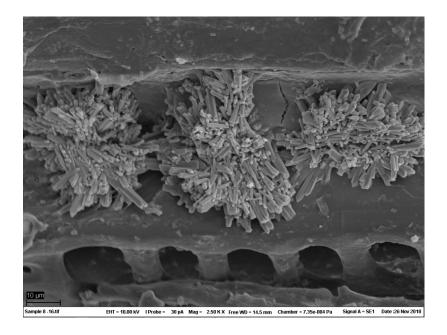
Figure 57. An SEM image of sample 8 coated with gold and palladium. The large salt crystals blur the cell walls and make it impossible to see whether the middle lamella region is deteriorated. A fracture between crystal 2 and 3 (from left) is seen.

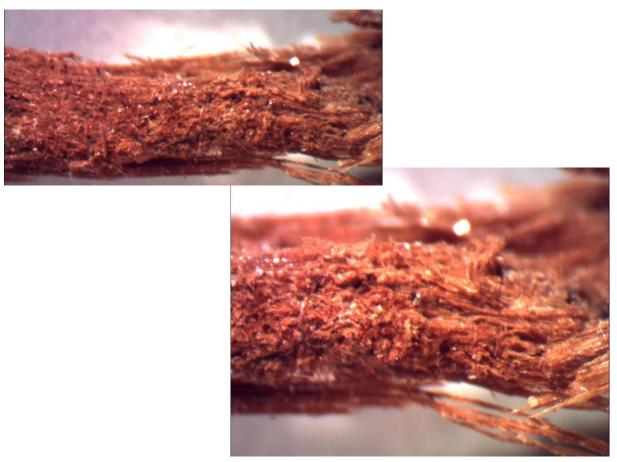
Figure 6. Stereomicrograph image of Sample 6 (ca magnification). The wood fibers fall easily apart and salt crystals are visible

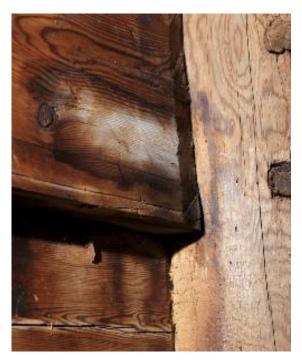
Figur 2. Detalj fra figur 1 som viser områder med indikasjoner på biologisk/kjemisk skade: lyse/hvite områder i treet med mørkere skjolder rundt. Foto: Riksantikvaren.

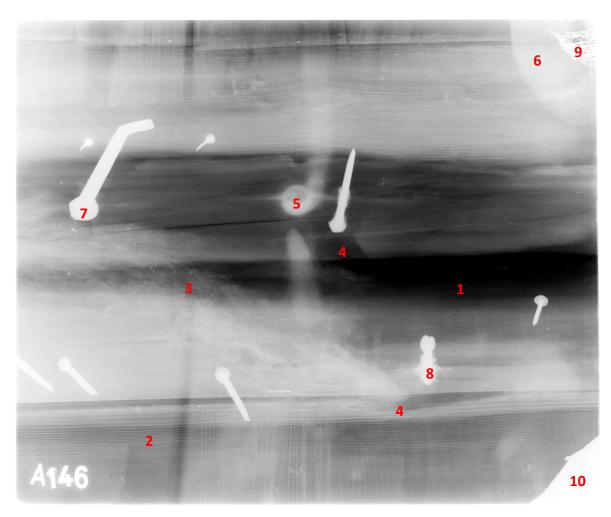
Figur 7. Røntgenopptak av søndre midtromssvill, opptak inntil sørvestre stav. Tilsvarer rød firkant i figur 5 og 6. Høyre kant av bildet viser området inntil staven. 1) I det mørke området er mye treverk borte/svært nedbrutt. 2) Friskt treverk, liggende fiberretning. 3) Nedbrutt treverk; årringer og fiberretning er gått i oppløsning og kan ikke leses i bildet. Irregulære klumper, opp til ca. 1 cm diameter. Noen lange fibre ligger diagonalt på fiberretningen. 4) Definerte hulrom på langs og tvers av årringene, muligens forårsaket av insektsangrep. 5) Kvist. 6) Takspon, tungeformet. 7) Spiker. 8) Rusten spiker. 9)Hønsenetting. 10) Blytekking. Foto: NIKU

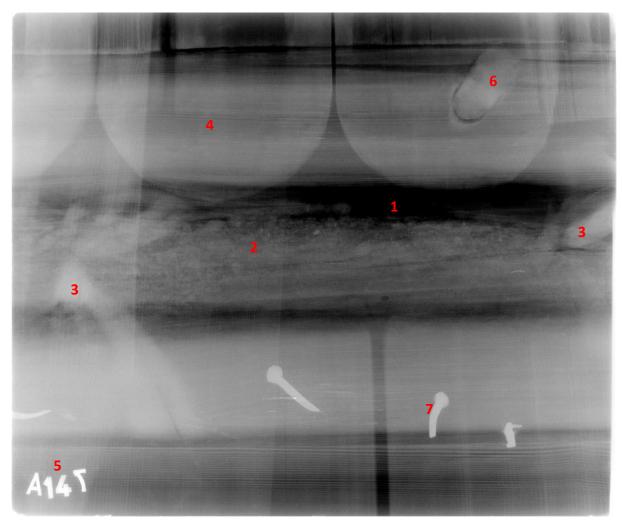
Figur 8. Røntgenopptak av midtromssvill, midtre opptak. Tilsvarer gul firkant i Figur 5 og 6. 1) I det mørke området er mye treverk borte/svært nedbrutt. 2) Nedbrutt treverk; årringer og fiberretning synes ikke. Irregulære klumper, opp til ca. 1 cm diameter. 3) Kvist. 4) Takspon, tungeformet. 5) Takspon, spisset. 6) Treplugg. 7) Spiker. Foto: NIKU

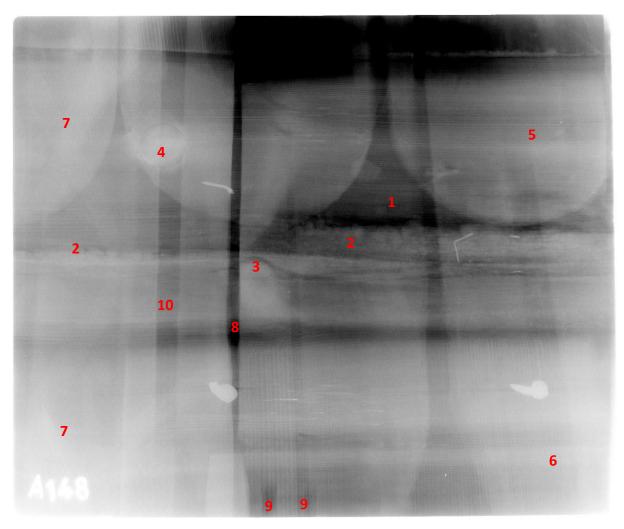
Figur 9. Røntgenopptak av midtromssvill, østre opptak. Tilsvarer grønn firkant i figur 5 og 6. 1) I det mørke området er mye treverk borte/svært nedbrutt. 2) Irregulære klumper, opp til ca. 1 cm diameter. 3) Kvist og sprekk. 4) Trenagl som sikrer sammenføyningen mellom midtromssvill og mellomstav. 5) Takspon, tungeformet. 6) Takspon, spisset. 7) Treskurd 8) Kant uttak av midtromssvill for innfelling i mellomstav. 9) Dendroprøveuttak. 10) Glippe ved svillas innfelling i mellomstav? Foto: NIKU

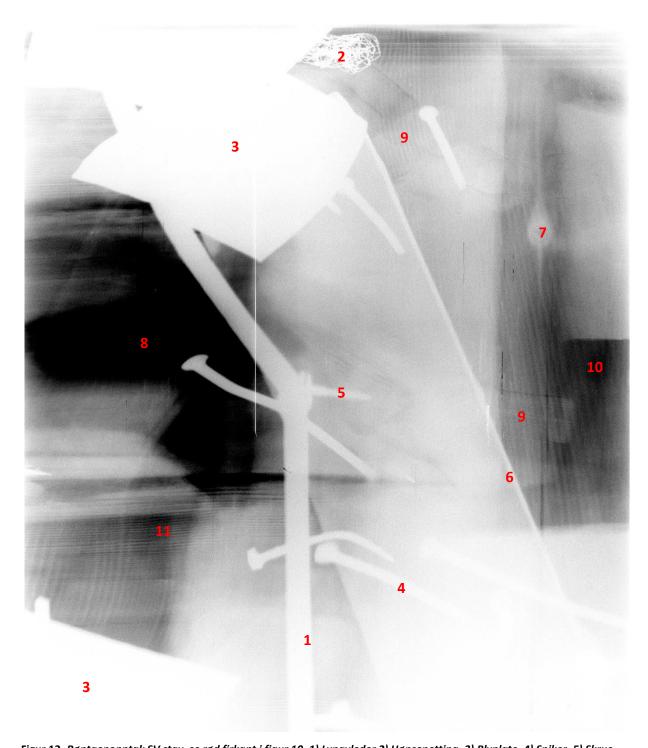
Figur 12. Røntgenopptak SV stav, se rød firkant i figur 10. 1) Lynavleder 2) Hønsenetting. 3) Blyplate. 4) Spiker. 5) Skrue. 6) Møne på omgangens tak. 7) Kvist 8) I det mørke området er mye treverk borte/svært nedbrutt. 9) Treplugger som sikrer S- og V-midtromssvill til stav. 10) Hulrom i konstruksjonen ved inntapping i staven fordi nedre del av Vmidtromssvillen mangler. 11) Område med hulrom/nedbrytning i øvre plank i buefelt. Foto: NIKU

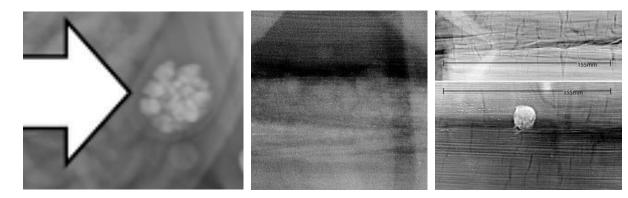
Figur 15, a-c. For sammenligning. 15 a: detaljfoto av figur 14, røntgenopptak av hund med blærestein; 15 b: detalj fra figur 9, uregelmessige klumper/kantete former i treet; 15 c: eksempel på to røntgenopptak av råteklosser i fuktskadet treverk, trolig brunråte (Stein, 2013). Råteskadet tre vil normalt sprekke opp på tvers av fibrene, mens formene/nedbrytningen vi ser på detaljen fra røntgenopptaket av midtromssvillen (figur 15 b) er uavhengige av fiberretning og kan ha blitt dannet av tilført materiale i treverket, eksempelvis urin og/eller ekskrementer fra flaggermus.
