Mari Arentz Østmo

11 A Late Iron Age Palisade Facing the Karmsund Strait

A stone construction, 2.2–3.7 metres wide, about 30 metres long, 0.3–0.6 metres high, and probably built in the 7th century, was discovered on the edge of the Avaldsnes settlement plateau. It probably represents the remains of the foundations for a wooden palisade. Its original extent is unknown, and some stones were likely removed over the centuries for reuse in fences and buildings. The construction's parallel rows of stones and the scatter of stones between them, as well as its position atop a steep slope on the edge of the plateau, are comparable with the low stone walls or ramparts of 3rd–6th-century fortifications elsewhere on the Scandinavian Peninsula. Around 400 such fortifications are known in Norway, in Sweden more than 1000. While there are possible exceptions such as Halsstein in Trøndelag, only rarely do Norwegian fortifications appear to have been permanently settled. The Avaldsnes fortification represents another possible exception, indicating that the phenomenon of hilltop settlement and enclosed farms is not restricted to continental Europe and Sweden. Material for comparison is provided by

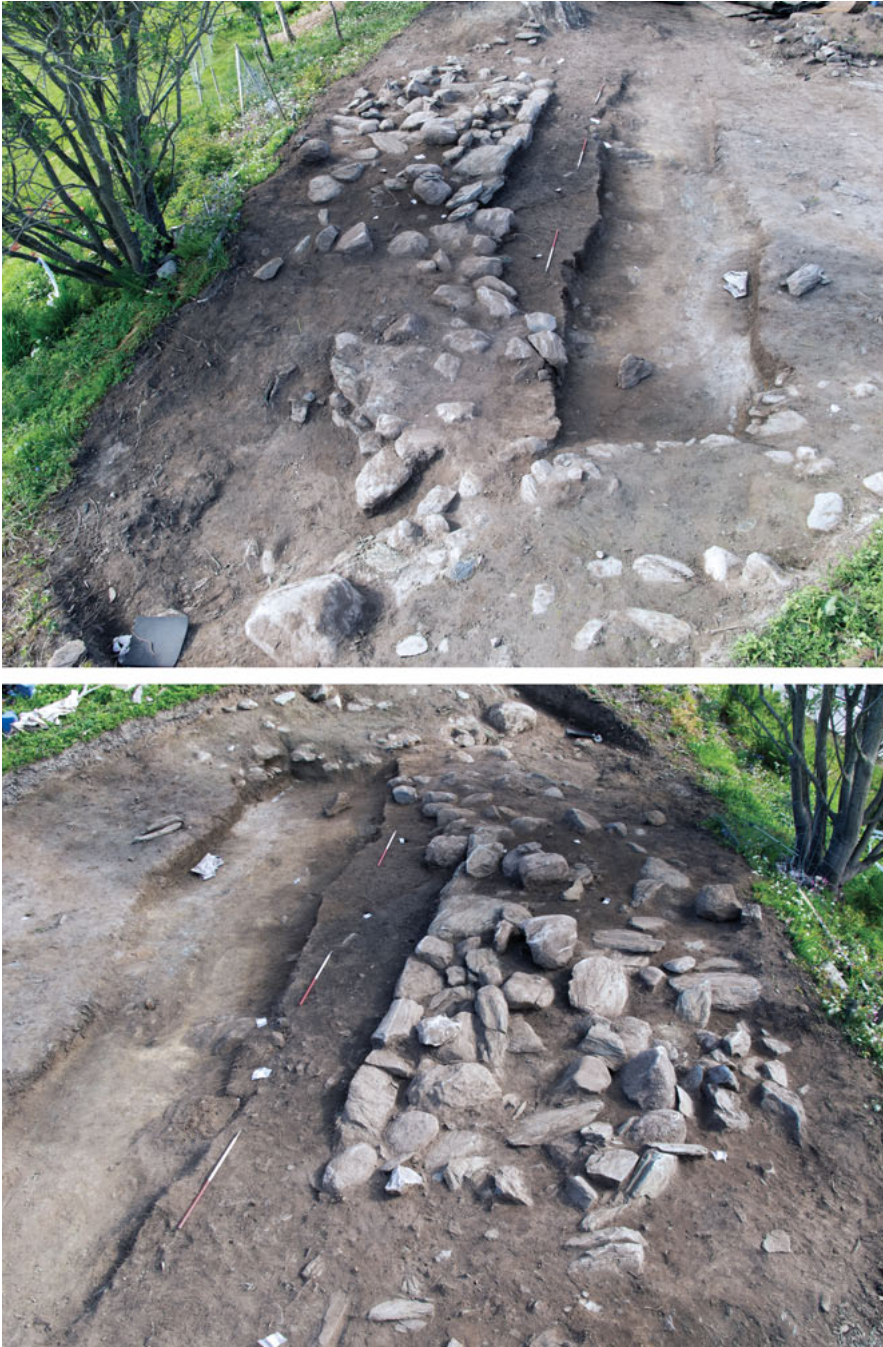
Fig. 11.2: The northern segment of the stone construction. The northernmost part curving up onto the Kjellerhaug, two layers of stones visible (above, facing south-southeast). The northern part of the main segment of A20 (below, facing north). Photo: MCH.

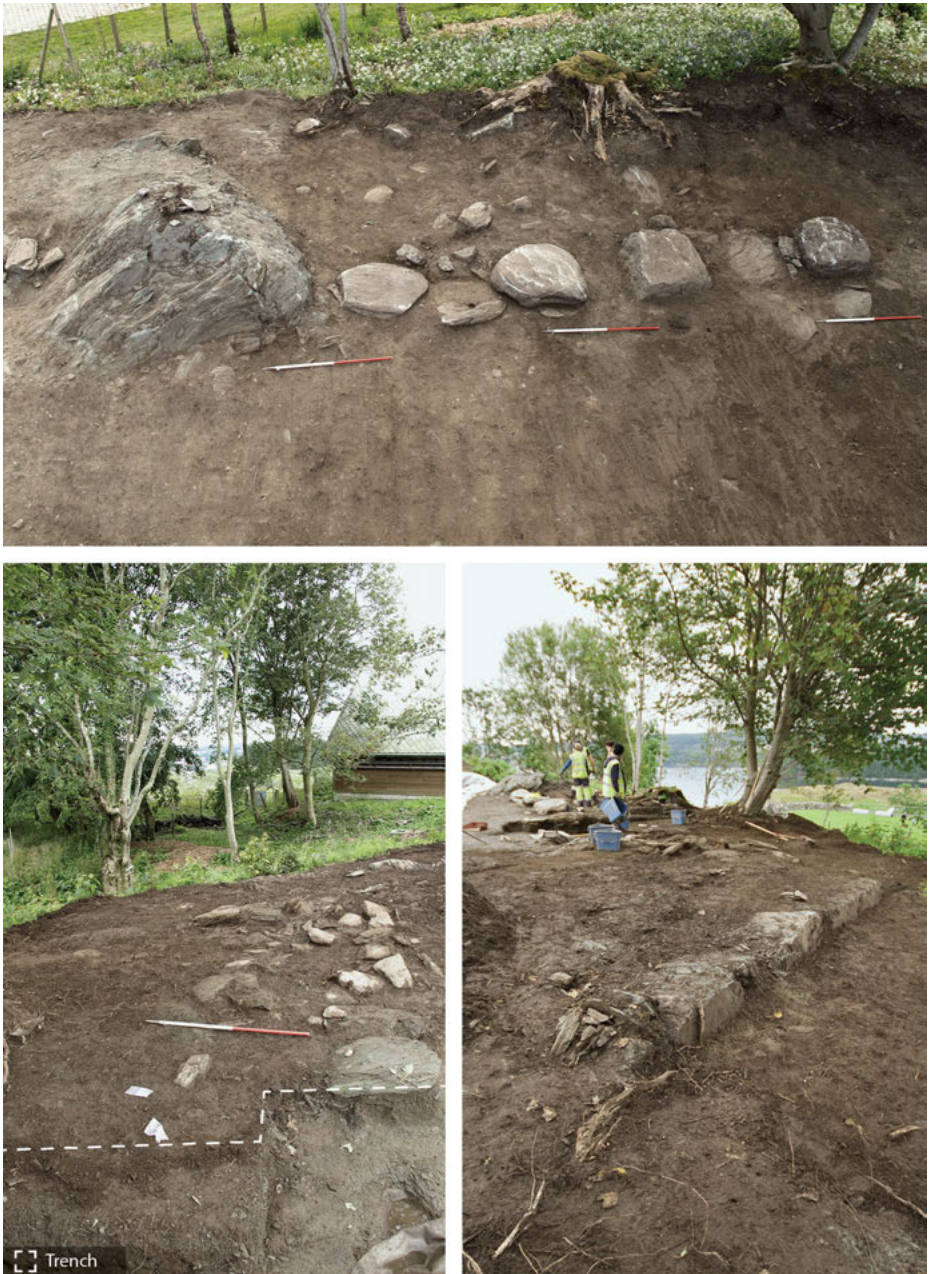
Fig. 11.3: The southern segment of stone construction A20: The northern part of that segment (above, facing east); the southernmost part slightly curving towards west (below left, facing south); the natural step in the bedrock where the terrain starts to slope towards the south and east (below right, facing north). Photo: MCH.

Immediately south of A20, an approximately 30 cm deep natural step in the bedrock running east–west marks the south-eastern end of the plateau (Fig. 11.3). South and east of this, the terrain becomes increasingly uneven and slopes more

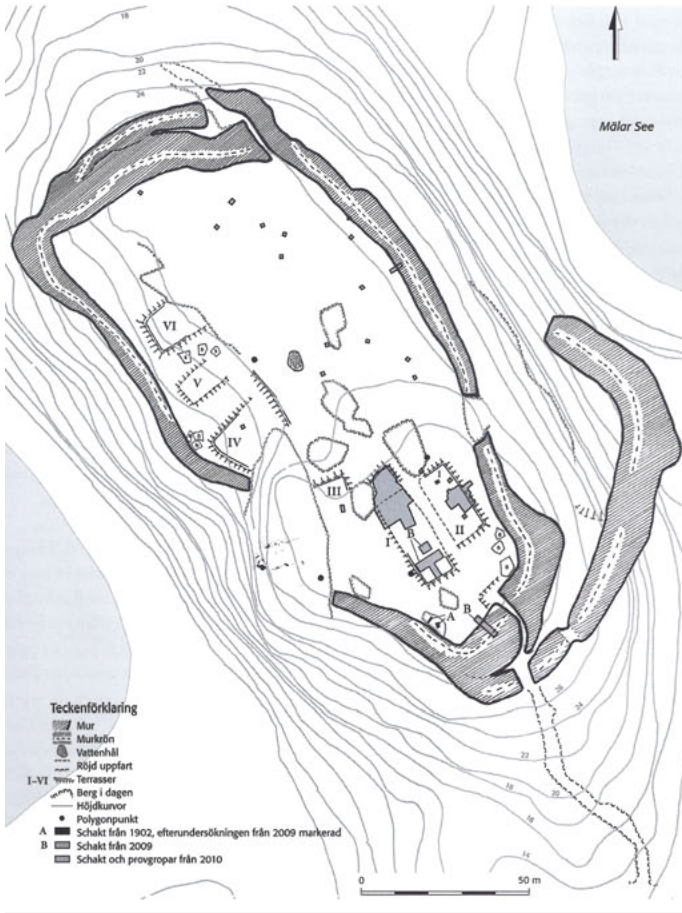
Fig. 11.5: Examples of defended and defendable Swedish parallels: Hilltop site, Runsa borg (upper, Olausson 2011a:fig. 1); Enclosed magnate farm, Lindö Utmark, Kärrobo parish (lower, Olausson 2009:fig. 1).

the enclosed magnate farm at Lindö Utmark in Västmanland, Sweden, arguing that they were “fortifiable only to a certain extent” by comparison with the heavily fortified sites such as Runsa Borg (Fig. 11.5; Olausson 2009:49). The defensible sites have insufficient ramparts or a placement not truly elevated from the surroundings, but the ramparts would still provide a limited degree of protection. Based on the excavated remains, A20 seems to have obstructed access to a part of the settlement from the east while adding to a monumental façade towards the strait; as such the Avaldsnes fortifications may be understood as defensible rather than defended.
