Regional mapping and frequency-magnitude analysis of debris avalanches and debris flows in Hordaland, Norway

Master thesis in Geosciences GEO5960
Geohazards
60 credits

Department of Geosciences
The Faculty of Mathematics and Natural Sciences

UNIVERSITY OF OSLO

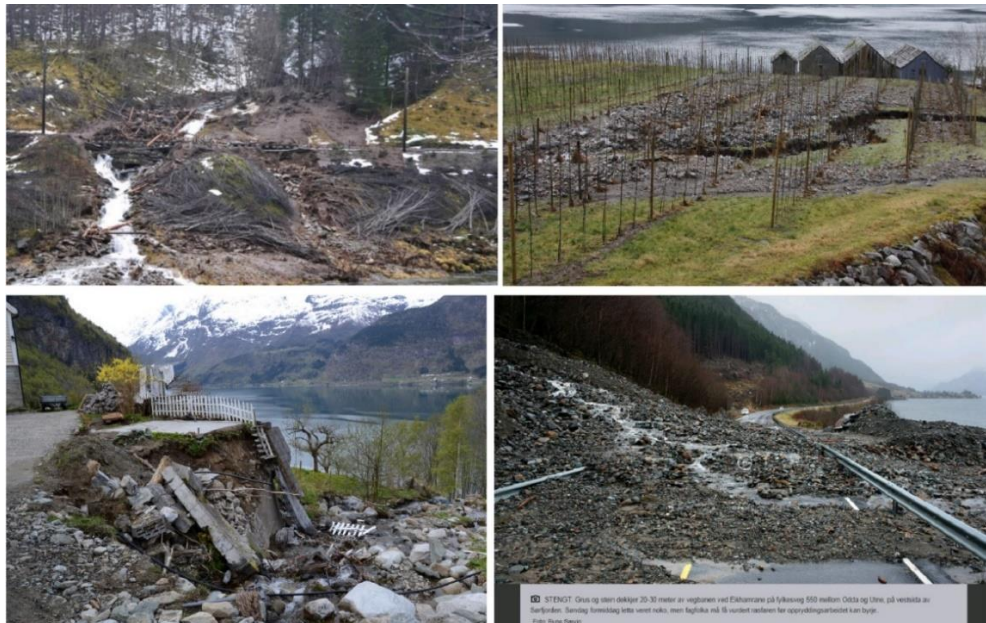
Figure 3.12: Economic damages in Hordaland. **Top:** Damaged railway after a landslide during “Dagmar” in 2011 on the left (Source: NRK). One of many apple farms, destroyed by a debris flow during “Dagmar” in 2011 (Source: Hardanger Folkeblad). **Bottom:** Destruction on private property after “Dagmar” in 2011 on the left (Source: Odd-Arne Mikkelsen/NVE). A blocked road after a debris flow occurred during the storm “Synne” in 2015 (Source: Bergens Tidende).

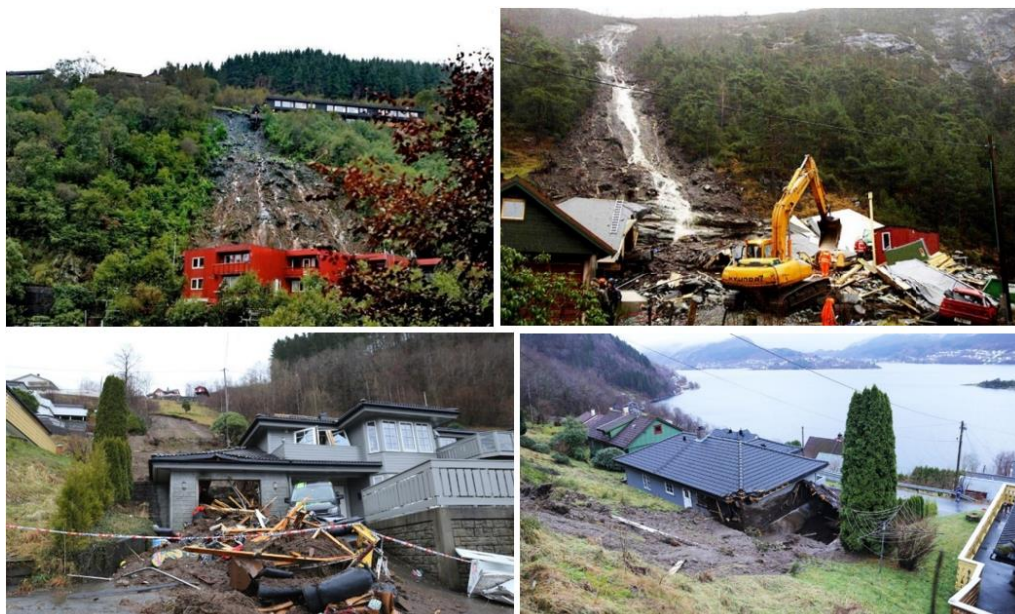
Figure 3.13: Lethal weather-induced landslides in Hordaland since 2000. **Top left:** Hatlestad Terrasse in Bergen night before September 14th killed three people in the residences, caused by storm Kristin (Source: Nettavisen). **Top right:** Nyborg in Åsane November 14th killed one person working in the house, caused by storm Loke (Source: Dagbladet). **Bottom:** Votlo on Osterøy December 7th killed one person living in the house, caused by storm Aina (Source: NRK).

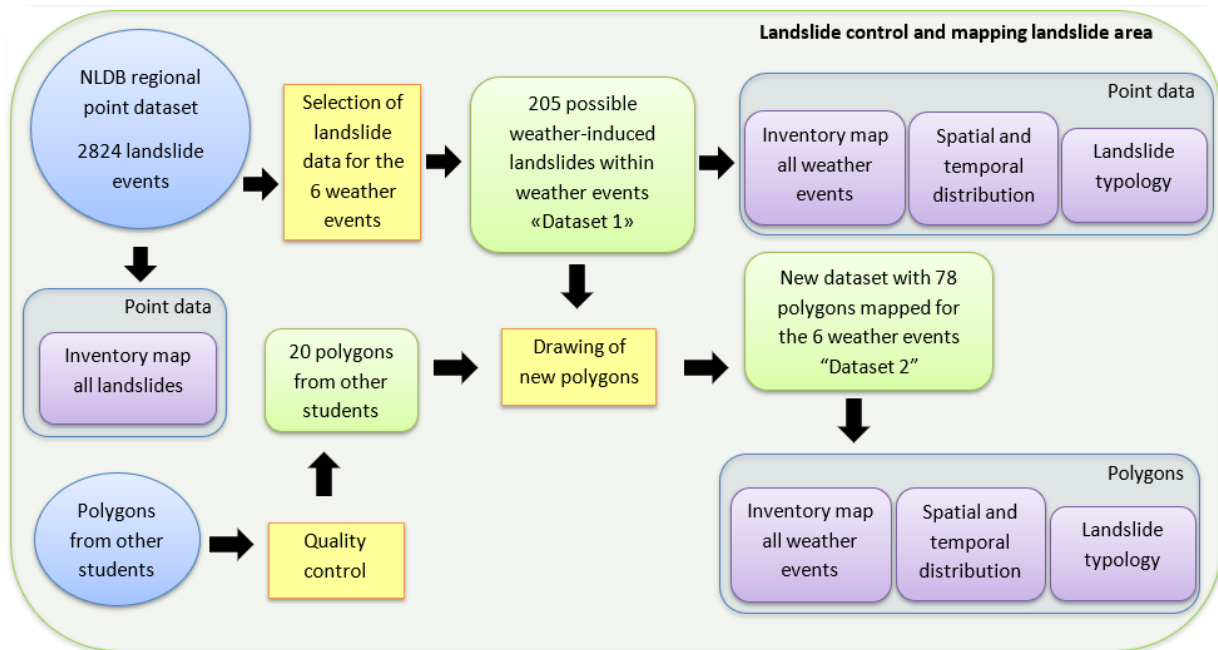
Figure 5.4: The methodology of the landslide control and mapping landslide area.

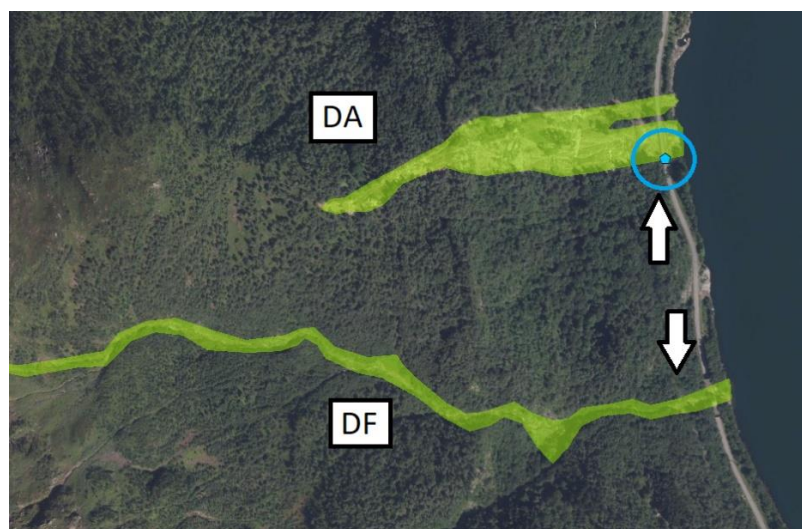
Figure 5.6: Example of two polygons drawn on top of an aerial photo. The debris avalanche (DA) is registered in the database; the point registration is shown in blue. The debris flow (DF) was not registered in the database but was featured in the news.

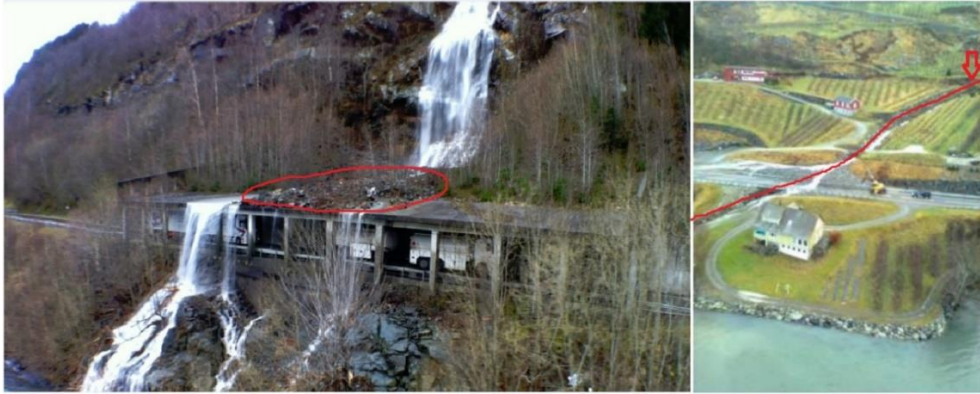
Figure 5.11: Examples of the use of photographs. **Left:** Picture of a landslide hitting a mitigation measure along Sør fjorden. The news coverage focused on the trailers trapped below it, as the road on both sides was blocked by other landslides, but this landslide was not registered in the database. Deposit material is shown with a red circle (Source; NRK). **Right:** Example of a landslide that might have the wrong date in the database, because of contradicting sources. The picture shows a debris flow after “Dagmar” 2011 from the NPRA, with the red line showing where the track is.

The left picture in figure 5.11 shows an example of a landslide that was featured in the media repeatedly but not registered in the landslide database. It is possible that this was because it was caught by a gallery (mitigation measure) above the road. The landslide was in the media due to the drivers seeking shelter beneath the structure, because of other landslides in the area. As the NPRA is responsible for registering landslides along the roads, it is assumed that the landslide was not registered because the road was not damaged.

Another landslide that was mapped is shown in the right picture in figure 5.11. The landslide was not registered as a part of the event “Dagmar” in 2011 but was registered as occurring one month before, during the storm “Berit”. A picture of the landslide was however used in a report from NPRA (NPRA, 2012) about landslides occurring during “Dagmar” and was therefore assumed to possibly be registered with the wrong date and included in the “Dagmar” data set.

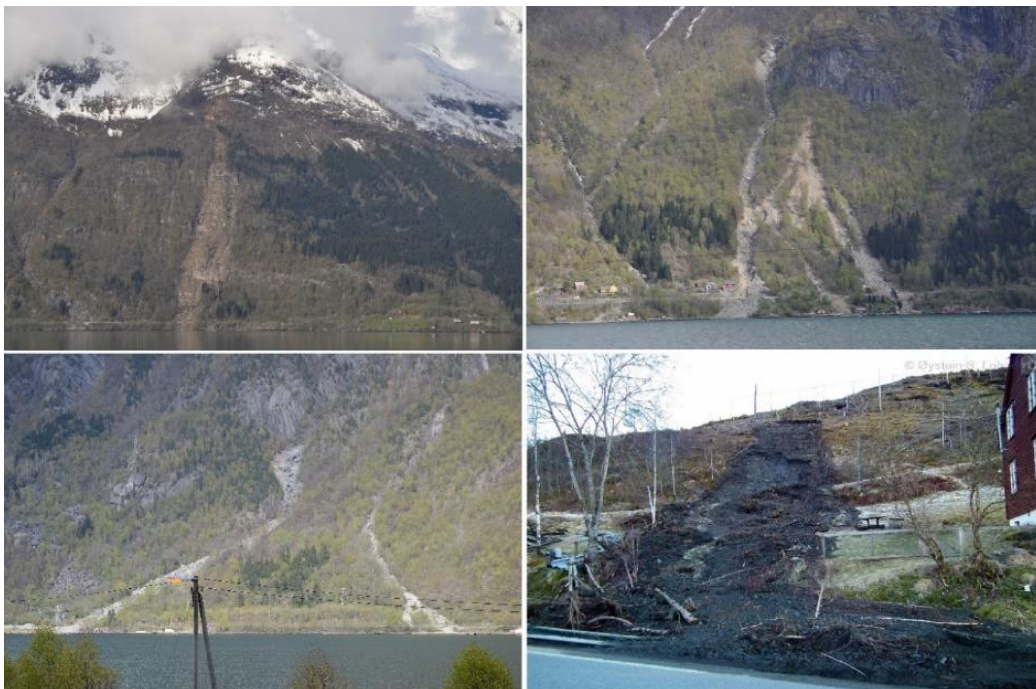
Figure 5.12: Examples of pictures of landslides taken by NVE personnel and available at RegObs. The two pictures on top that was taken by Aart Verhage, and the lower left that was taken by Odd-Arne Mikkelsen, all three pictures taken in the field after “Dagmar” 2011. The lower right is a registration from the RegObs platform of a landslide occurring March 20th, 2014, taken by Øystein S. Lohne.

Several pictures were obtained from NVE, taken during a field trip in Sør fjorden in May 2012 after “Dagmar” 2011. These were used to confirm and check some of the mapped landslides. Some pictures taken by civilians were also obtained from RegObs. Figure 5.12 shows a few of the pictures used to confirm landslides registered in the NLDB.

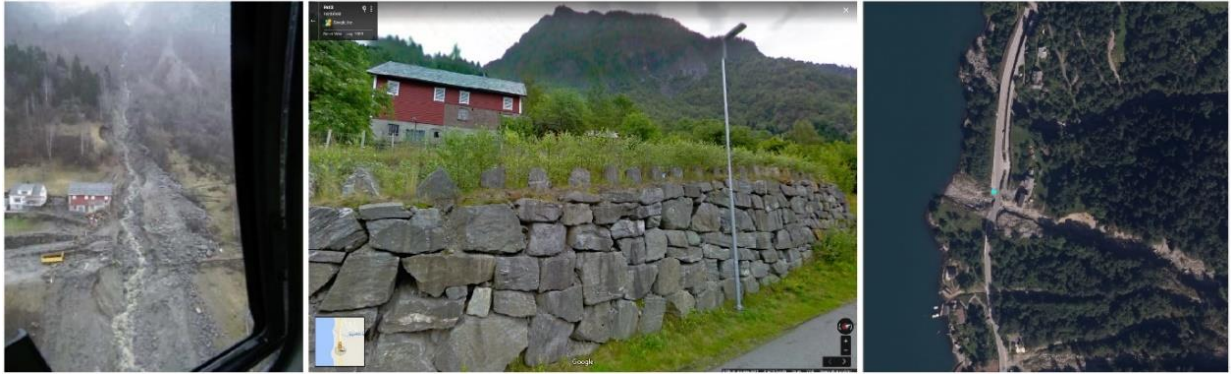
Figure 5.14: Example of how google street view was used to find the right location of landslides. Picture taken by the NPRA, the location on google maps and the aerial photo of the same area.

Google street view was used to find the right location of some landslides. Photos that were obtained from the Norwegian Public Road Administration (NPRA, 2012) were used together with aerial photos to map the polygon. An example is shown in figure 5.14. The location of the landslide pictured on the left was found in google street view (middle). The same landslide pictured in an aerial photo is shown in the right. The pictures obtained from google street view were from 2009 and did therefore not show the landslide, but the buildings in the area coincide with photos and aerial photos.

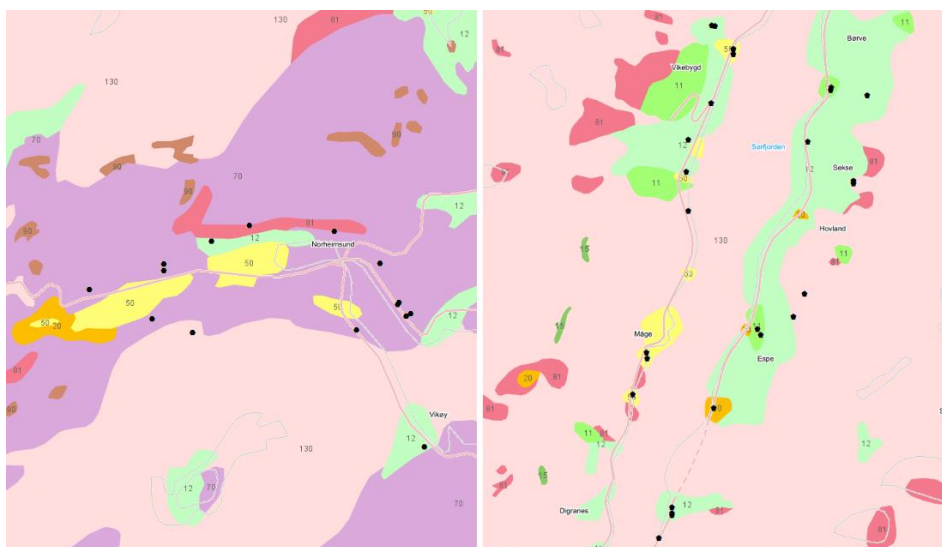
Figure 7.4: Example of landslide point data from “dataset 1” together with the quaternary deposit. “March 2014” event in Nordheimsund on the left and “Dagmar 2011” in Sjørfjorden on the right (the right picture shows only 27 of the landslide points due to the resolution of the map).

The spatial distribution of “dataset 1” is influenced by many landslides having occurred along roads, railways and close to buildings and other infrastructure. The different spatial patterns between the different weather events could be partially explained by the spatial distribution of the rainfall and snowmelt. The landslide events during storms “Berit 2011”, “Dagmar 2011” and “Synne 2015” mostly follow the steep sides of the fjords. The landslide events on March

20th and in October 2014 both have many landslides occurring in less steep areas, in Nordheimsund, and around Evanger. The October event seems to have landslides spread all over the county while the March event was more clustered. The landslides from “Hilde 2013” are spatially distributed in the northern part of the county because this weather event hit the Western coastline further north, and seemed to have less impact on Hordaland than the other weather events. Due to the different weather events having both different triggers and clusters, a quick comparison was made between the event on March 20th in 2014 and “Dagmar” in 2011 (figure 7.4). 15 out of 35 landslides during the “March 2014” event occurred in Nordheimsund, consisting of mostly weathered material. In contrast, 42 out of 85 landslide events during “Dagmar” occurred in Sjørfjorden, consisting mostly of “thin or no cover” and “moraine material”. The spatial distribution of the landslide events (appendix 5), confirms how the named extreme weathers (except Hilde) all trigger landslides in Sjørfjorden, while the events on March 20th and in October 2014 mostly trigger landslides in Nordheimsund. The quaternary deposit is very different in the two areas. Nordheimsund consisting of finer materials might need more water input to trigger landslides. In comparison, Sjørfjorden, with steep slopes and thin materials, might not need as much water input to trigger landslides. This implicates that Sjørfjorden is more susceptible to landslides during winter storms, and Nordheimsund is more susceptible to heavy snowmelt and long-duration rainfall. It is also observed that most landslides registered in Sjørfjorden are debris flows, while many landslides in Nordheimsund are smaller debris slides.

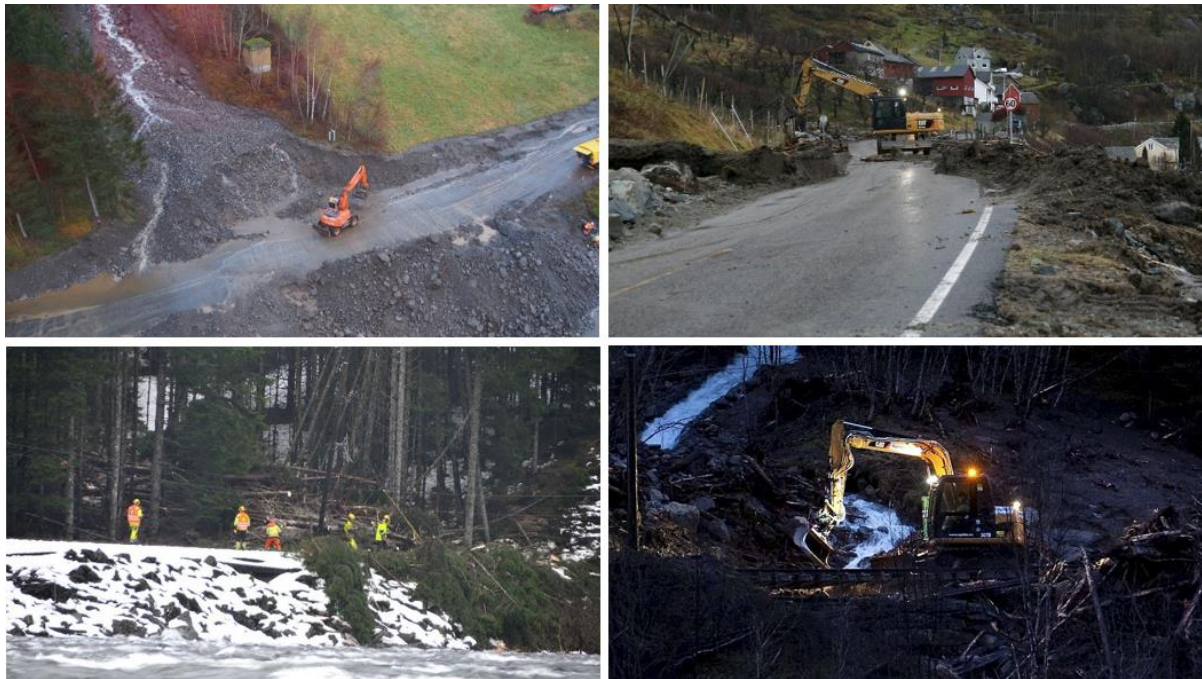
Figure 7.7: Roads (top) and railways (bottom) getting cleared quickly after landslides. All pictures were taken during “Dagmar” in 2011, except the top left, from “Hilde” (2013) top left.

Using media as a source had a good outcome during the mapping, as they contained both descriptions and pictures. These were most useful for large events affecting roads and infrastructure, as expected. Media sources often used dramatic headlines and kept the focus on people affected, and when the situation would be resolved. Articles had variable descriptions of the landslides and could have the wrong typology. Several of the pictures used in media did not show the entire extent of the slide, but rather either a picture of the deposit, clearing of the streets or railways (figure 7.7), damages caused by the landslide, or people inspecting the damages to their property. Smaller landslides were often, if mentioned at all, commented briefly. Pictures taken of smaller landslides were often taken at close range and was therefore not much help in mapping the extent and precise location. For instance, several debris slides occurring during the event on March 20th, 2014 were mentioned in an article describing the evacuation of the inhabitants in the area, but no pictures or descriptions of the landslides were available (figure 7.8).

reported, while the larger landslides got most of the attention. Landslides blocking roads and railways were quickly cleared (figure 7.4), and this also influenced the lack of visibility in aerial photos taken years later. Similar causes for lack of smaller magnitudes are also found in other works, as Stark and Hovius (2001), Brardinoni and Church (2004), Jakob (2005), Guzzetti (2005) and Corominas and Moya (2008). The choice of basing the analysis of extreme weather events might have also influenced the number of smaller registered landslides. It is also vital to include other possible explanations for the lack of smaller magnitudes, besides lack of data. As mentioned in chapter 2.2.1, geomorphological explanations are also possible; both the significance of water and groundwater and the different influence of cohesion and friction on small and large landslides, respectively. The county might be more prone to larger landslides due to the topography, while smaller magnitudes are prevented by vegetation as proposed by Dahl et al. (2013).

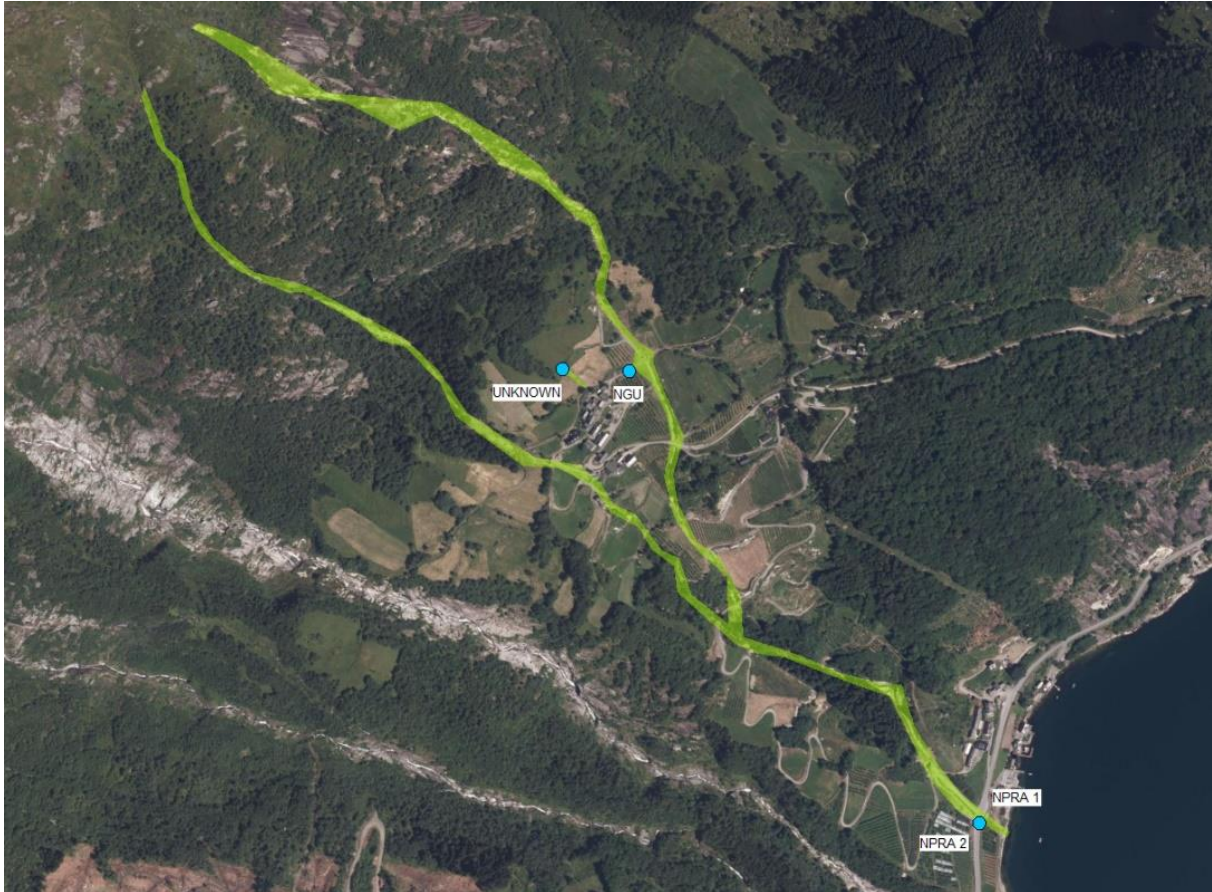
Figure 7.9: Example of double registration. Three landslides, with four registrations. The registrations varied in the description, some mentioning more than one slide, and the points were in different locations.

The mapping was based on the available data in the national landslide database, and this is contributed to by several different authors. Several landslides were registered by civilians and unknown contributors. As Jakob (2005) explains, the human memory can be highly selective, and they might be biased towards more recent events. People can also favor larger events and events with great consequences for the affected. Some landslides had several registrations for the same landslide, or a registration mentioning several landslides. One example of this was seen for three landslides occurring in Rogdo in Ullensvang during “Dagmar” in 2011 (figure 7.9). The three landslides had four registrations, some mentioning more than one landslide. Two of the landslides combined into one track and hit the main road together. The NPRA made two registrations of these two landslides, while NGU made one registration for both landslides and placed the point further up the slope. An unknown contributor made a registration mentioning all three, but with a focus on the smaller landslide occurring further upslope in between other two. It is important to have a common and clear system for registrations in the NLDB to avoid problems like this. The accuracy of time and location of the landslide was also variable. Time accuracy varied from exact to 5 years, and location accuracy varied from exact to 5000 meters.
