An outbreak of skin rash traced to a portable floating tank in Norway, May 2017

Hyllestad Susanne, Lange Heidi, Guzman-Herrador Bernardo, MacDonald Emily, Lund Vidar, Aavitsland Preben, Vold Line. An outbreak of skin rash traced to a portable floating tank in Norway, May 2017. *Euro Surveill.* 2019;24(38):pii=1900134. <https://doi.org/10.2807/1560-7917.ES.2019.24.38.1900134>

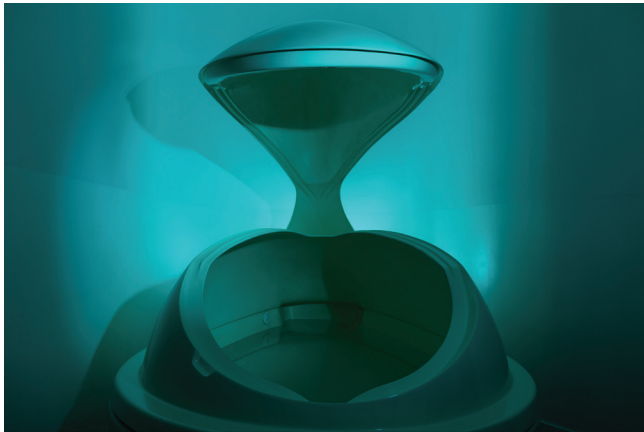
FIGURE 1

A typical floating tank for single-person use in commercial spas

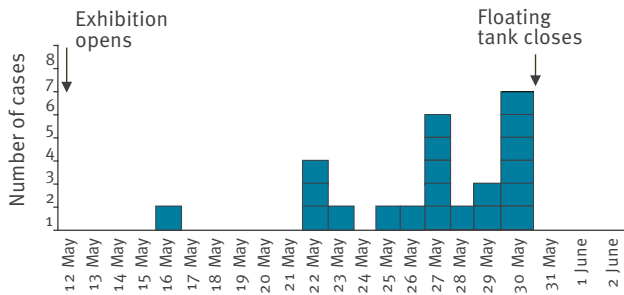
FIGURE 2

Epidemic curve of an outbreak of skin rash following bathing in a floating tank at an art exhibition, Norway, May 2017 (n = 21)

One case was excluded from the epidemic curve because of inconsistent reporting of the time of bathing and time of developing symptoms.

The median time from bathing to development of symptoms was 2 days (range: 0–4). Most cases occurred after the floating tank had been in operation for 9 days (Figure 2). The floating tank was closed on 30 May 2017. None of the investigated risk factors were significantly associated with the infection (Table 2).

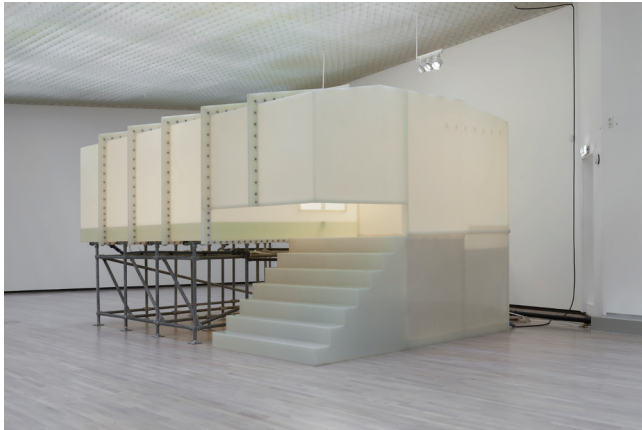
FIGURE 3

The floating tank from the exhibition, Norway, May 2017

The floating tank (Figure 3), created in 1999, was part of a temporary exhibition at the art gallery. The art gallery personnel and a consultant pool specialist installed the floating tank according to the supplied instruction manual. The floating tank was filled with fresh water from the municipal water supply system and salt (magnesium sulphate) was added before the opening of the exhibition. Personnel at the gallery were responsible for the management and routine maintenance of the floating tank. The pool specialist gave advice on salt and chlorination, including dose and monitoring. The exhibition period started on 12 May 2017 and lasted until 10 September 2017.

Visitors borrowed towels and bathrobes before entering the floating tank, and they could be immersed for up to 20 min with a maximum of four people at the same time. The art gallery personnel handled the registration of borrowed and returned towels and bathrobes. Towels and bathrobes were cleaned after each visitor, which was handled by a cleaning firm. The visitors were encouraged to shower before and after the float to avoid reaction with the salt, as described in the operation manual of the floating tank. Showers were available in the existing staff changing rooms in the gallery, in addition to a shower that was a part of the design of the floating tank. This inbuilt shower was connected to the municipal water supply (fresh water). According to the art gallery personnel, most users chose to use the showers in the changing rooms.
