Case Report

Emergency Disposal Solution for Control of a Giant Landslide and Dammed Lake in Yangtze River, China

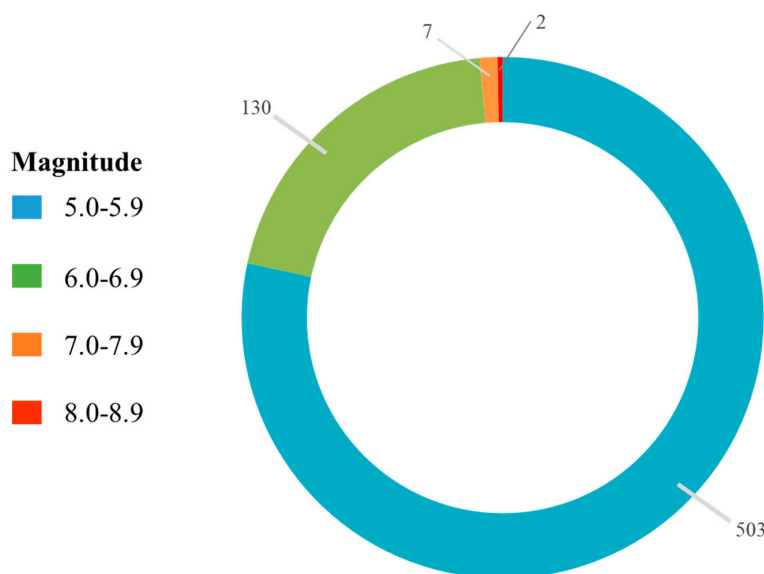
Figure 3. Data on earthquakes in Tibet. Data on earthquakes larger than magnitude 5.0 in Tibet during 1900 and 2017, extracted from the United States Geological Survey (USGS) [26] and the China Earthquake Networks Center (CENC) [27].

First—considering the earthquake factor—Tibet in China is an earthquake-prone area, and a great number of earthquakes (642, respectively) larger than magnitude 5.0 occurred in Tibet during 1900 and 2017. Out of these earthquakes, there were 503 measuring a magnitude of 5.0–5.9, 130 measuring 6.0–6.9, 7 measuring 7.0–7.9, and two measuring 8.0–8.9 (Figure 3).

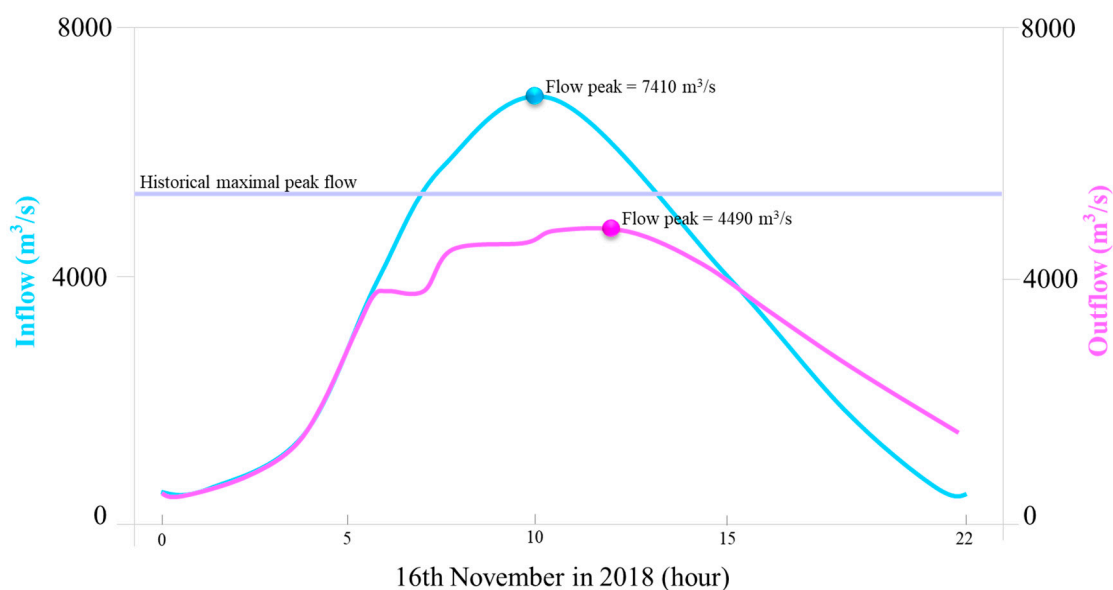
Figure 6. Sketch map of reservoir operation for releasing water in the Liyuan Reservoir.

Before the dam broke on 13 November, 2018 (Supplementary Video S2), four operational commands on cascade reservoirs were issued by the CWRC to cope with the dam break based on in-situ survey and hydrological forecasting, as described below. To deal with the floods caused by dam break, a series of reservoir operation was implemented started from 5 November, 2018. Three cascade reservoirs (Liyuan, Ahai, and Jinanqiao) vacated a total storage capacity of 0.62 billion cubic meters on 5 November, 2018. It followed six cascade reservoirs (Liyuan, Ahai, Jinanqiao, Longkaikou, Ludila, and Guanyinyan) that vacated a total storage capacity of 1.03 billion cubic meters on 10 November, followed by 1.189 billion cubic meters on 14 November, and finally reached 1.3 billion cubic meters on 15 November.

A few hours after the dam break, the peak flow discharge reached 28,300 cubic meters per second (cms) at the Yebatan hydropower station (19:00, 13 November), 20,900 cms at the Batang station (02:00, 14 November), 15,700 cms at the Benzilan station (13:00, 14 November), 7170 cms at the Shigu station (08:00, 15 November), and 7410 cms in the Liyuan Reservoir (10:00, 16 November), respectively. We noticed that reservoir inflow increased by 30% to 60% at the above-mentioned upstream reservoirs, whereas it only increased 5% to 20% at downstream stations, as compared with historical maximal peak flows. Taking the Liyuan Reservoir as an example, the decreasing rate of the flood peak reached 40%, based on the maximal inflow (7410 cms) and outflow (4490 cms) (Figure 6 and Supplementary Video S3). In other words, the joint operation of the six cascade reservoirs released a total of 1.3 billion cubic meters in storage capacity for flood control would pave the way not only to reduce a large-scale (10,000-year return period) flood into a small-scale (10-year return period) flood but to minimize the flood risk raised by the Baige landslide as well.
