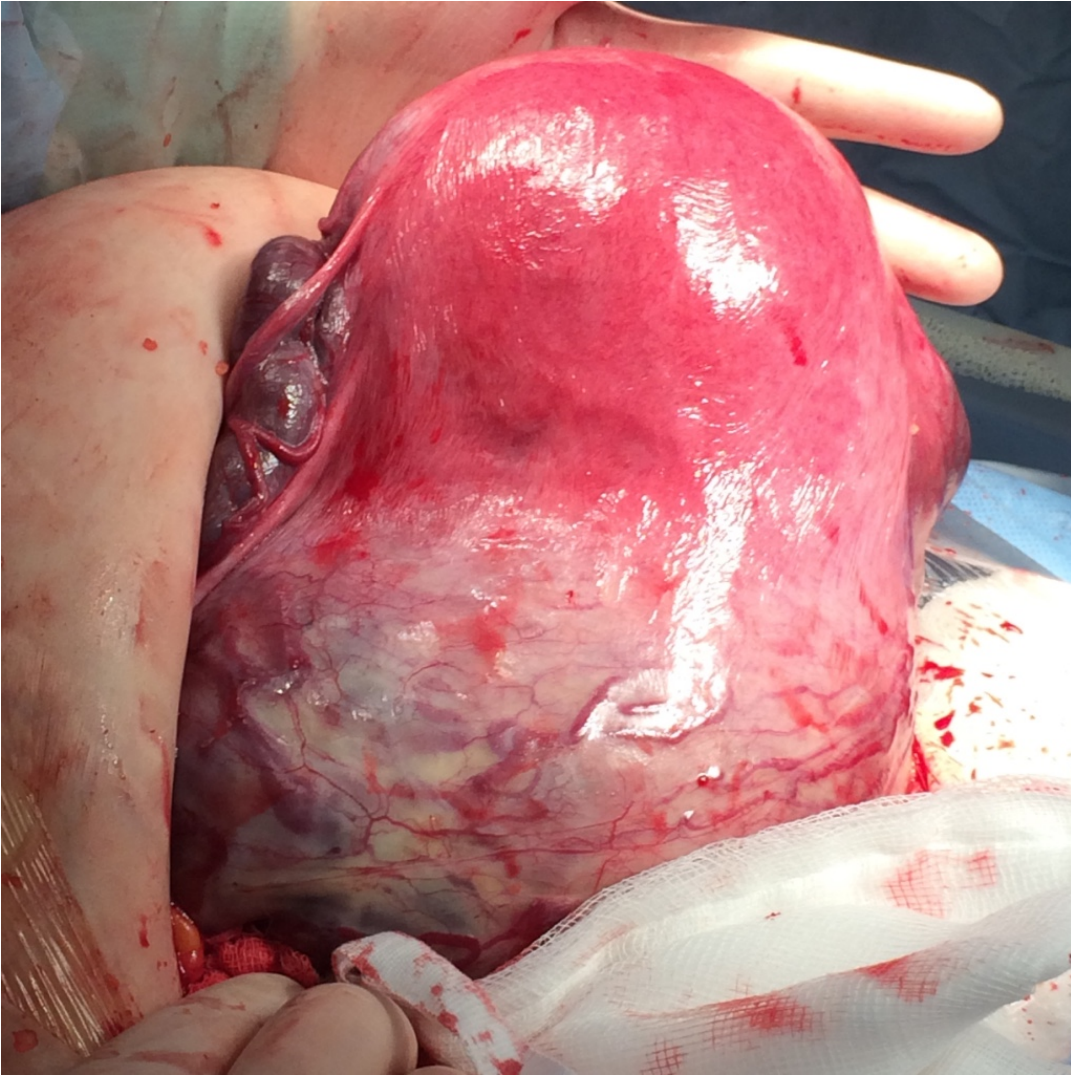
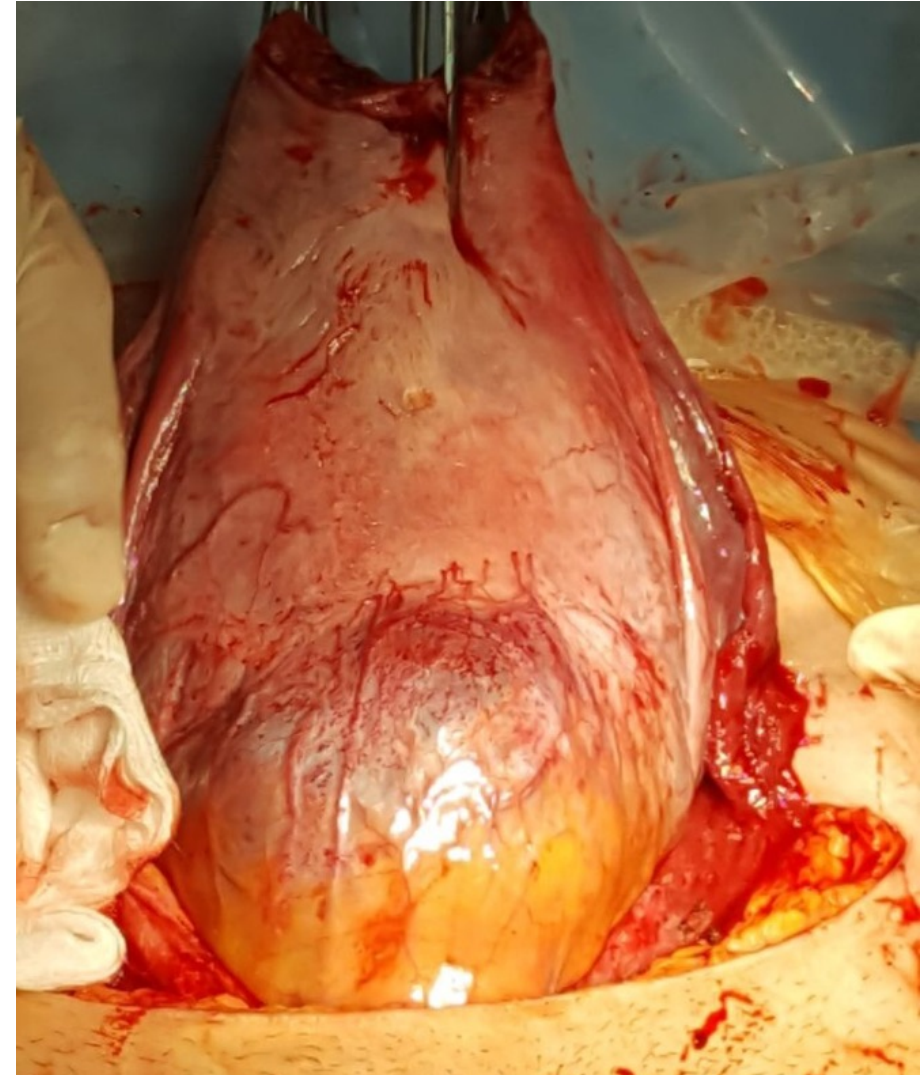
*Figure 1: Uterus over the placental bed appears abnormal (note the bluish/purple appearance) with obvious distension of the lower segment (a 'placental bulge')*

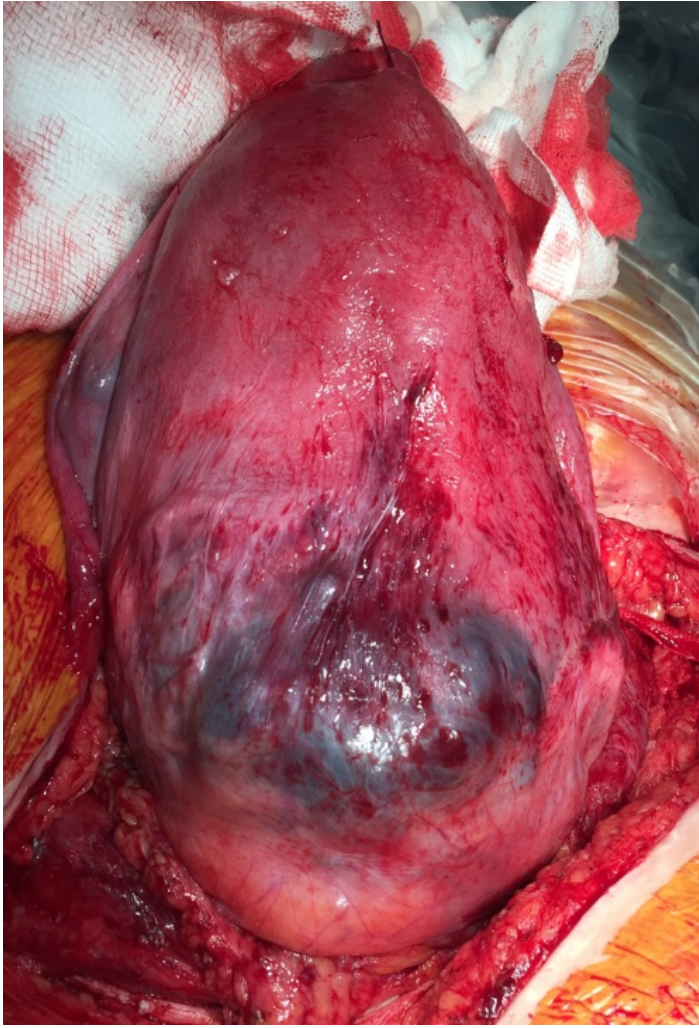
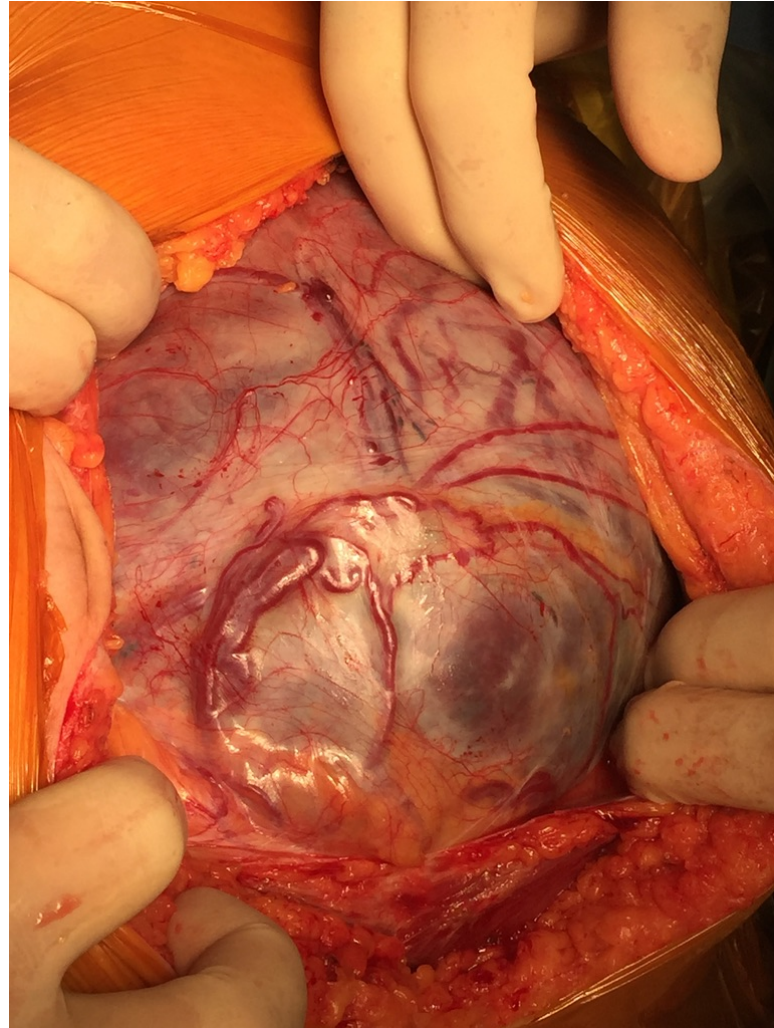
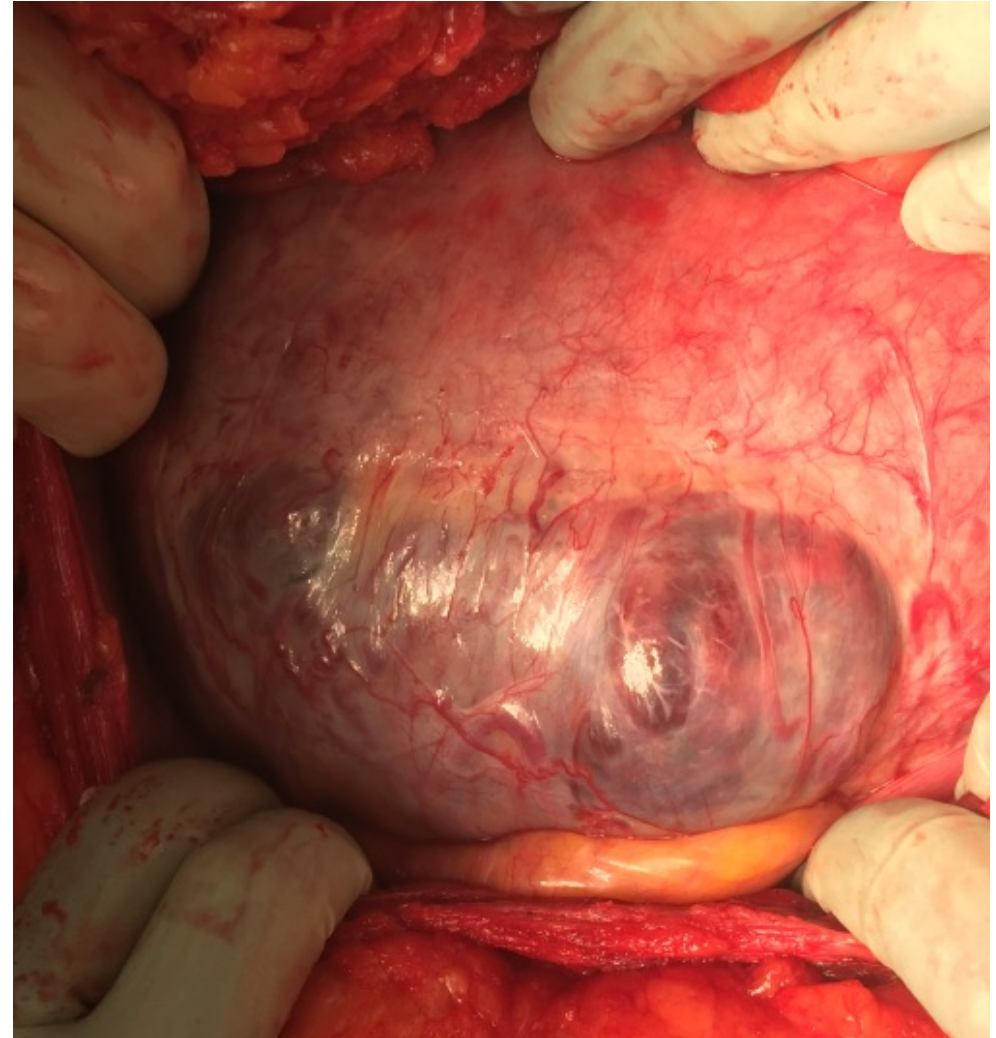
Figure 2: Placental tissue seen to have invaded through to the surface of the uterus. This may or may not have penetrated the serosa.

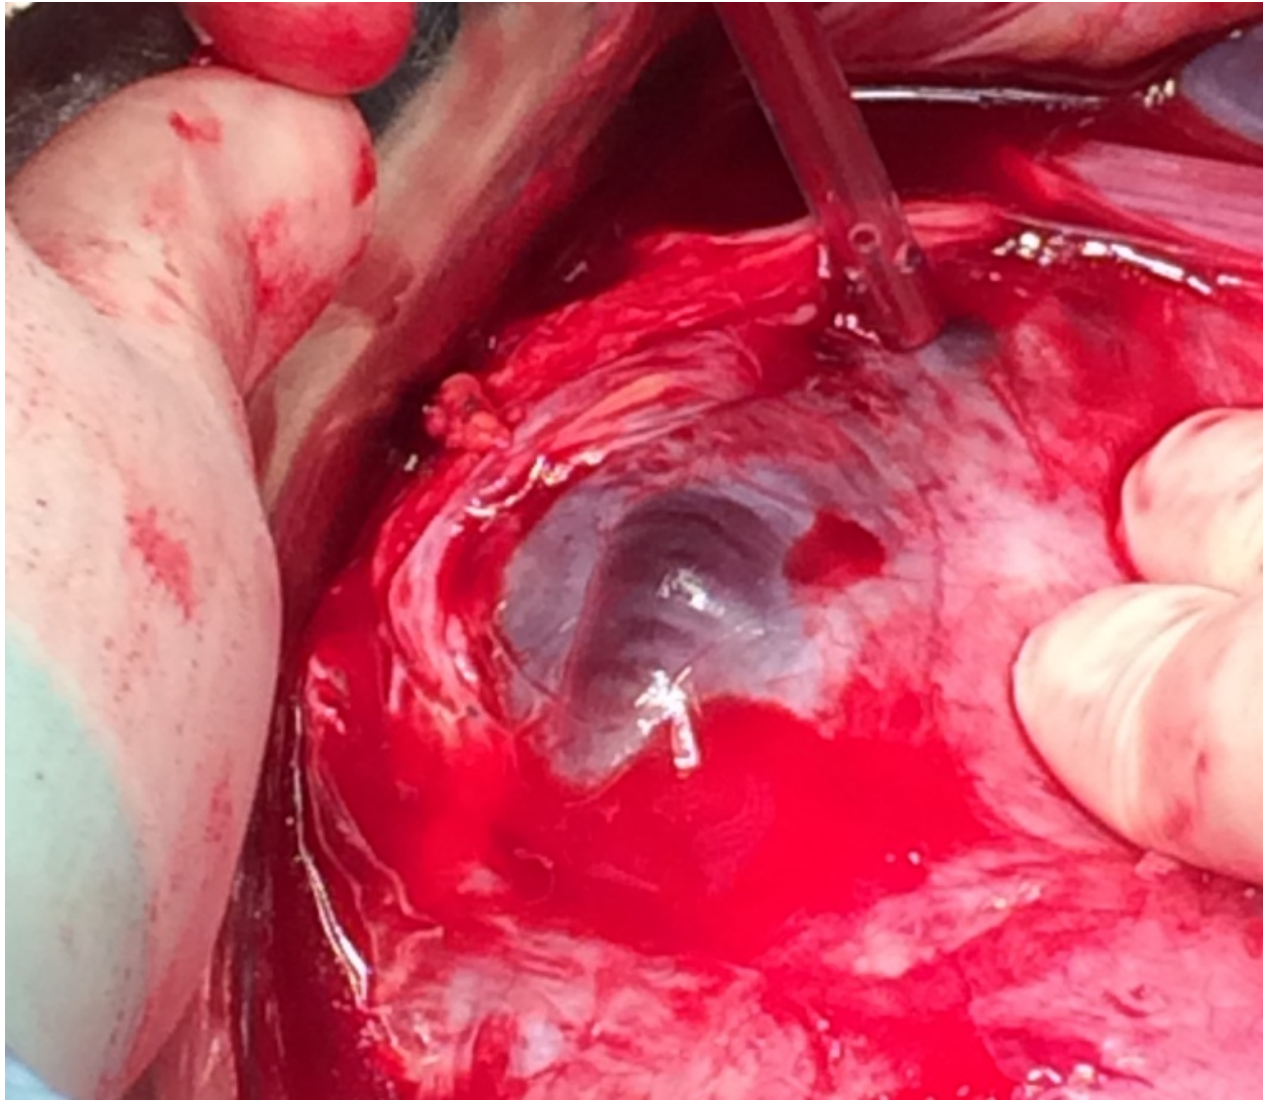
Figure 3: A 'uterine window' which is a uterine scar dehiscence with the placenta visible directly underneath it. NB the surrounding uterine tissue appears normal and there is no abnormal neovascularity.

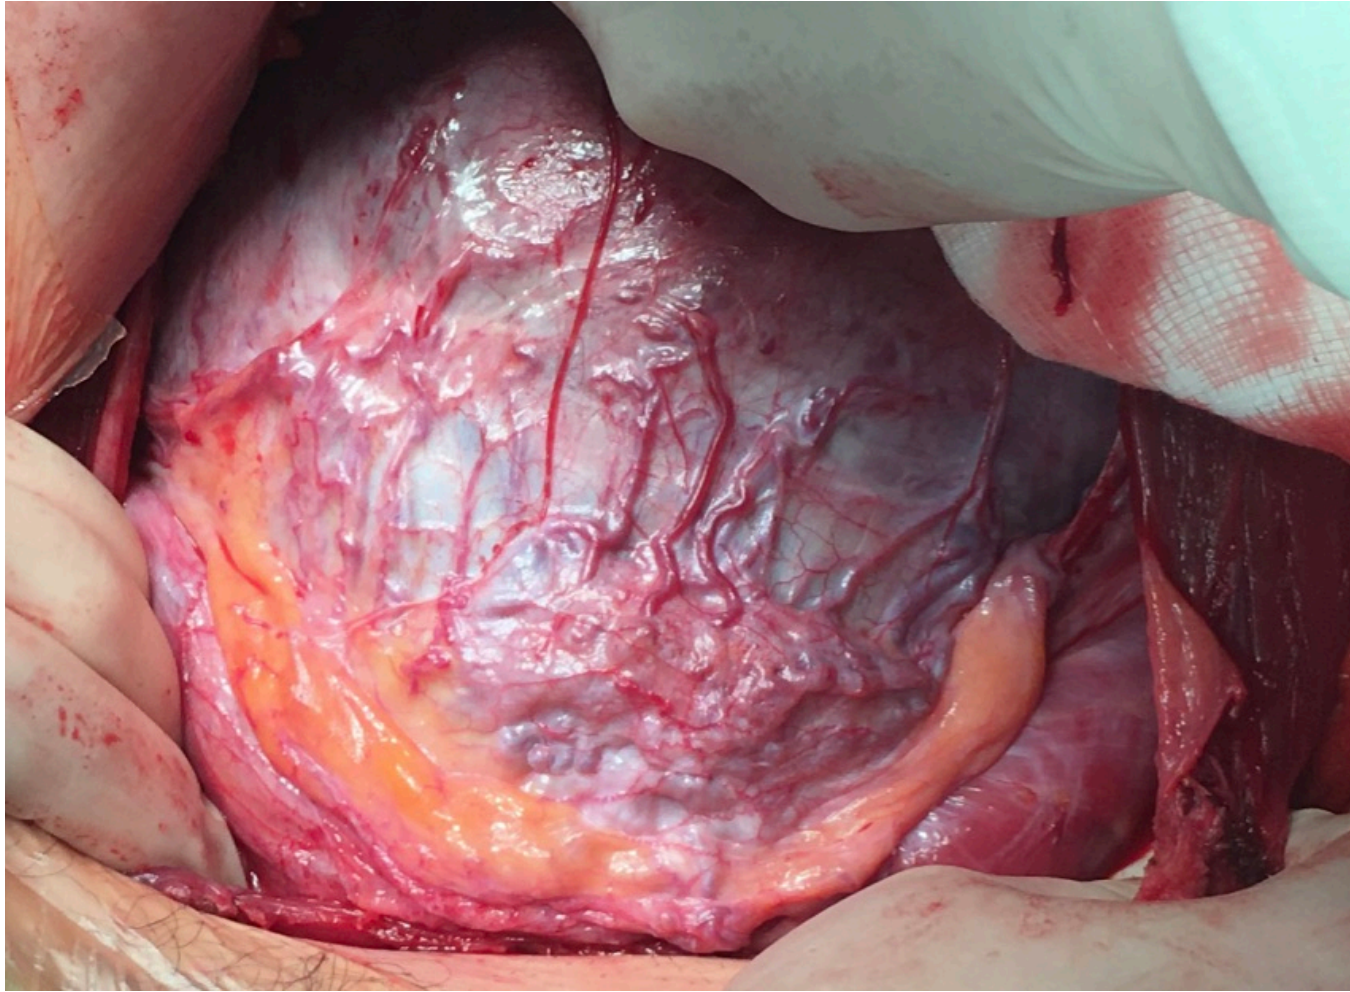
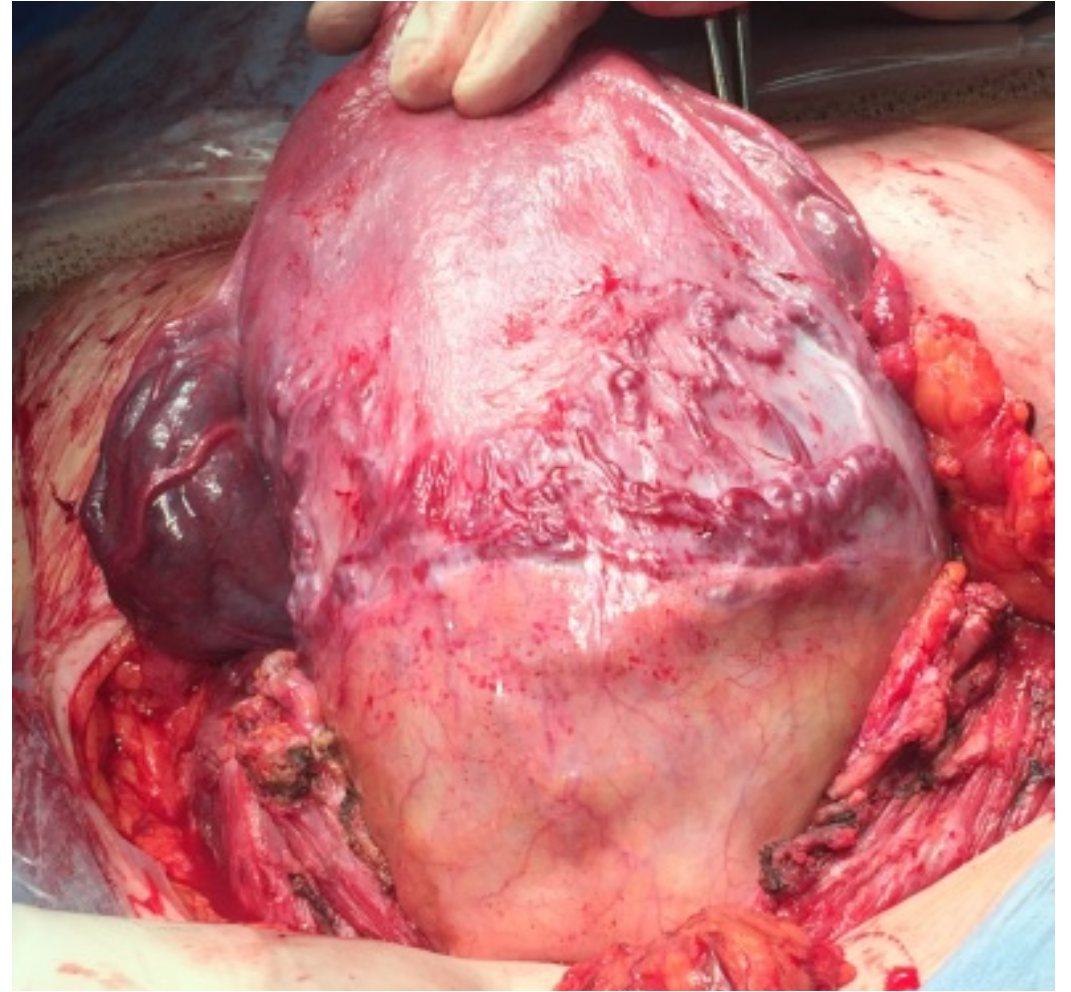
Figure 4: Excessive, abnormal neo-vascularity in the lower segment (note the vessels running cranio-caudally).
