# **Failure of an Earth Dam**

*An analysis of earth dam break – Årbogen dam, Nedre Eiker municipality, Norway*

Master Thesis in Geosciences

**June 2011**

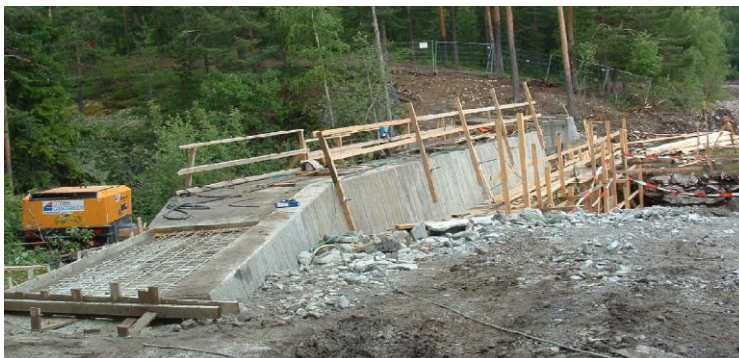
Figure 1.4: Årbogen Dam during the rehabilitation in 2003

In the rehabilitation works there are several measures carried out to improve dam stability, flooding lead capacity as well as secure against leaks. In addition, the actual spillway enhanced to improve flood lead. Along the downstream side a downstream reinforcement cast was constructed against the existing wall.

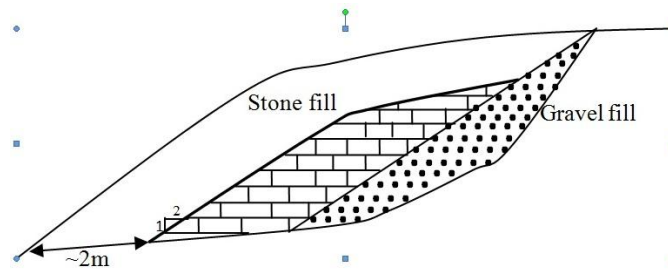
The larger stones are sorted out and placed in the top layer with a slope of 1:2 but, the pit did not filled entirely. The refill ended at about 2m inside the toe of the avalanche pit. A rough sketch of the refill structure shown in the figure 3.3 and figure 3.4 shows a partially filled avalanche pit.

Figure 3.3: Refill structure of avalanche pit

During the inspection carried out by Norwegian Geotechnical Institute (NGI), it was proposed that some immediate temporary measures to be done. In oral proposal the client was agreed to keep the drainage open to maintain lower water level and to partial refill the avalanche pits. The pits were filled with gravel with an outer layer of coarser stone about 2-3 meters. Both of the layers should represent filters for the inner natural deposit.

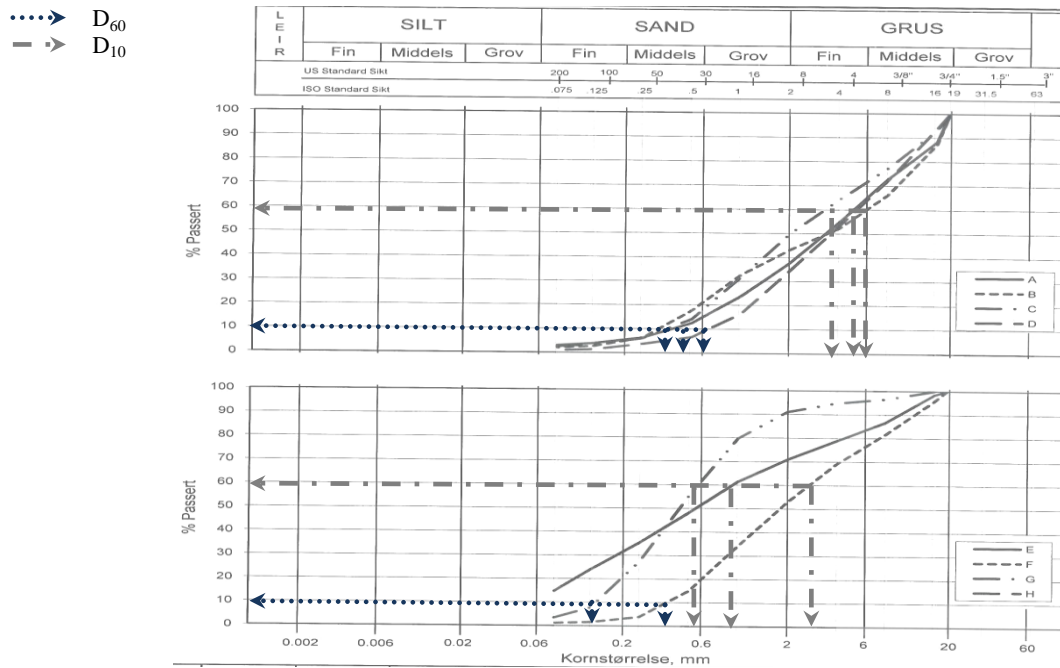
The particle size analysis has been done in the geotechnical laboratory at NGI. Totally seven samples were analyzed for PSD with four samples were taken from the avalanche pits and rest of them were collected from the boreholes (two samples from borehole 2 and one from borehole 4). 'Wet sieving' method was applied for all the analysis and the PSD curves were plotted for each corresponding samples.

The PSD curves are used to calculate the *Coefficient of Uniformity* ( $C_u$ ) and the results have been used to describe the samples under the standard soil classification system. The figure 3.4 shows the PSD curves for all seven samples. For easy identification, samples are named from A-G. Samples A, B and C are representing the borehole samples and D, E, F and G are representing the samples from the avalanche pits. The Calculated  $C_u$  values and the description of the samples are listed in the table 3.1

Figure 3.4: Particle Size Distribution (PSD) curves (Taken from NGI laboratory)

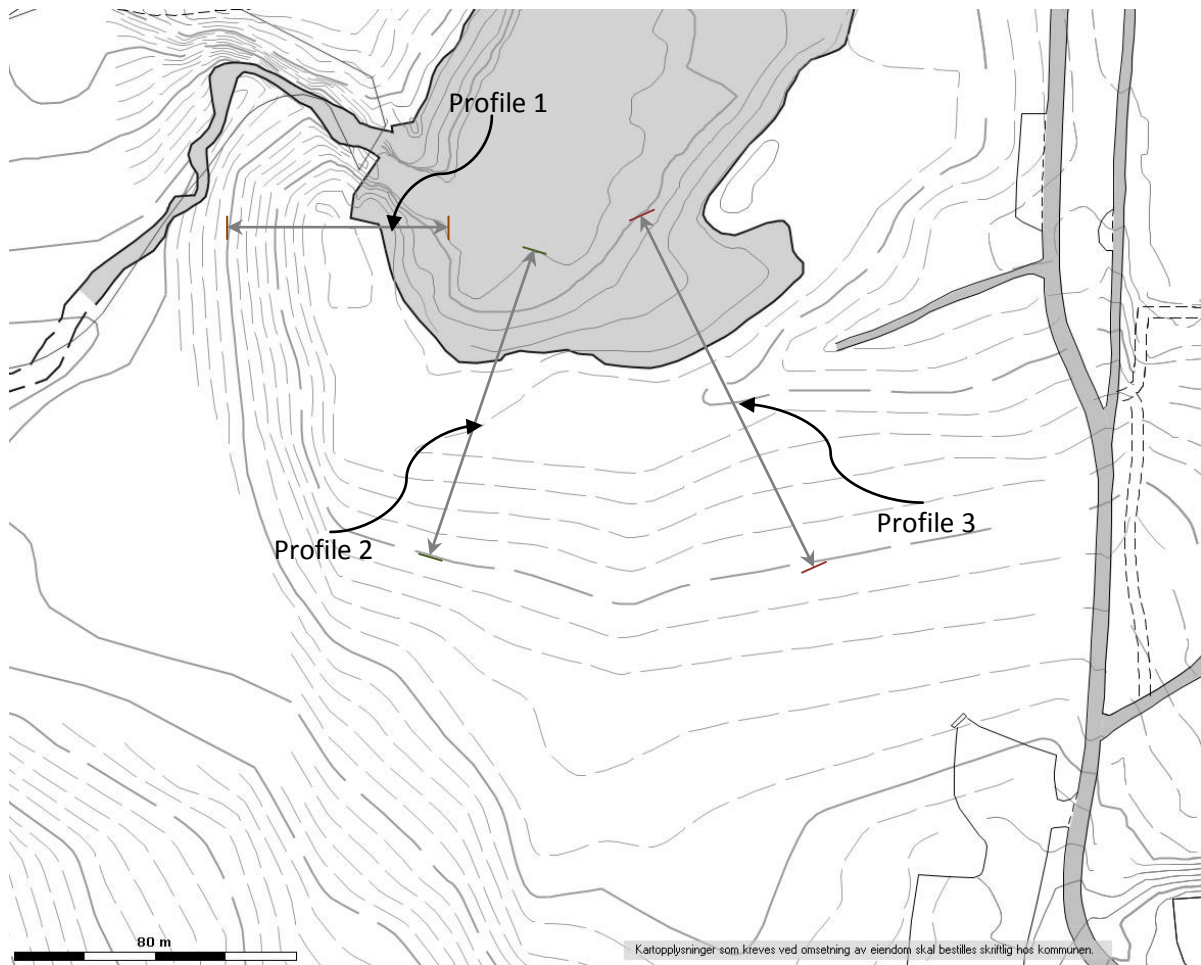
The figure 3.5 shows a contour map of the Årbogen dam site with the profiles which were created for stability and seepage analysis. Profile 1 consist quiet steep slopes in both upstream and downstream sides when compared with the two other slopes. Also this profile is situated in the area where the major slides were happened.

Figure 3.5: Selected profiles for stability and seepage analysis

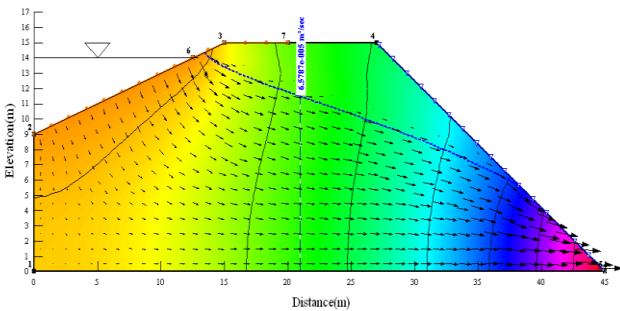
Figure 3.8(a): Seepage condition after 3 days and 21 hours of flooding

Figures 3.8(a) and 3.8(b) shows the seepage condition at 3 days and 21 hours and after 11 days and 16 hours of flooding respectively. The reservoir level indicated in the figures is the water level corresponds to the normal conditions. A new water table is formed at the initial stage as a result of the combination of flooding water level in the dam and the water table at normal dam condition (before flooding).

After 3 days and 21 hours the water table is increased ~0.5m and after 11 days and 16 hours it increased to 1m above the normal water table and interact the top of the profile at point 7 (figure 3.8(b)). A curve towards the upstream side is observed because of the quick saturation of the top layer.

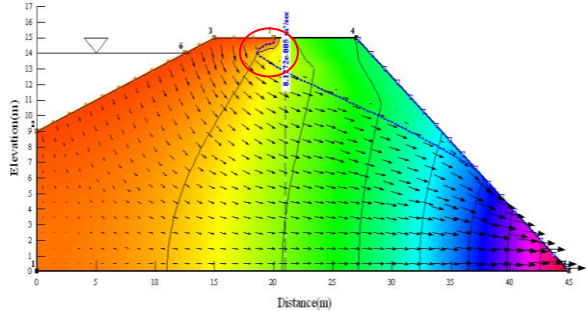
Figure 3.8(b): Seepage condition after 11 days and 16 hours

Between the above time intervals the water flux increased from  $6.578 \times 10^{-5} \text{m}^3/\text{s}$  to  $8.1272 \times 10^{-5} \text{m}^3/\text{s}$ . it shows the seepage through the deposit is increased because of the increasing head difference.

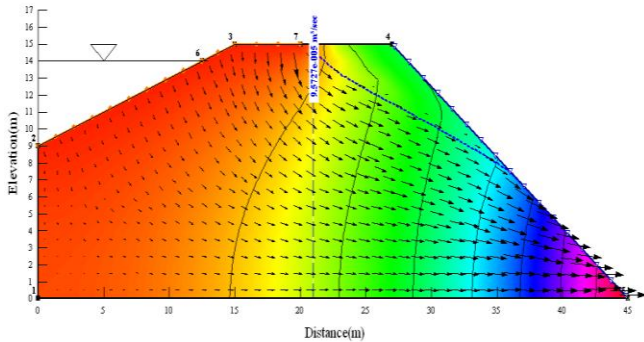
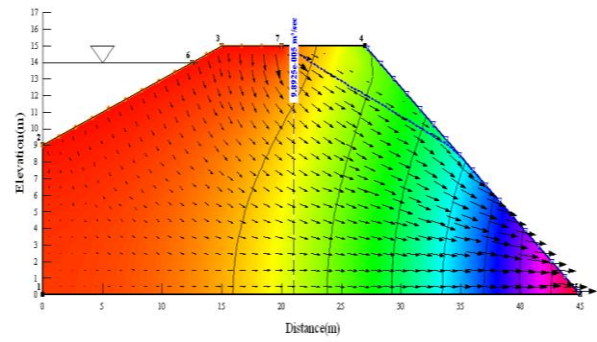
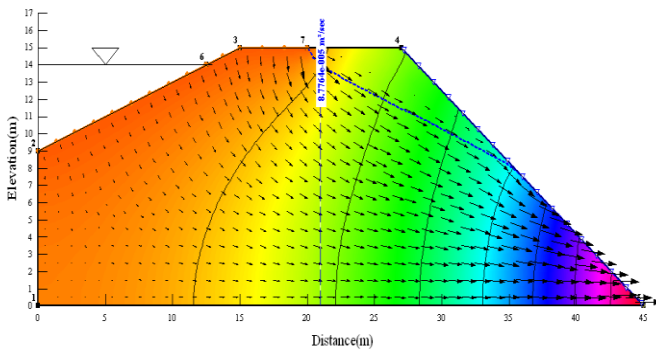
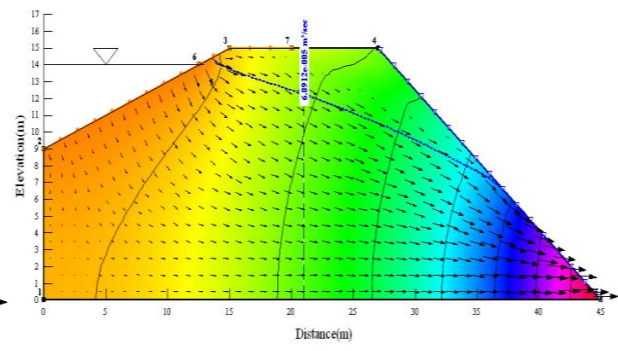
Figure 3.8(c): Seepage condition after 15 days and 13 hours of flooding

Figure 3.8(d): Seepage condition after 35 days of flooding

Figure 3.8(e): Seepage condition after 38 days and 31 hours of flooding

Figure 3.8(f): Seepage condition 77 days and 18 hours of flooding

Figures 3.8(c) to 3.8(f) show the seepage conditions for various time periods after the flooding. The water table tends to elevate continuously until a certain time period and then lowered to initial position. The seepage through the deposit also shows same variation as the water table. These changes happened because of the increasing head at the upstream side. Forward and backward movement of the total head contours clearly indicates the pressure changes.

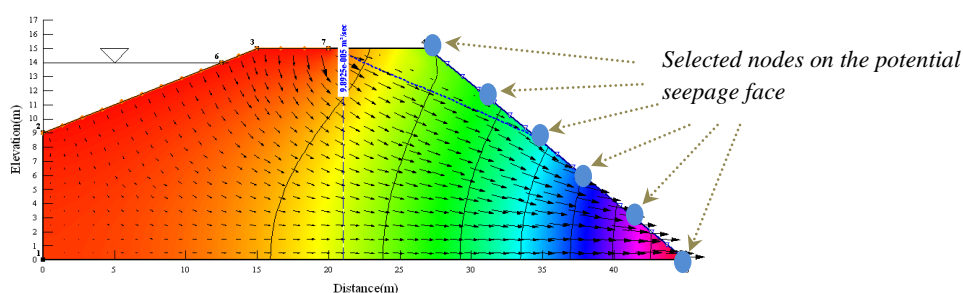
Figure 3.9: Selected nodes on the potential seepage face

Figure 3.9 shows the nodes on the potential seepage face which are selected for the analysis of pressure variation. *SEEP/W* program allows generating the graphs with distance and time as independent variables.

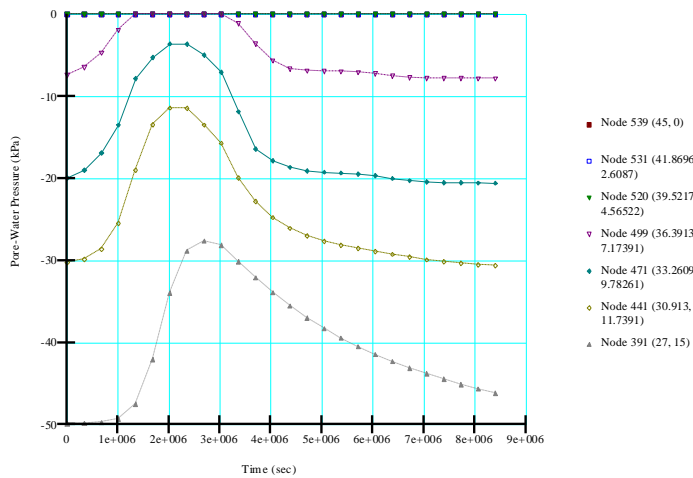
Figure 3.10: Pore-water pressure changes with time at potential seepage face

Pore – water pressure changes with time in 7 nodes on the potential seepage face is shown in the figure 3.10. Pore-water pressure changes all nodes are similar way. The node at the bottom of the geometry (node 539) always has higher pore-water pressure than other nodes, because the node is saturated at all. But the increasing seepage caused an elevation in the graph. The pore-water pressure which corresponding the other nodes will be below at any time of the analysis and arrange themselves according to the degree of saturation at each nodes.

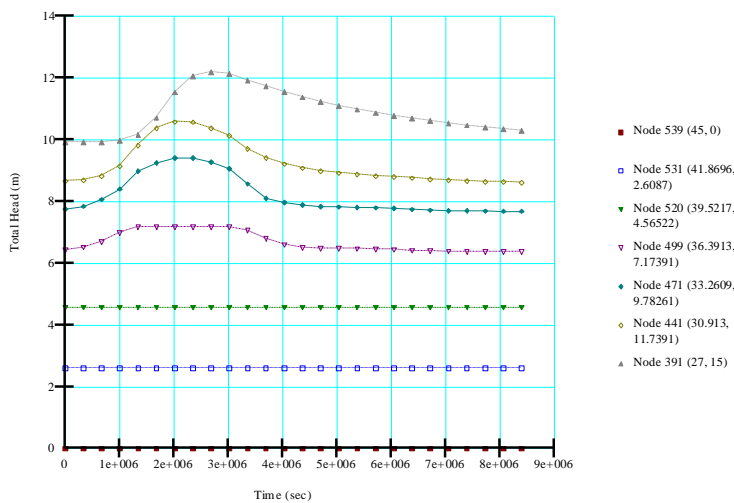
Figure 3.11: Total head changes with time and distance at potential seepage face

Figure 3.11 shows the changes of total head with time and distance at same nodes on the potential seepage face. The node at the bottom of the downstream slope (node 539) is defined as a boundary condition with zero pressure. Therefore the total head at the node 539 is always zero. Total pressure at the nodes 531 and 520 are not change with time because; it always being below the water table. At all other nodes, the total pressure continuously increase with time until the water table reaches to the maximum and then started to reduce.

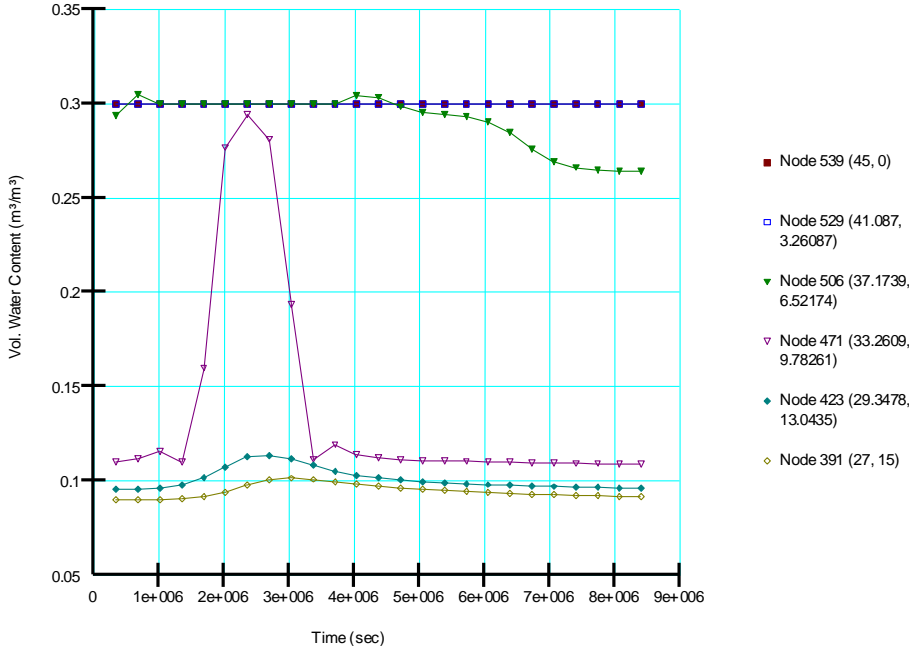
Figure 3.13: Change of volumetric water content with time

The figure 3.13 shows the changes in the volumetric water content of the soil at selected nodes. Nodes 506 and 529 are representing the soils which have higher volumetric water content. Because the nodes always lay below the water table, hence they are fully saturated. Similarly, the nodes 423 and 391 are always above the water table and hence, partially saturated. A large changed observed in the node 471 because; the water table raised above the node at a time and the soil become fully saturated.

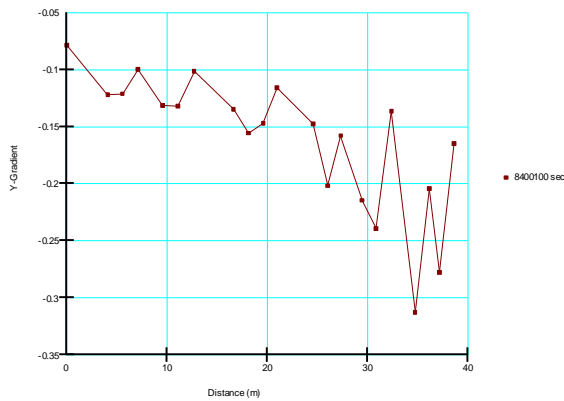
Figure 3.14: Change Y gradient with distance at the end of the flood

The figure 3.13 shows the changes in Y gradient (hydraulic gradient) with distance at the end of the flooding. In the upstream slope of the deposit (distance 0), the changes in the Y gradient is low and increases with the increasing distance. When it approaches to the downstream slope, the variation in the Y gradient is very high. The reason for the increases could be the widening of the flow path towards the downstream side. This indicates the increased erosion and the the initiation of piping in the downstream slope.

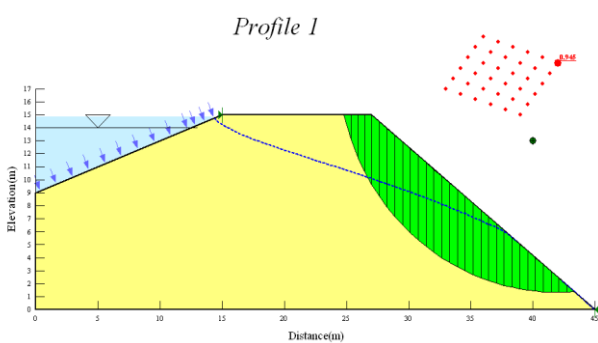
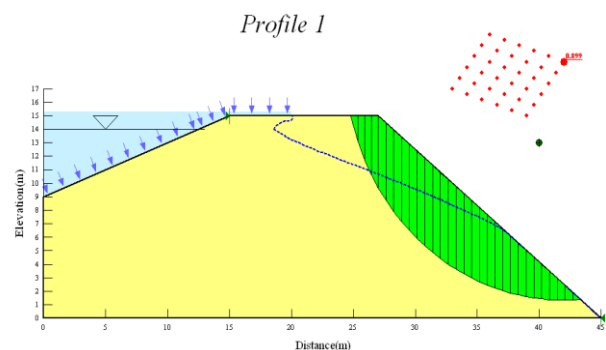
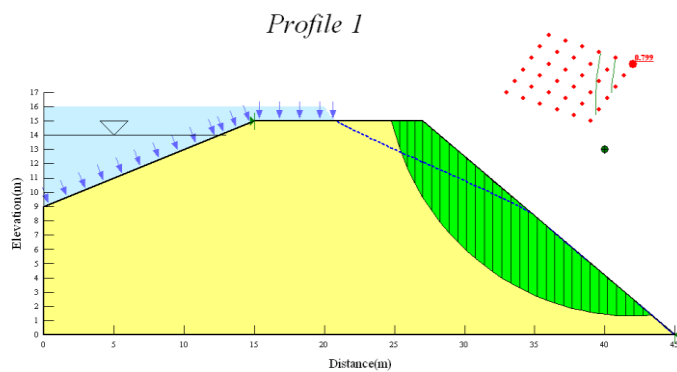
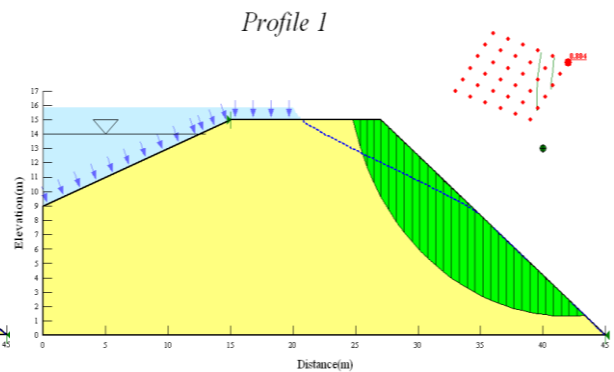
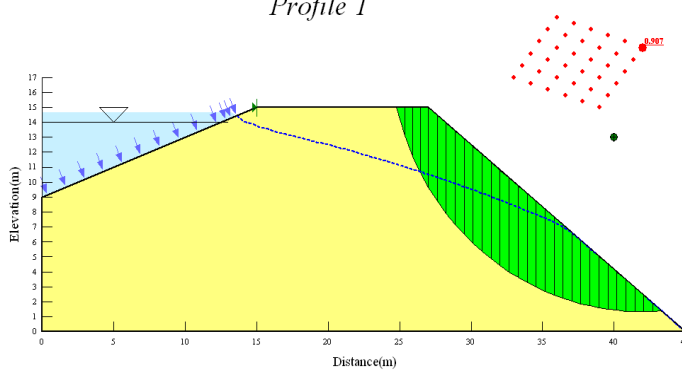
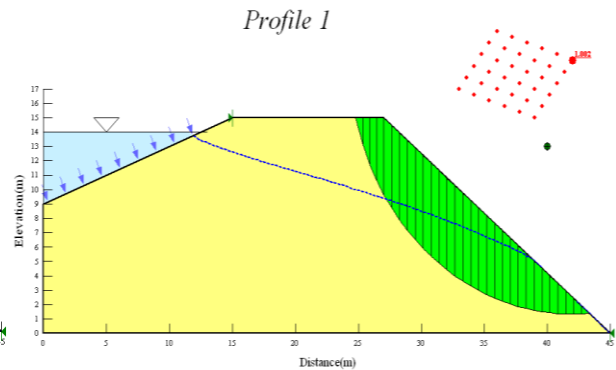
The stability has been analyzed for four different time periods after the flood. They are 30 minutes, 4 days, 33 days and 97 days (last time period). All the analysis carried out based on *Morgenstern-price method*. The factor of safety was obtained for each analysis with keeping the same slip surface for all analysis. Stability conditions for each time period are shown in figures 3.14(a)-3.14(f)

Figure 3.15(a): Stability analysis after 3 days and 21 hours

Figure 3.15(b): Stability analysis after 11 days and 16 hours

Figure 3.15(c): Stability analysis after 23 days and 8 hours  
Profile 1

Figure 3.15(d): Stability analysis after 27 days and 5 hours  
Profile 1

Figure 3.15(e): Stability analysis after 38 days and 21 hours  
Profile 1

Figure 3.15(f): Stability analysis after 97 days and 5 hours  
Profile 1

The results proved that the deposit is potentially unstable in theoretically. But some other situations at the field may increase the possibility of failure. The suspected factors may be

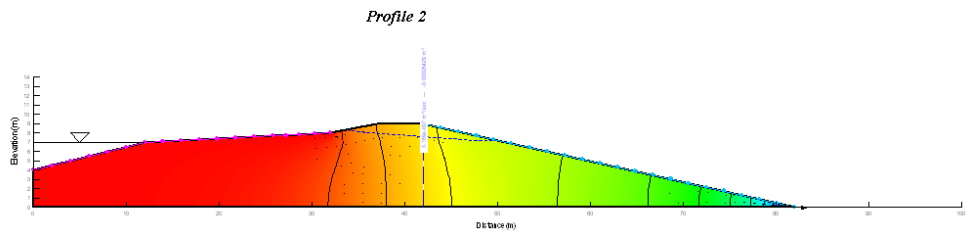
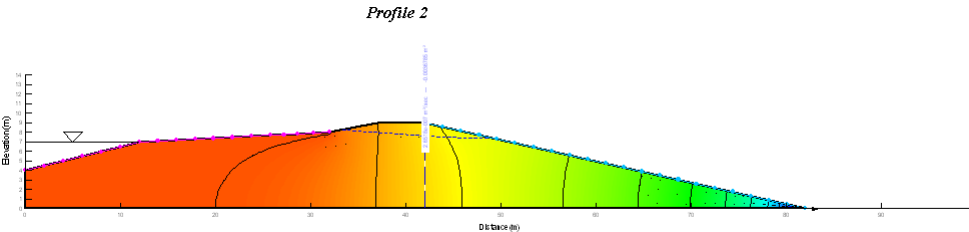
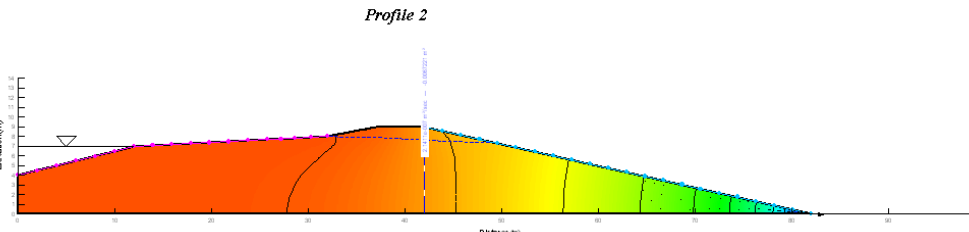
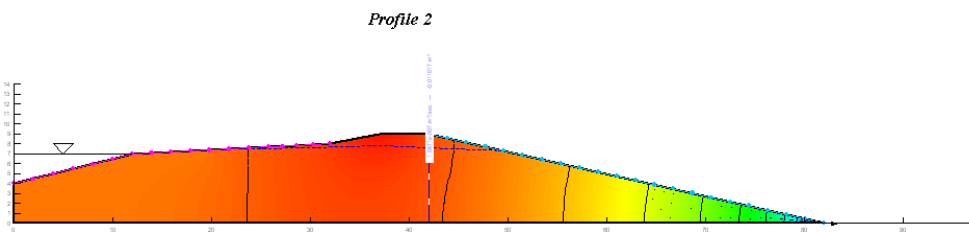
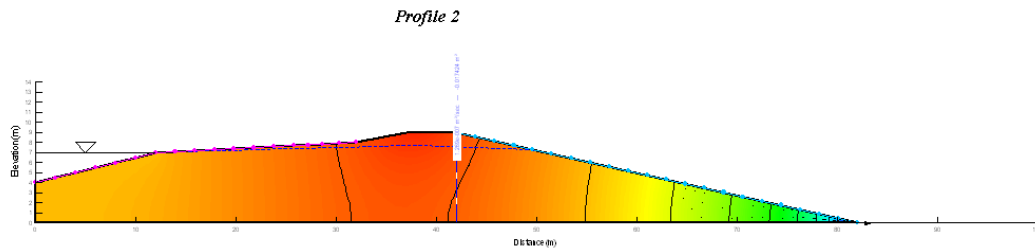
Figure 3.16(a): Seepage conditions at initial stage

Figure 3.16(b): Seepage conditions after 3 hours and 30 minutes

Figure 3.16(c): Seepage conditions after 7 hours and 20 minutes

Figure 3.16(d): Seepage conditions after 14 hours and 25 minutes

Figure 3.16(e): Seepage conditions after 28 hours (Last)

The figures 3.16(a) – 3.16(e) shows varies stages of transient seepage analysis. From the initial stage, the water table is lowering and the total flux through the embankment is decreasing with increasing time. These results are summarized in the table 3.4

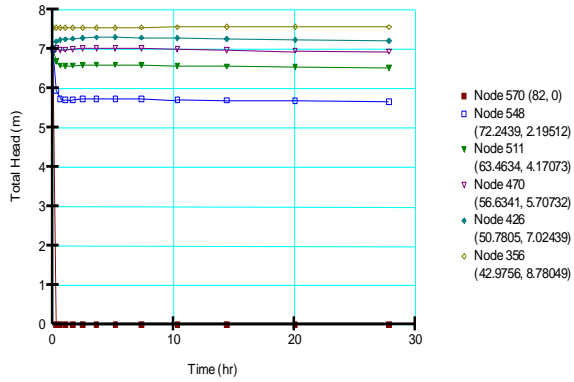
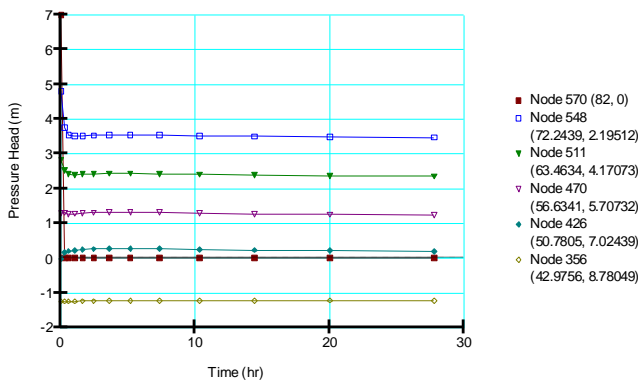
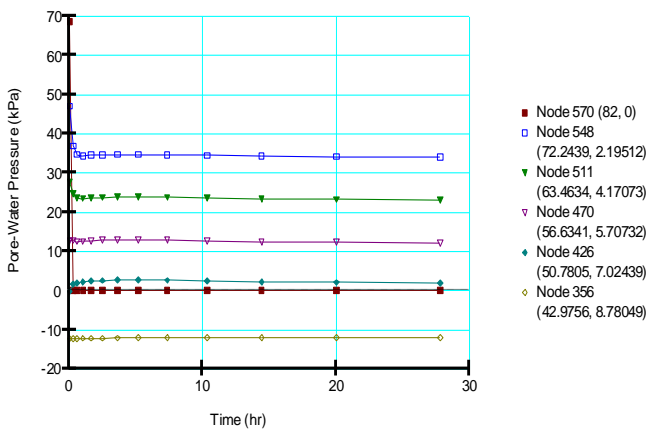
470, 426 and 356) on the potential seepage face have been selected for the analysis of pressure changes. But, we can observe that there are no huge changes in the pressure conditions throughout the time as we observed during the analysis of profile 1.

Figure 3.17: Total head Vs Time

Figure 3.18: Pressure head Vs Time

Figure 3.19: Pore-water pressure Vs Time

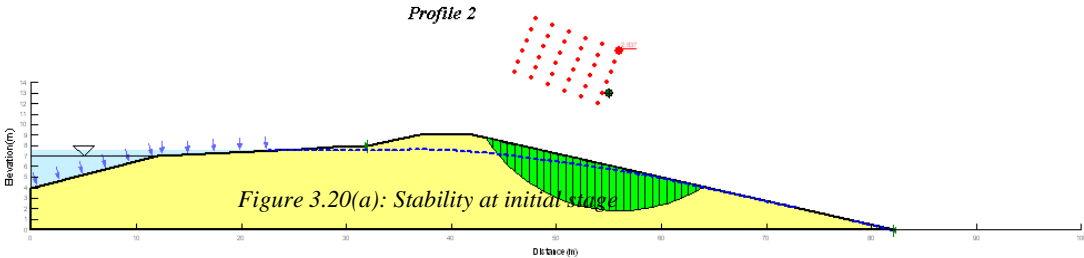
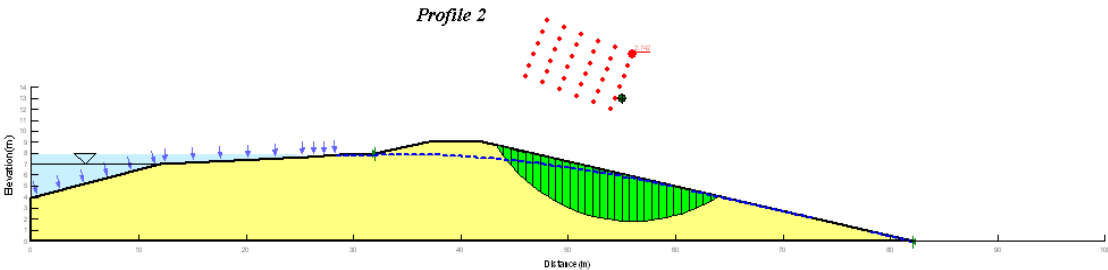
Stability analysis has been done with Mohr-Coulomb method and the strength parameters are defined as follows; Unit Weight = 18kN/m<sup>3</sup>, Cohesion = 5 kPa and Phi = 36°. Factor of safety is calculated using *Morgenstern-Price* method. Figures 3.20 (a) and 3.20 (b) show the results of stability analysis of initial and final stage of the flooding condition respectively.

Figure 3.20(b): Stability at initial stage

Figure 3.20(b): Stability at final stage

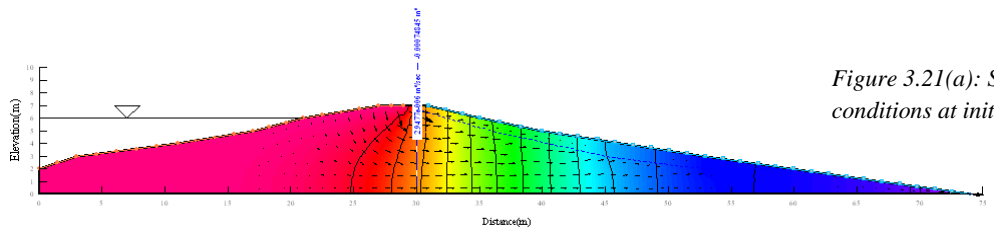
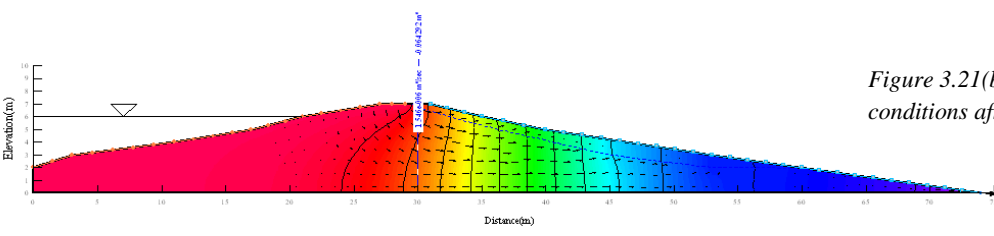
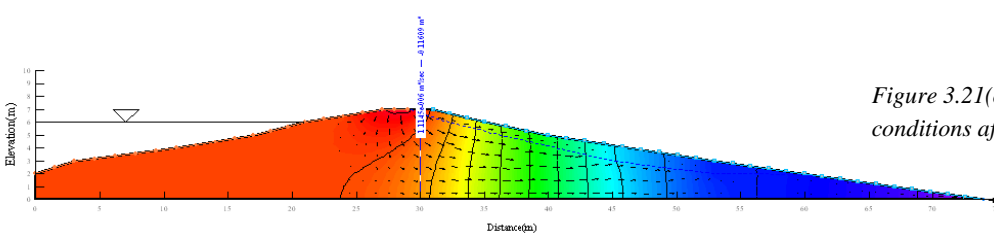
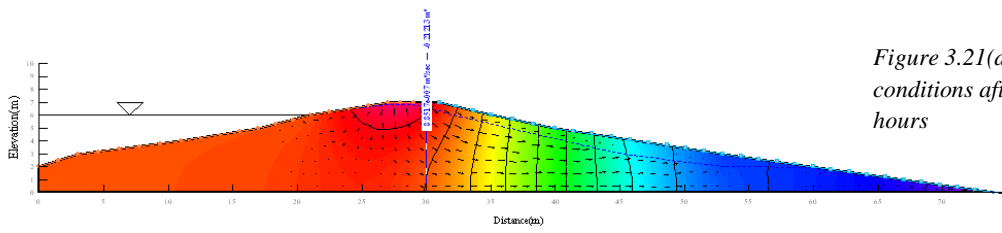
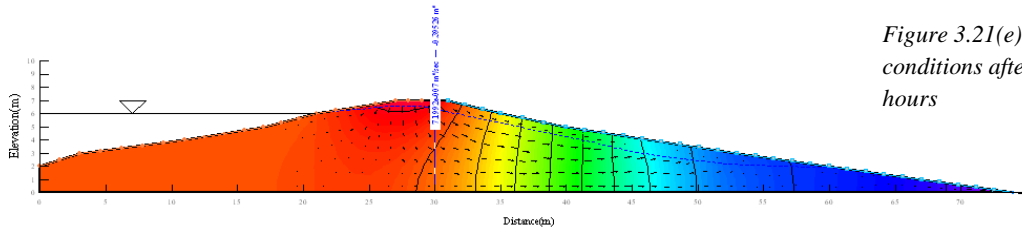
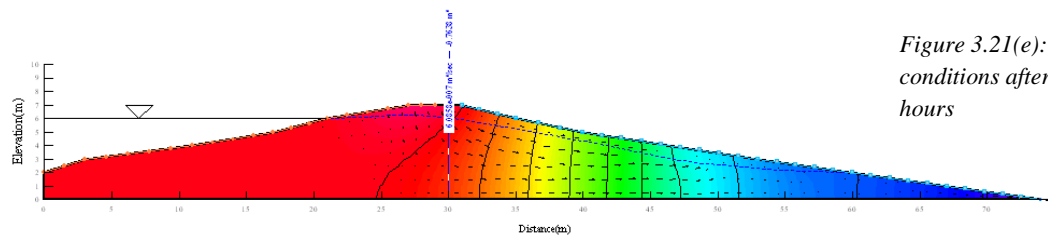
Figure 3.21(a): Seepage conditions at initial stage

Figure 3.21(b): Seepage conditions after 9 hours

Figure 3.21(c): Seepage conditions after 21 hours

Figure 3.21(d): Seepage conditions after 2 days and 2 hours

Figure 3.21(e): Seepage conditions after 4 days and 21 hours

Figure 3.21(e): Seepage conditions after 11 days and 12 hours

From the visual interpretation of the results, we can clearly see that the water table lowering with increasing time. Changes of total flux and the total volume of water discharged with the time is listed in the table 3.5

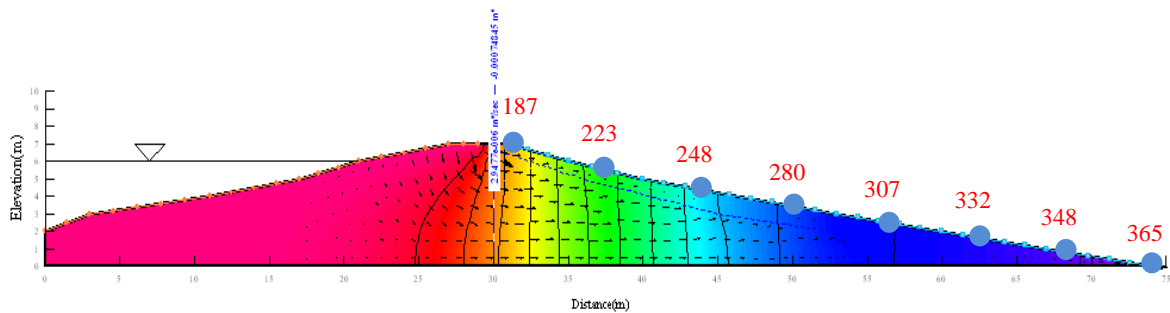
Pressure and flow properties have been analyzed along the potential seepage face. There are 8 nodes (node 365, 348, 332, 307, 280, 248, 223 and 187) on the potential seepage face have been selected and the properties change with time plotted graphically. Figure 3.22 shows the selected nodes on the potential seepage face and the figures 3.23(a) – 3.23(c) illustrate the pressure changes.

Figure 3.22: Selected nodes on the potential seepage face

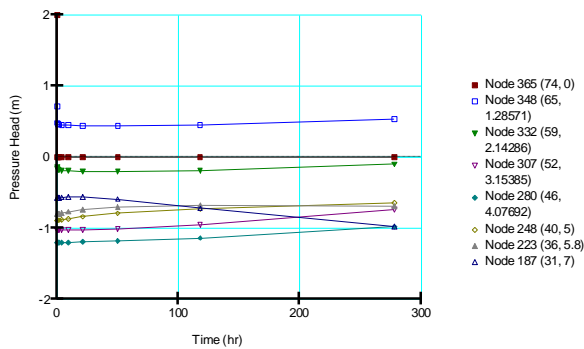
Figure 3.23(a): Change of pressure head with time

The same results have obtained in case of pore - water pressure and the pressure head changes (figures 3.23(c) and 3.23(b)). The node 348 only has the positive pressure head as well as the pore-water pressure because; it is the one and only node which lies above the water table at all. But, considerable changes observed at the node 187 (on the top). Because, at the very early stage, water table was very close to the node 187 and with time it has moved apart from the node. Therefore, further reduction in pore-water pressure and pressure head is observed at the node 187.

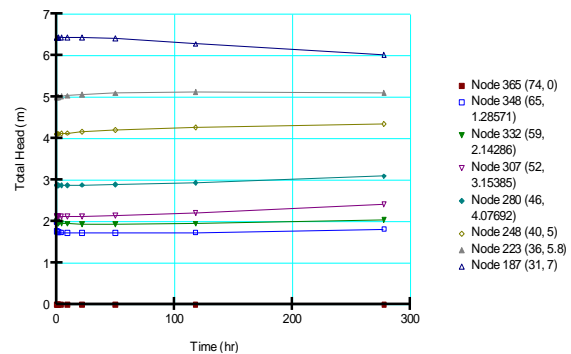
Figure 3.23(b): Change of total head with time

Total head, at the node 365 is always zero because it defined as a boundary condition and increasing with the elevation of the nodes (Figure 3.23(a)). But the total pressure at all the nodes does not change so much with the time. It is because that the portion of the water table which representing the downstream side doesn't show big variation. Only change observed at the upstream side.

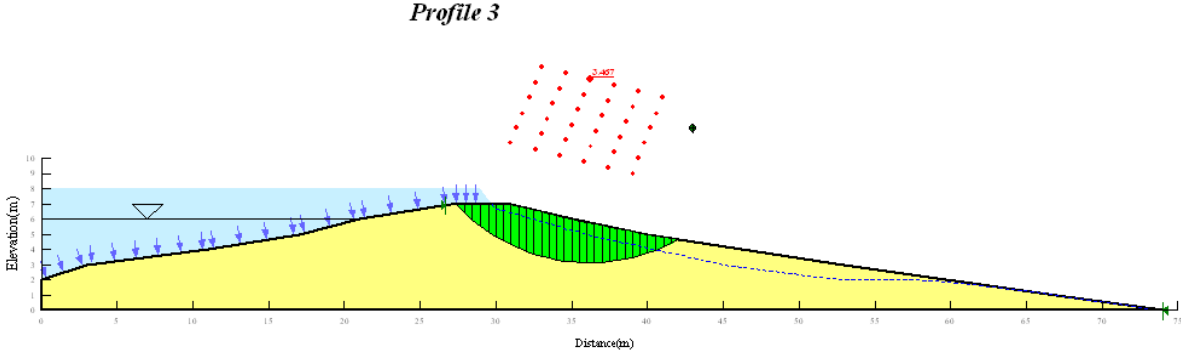
Figure 3.24(a): Stability at initial stage

The factors of safety for the initial (3.457) and final (3.997) stages are extremely high. So, the slope has enough stability even in critical flood conditions. We can clearly know the reasons for the extreme stability are

1. The slope is very gently steep on downstream side
2. No huge changes in pressure conditions
3. Very low amount of seepage through the dam even in the extreme flood situations

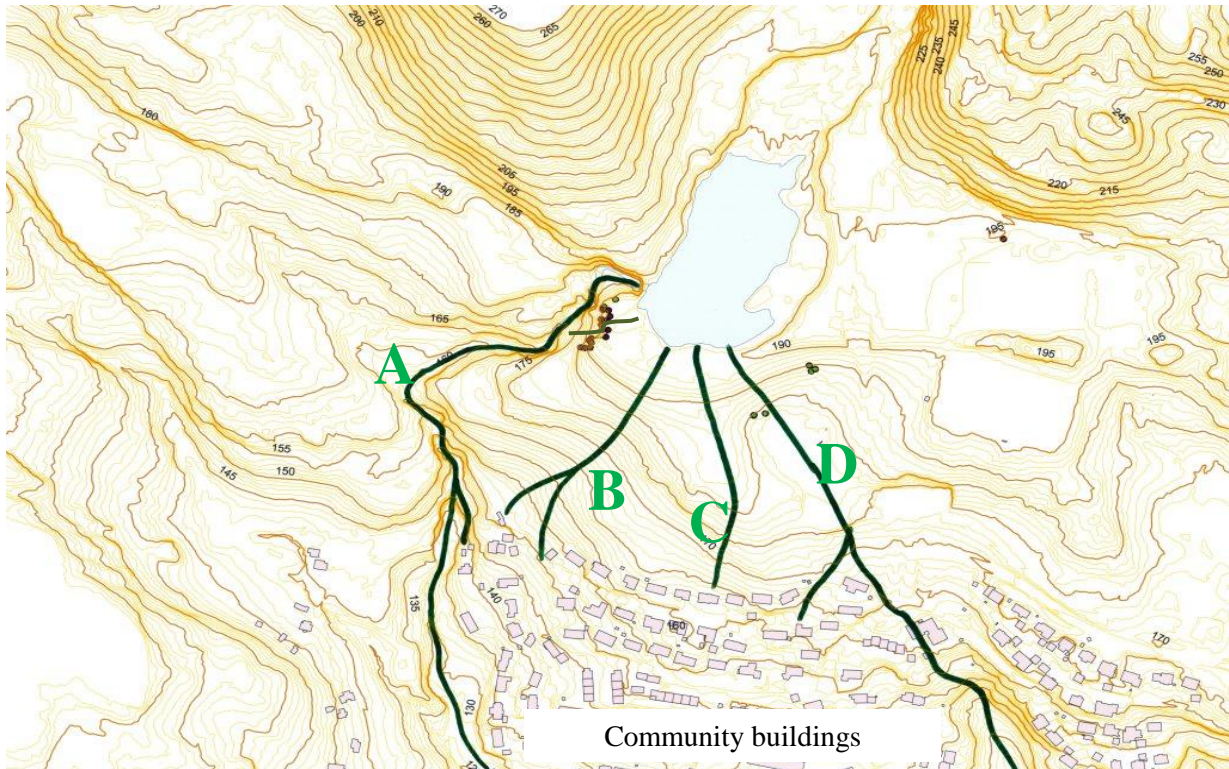
*Figure 3.25: Possible flood paths down to the community residences*

The dam Årbogen situated between 180-190 m above the mean sea level. This elevation is low at the downstream side increases towards the upstream side within that range. In the downstream side, community residences established almost 20m below the dam with a distance of ~300m. Therefore, the flood waves produced due to the dam failure have enough potential to reach and impact the community structures.

The elevation contours in the figure 3.25 clearly shows that the upstream side of the dam is highly elevated area. Therefore, in the flooding situations flood waves never travel in a direction other than the direction of the flood path those indicated in the map. The A, B, C and D are some possible flood paths which reach the community buildings in different areas. However, each flood paths should have distinct characteristics.

The flood A is generated by either dam failure or direct overflow. Because, the stability analysis of profile 1 shows that the possibility of slope failure in the area (corresponds to the flood path A) is quiet high. The flood A travels through a valley until it passes the residences. Also there are very few buildings near to the flood path. Therefore impact from the flood wave A is considerably low.
