Master Thesis, Department of Geosciences

# Human activity as a cause for landslides in Norway

*Case study of two man-made debris flows in Otta, Central Southern Norway*

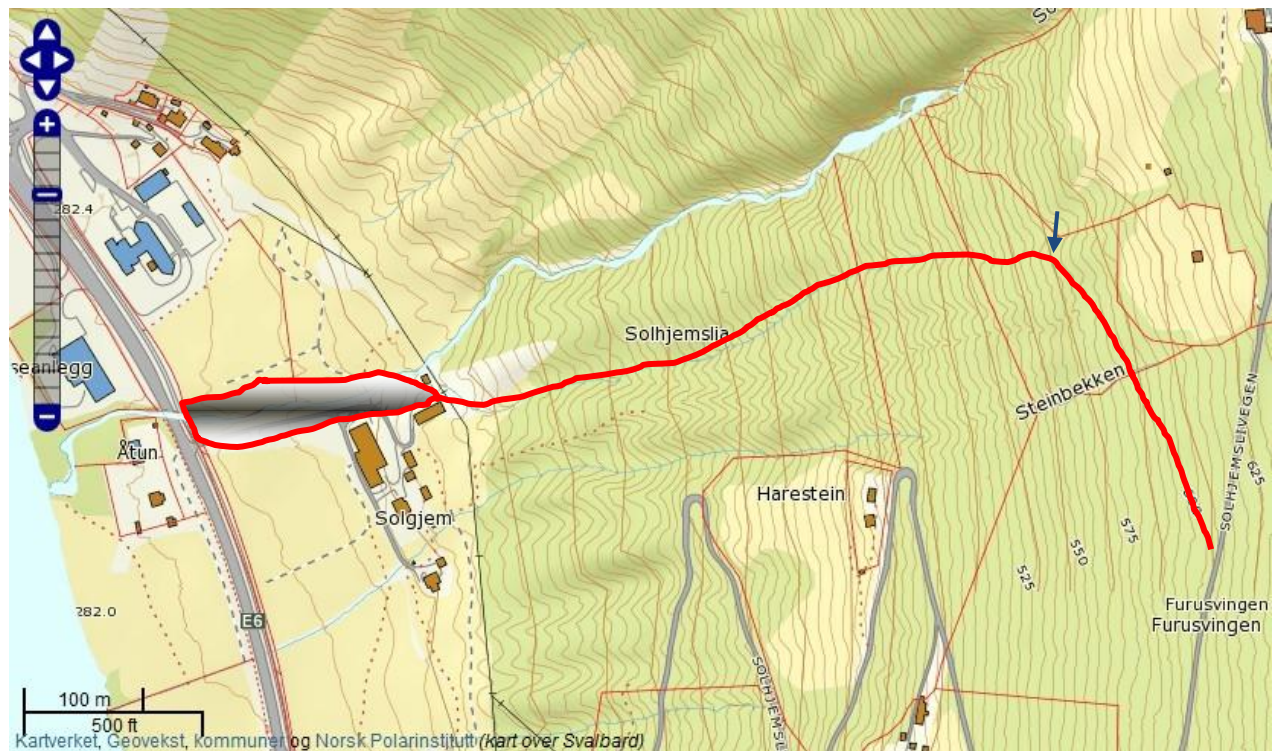
Figure 1.2 The study area map of the Solhjem debris flow occurred in 10<sup>th</sup> June 2011. Red curve shows the track of the debris flow, and the gray shadow represents the deposition zone, taken from [www.norgeskart.no](http://www.norgeskart.no). The pot pointed by the blue arrow was the failure point of the slope.

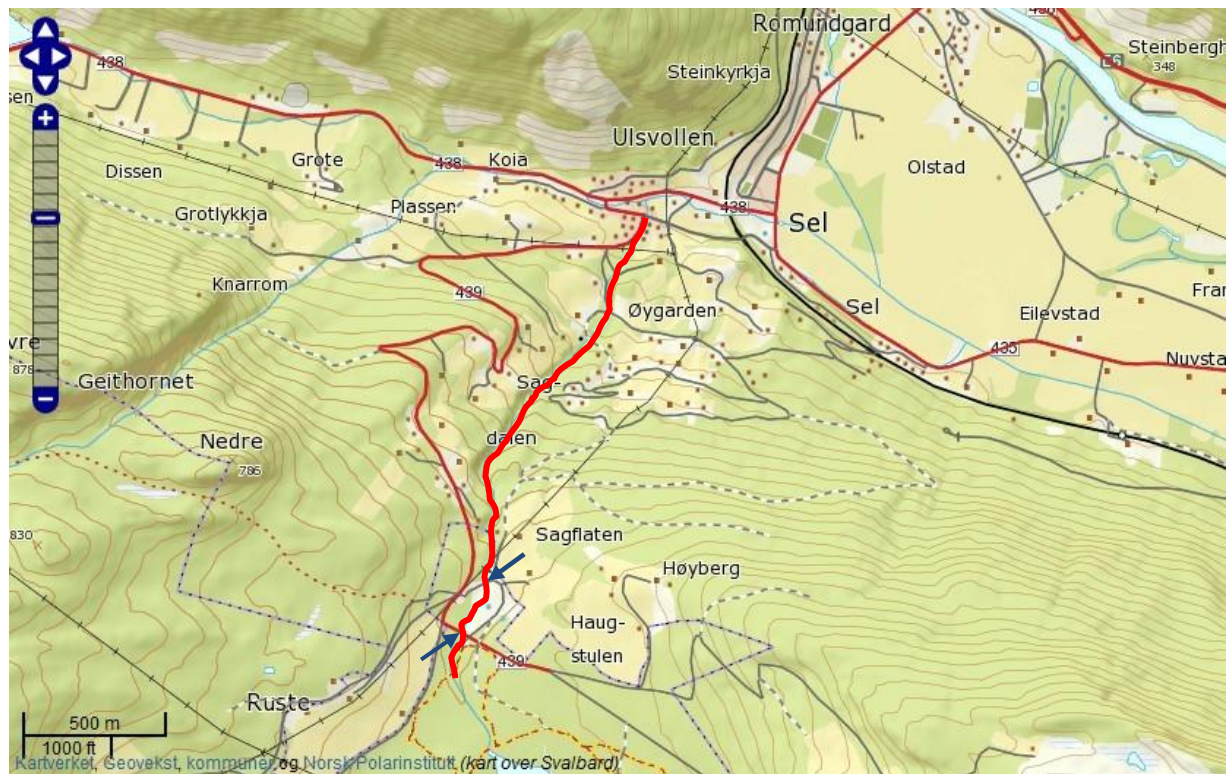
Figure 1.3 The study area map of the Sagdalen debris flow occurred in 10<sup>th</sup> June 2011, red curve shows the track of the debris flow, and the two pots pointed by the blue arrows represented the destroyed bridges, taken from [www.norgeskart.no](http://www.norgeskart.no).

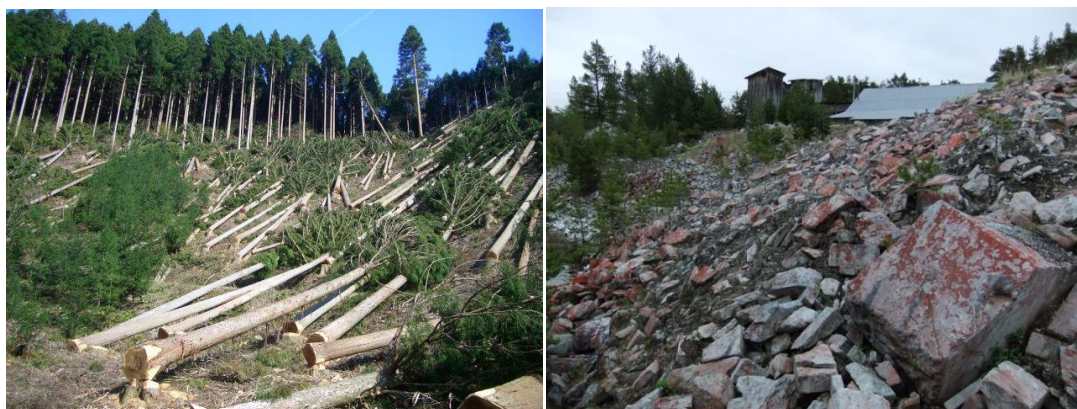
Figure 4.2. a) deforestation, taken from [www.greeningforward.org](http://www.greeningforward.org) b) soapstone dumped in upstream of Sagdalen, some of which being flushed and blocking the drainage channel.

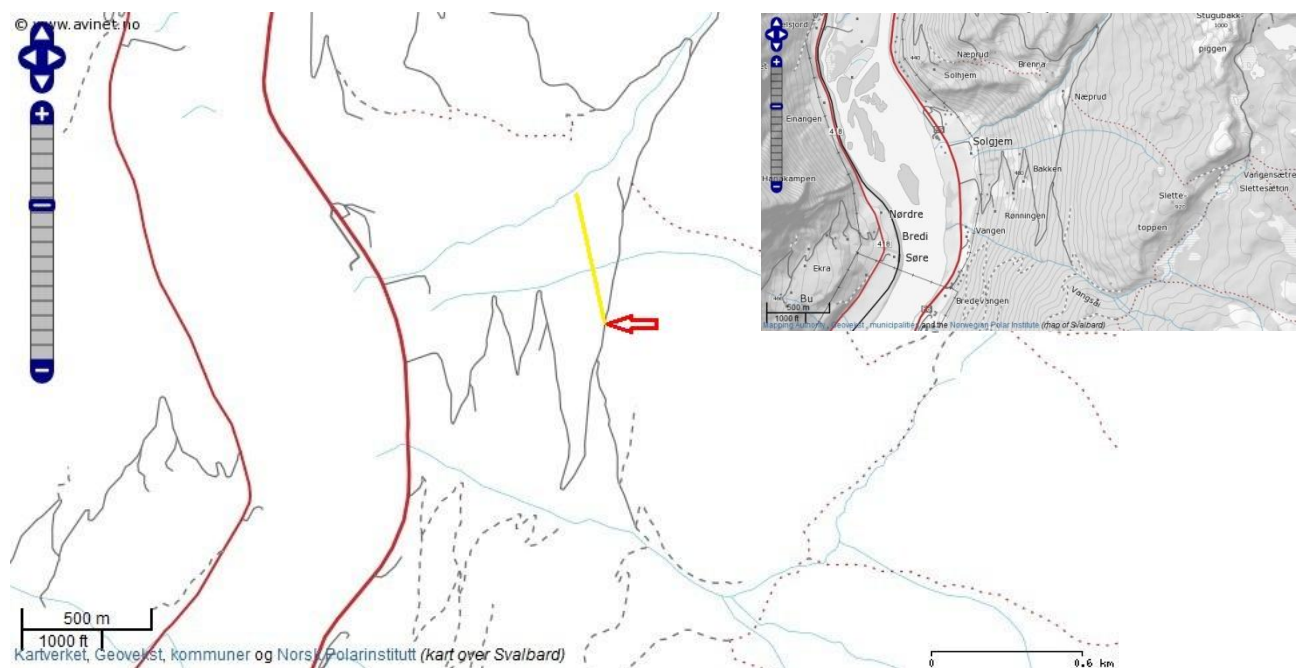
Figure 4.3.1 The road, the black line showing in the map, built in the source location of Solhjem. The yellow line marked in the picture is one old small road unrecorded in [www.norgeskart.no](http://www.norgeskart.no), and the joint pointed by the red arrow is the start point of the debris flow in Solhjem. The road lines represent the main high way, taken from [www.norgeskart.no](http://www.norgeskart.no).

In Solhjem, the starting point for the debris flow was at exactly the joint of the roads. Due to slope cutting of the main road marked by the black line and the old small road marked by the yellow line, the drainage of the slope had been cut. The surface flow followed the roads direction in the channel instead of following the direction of the elevation difference. And then, the gathering surface flow turn down in the joint through one plastic drainage pipe buried under the road to the old road marked by the yellow line. Walking down the old road, flushed channels could clearly be observed due to the strong erosion, which also indicated us the flow direction. Till the end of the old track where the further failure occurred, the channels became deeper and deeper.

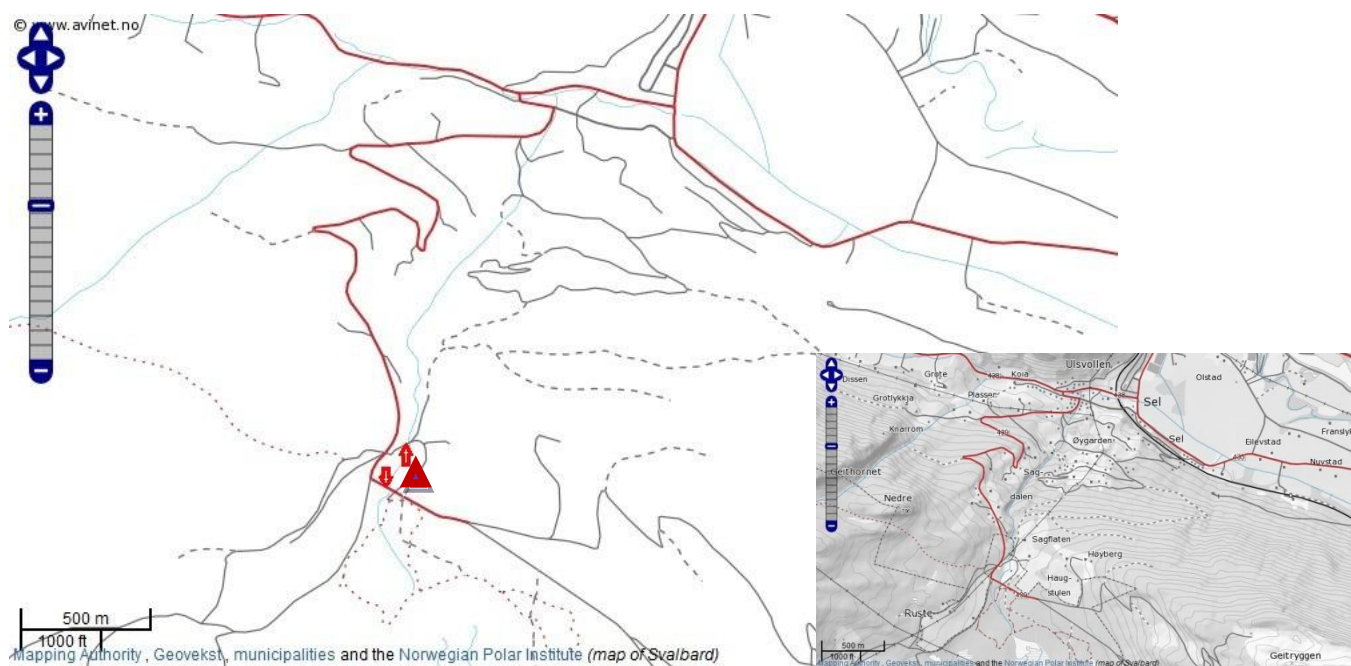
Figure 4.3.2 The two joints of road and river pointed by the red arrow, showed where those two bridge was destroyed. The red triangle showed the position of the dumped soapstone, taken from [www.norgeskart.no](http://www.norgeskart.no).

In upstream of Sagdalen, several bridges were built to meet the needs of the transportation. Socket reinforced concrete drainage pipes were buried for the stream going through. The designed pipe could meet the volume of a normal flow situation due to little rainfall. For the first joint, the diameter of the drainage pipe was around 400 mm compared to around 1000 mm diameter of the drainage pipe in the second joint. Though the flow cannot meet half of the pipe mostly of the year, the instantaneous volume could be enlarged several times during the strong precipitation. The flow was capable of carrying rock and depositing in the pipes. Facts worthy to notice were that between the joints, the soapstone waste dumped in the bank offering more source materials and probability to lead to such a situation. Even the diameter of drainage pipe for the second joint reaching 1000mm, completely blocking still managed to be accomplished under such a situation.

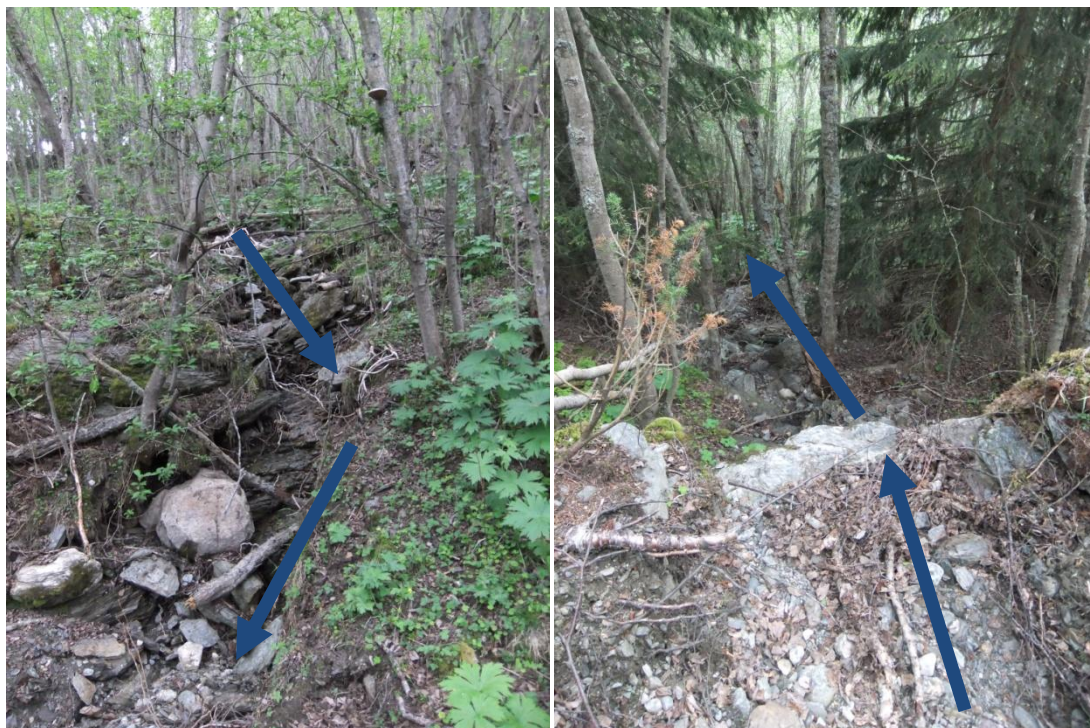
One track of little stream (part e as mentioned) crossed from the right side of the road and no flow was observed during the investigation. The fine material was flushed away and left the debris including boulders, particles and woods. Some trees were lodging on and blocking the road. Clearly another small track could be found in the left side of the road. Also deepen erosion on the road after the point indicated that the stream flowing in both directions of down-slope and down-road. The phenomenon of deepen erosion track showed that the flow had stronger entrainment capacity after the merging point while the slope angle showed no dramatic changing. It would be reasonable to predict that more flow merged into the direction along the road.

Figure 5.2.2.2.1 The merging stream on the right of the road is in the first picture and the flowing track on the left of the road in the second picture.

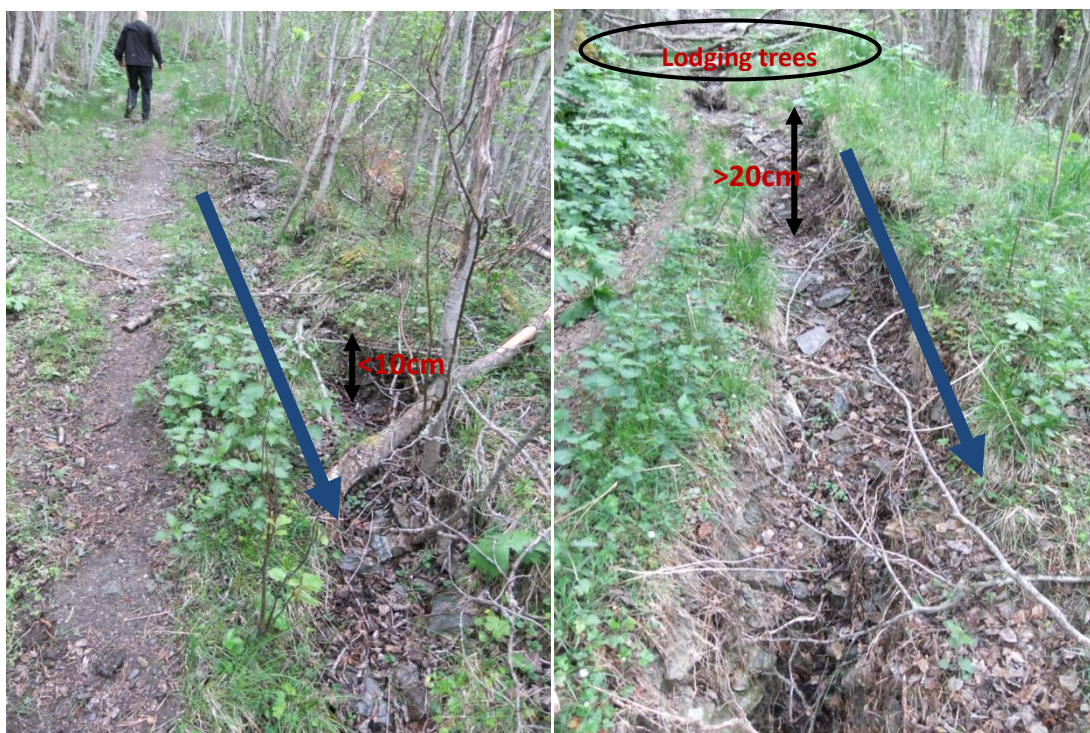
Figure 5.2.2.2.2 The channel formed by erosion before (left) and after (right) the merging point.

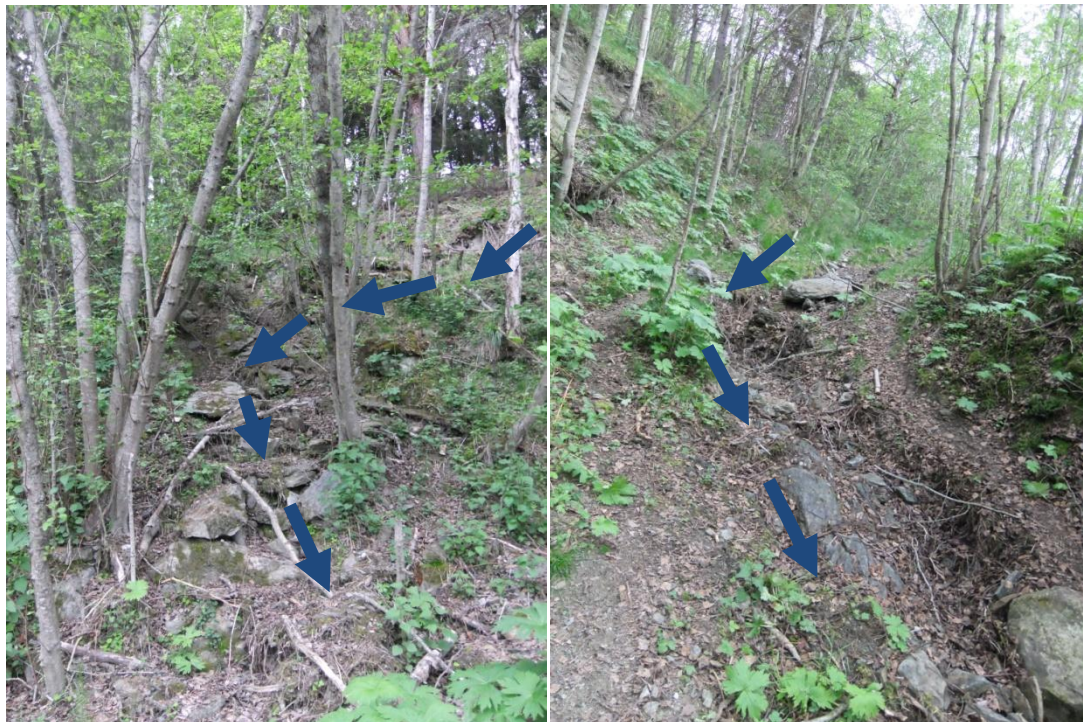
Along the road, track of the channels showed slight left-turning and led to the end. Another small track (part c), found in the right slope, and merged in the position. Huge part of the road was gone with the debris flow. Thorough the walking to here, exposed bedrock and deposits were found.

Figure 5.2.2.3.1 The small track (part c, left) and the slight left turning in the way coming to failure point (right).

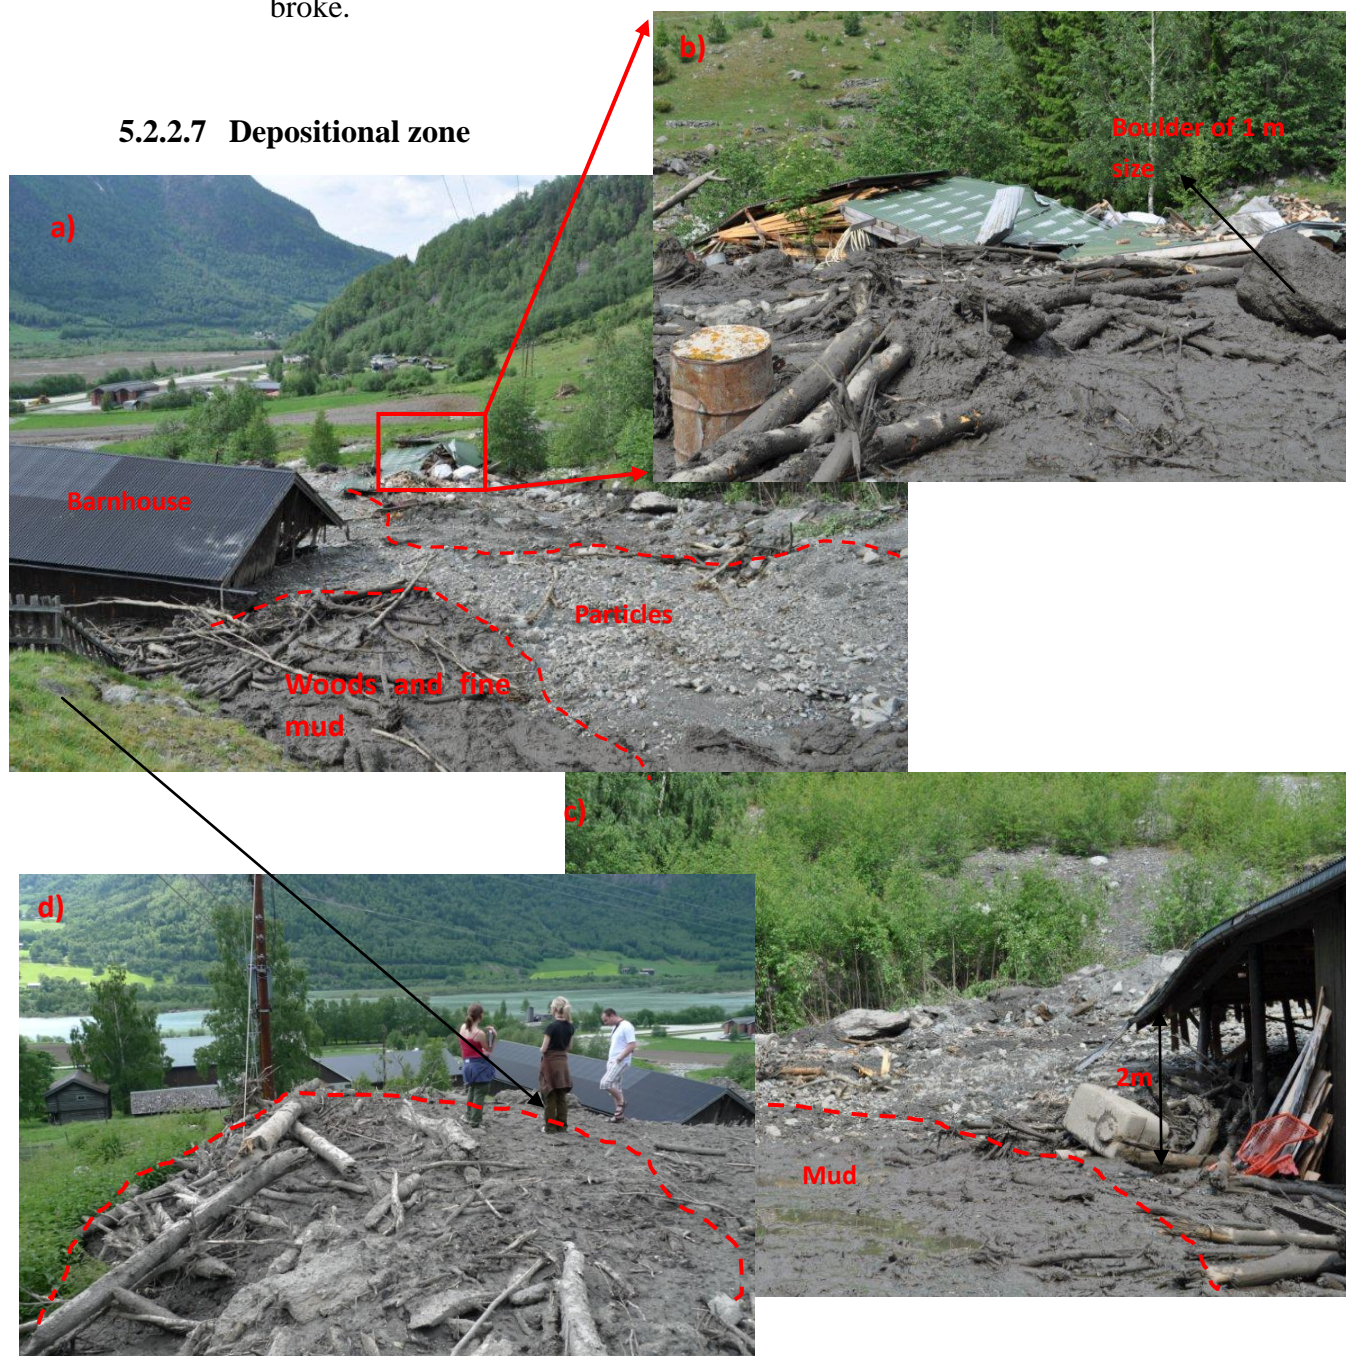
Figure 5.2.2.8 Depositional zone, a), b), c) taken by Hans Roger, and d) taken by Terje H. B..

Large amount of debris deposited on the open field from the track, spreading and running out till the E6. Most of debris including the woods, particles and boulders did not cross the stream track and lay on the left side of the stream. Part of fine mud and woods were left over on the Point 115, showing in d) and also next to the barnhouse, according to a). We get part of fine materials were left of the flow direction while the particles and boulders were entrainment by the flow to the further right. Huge boulders located on the open field between Point 116 and barnhouse mostly. However, the fine materials and woods entrained by the flow were carrying further than particles till E6. Sadly, the deposits were cleaned up days later, and not left us very good pictures about the further place.

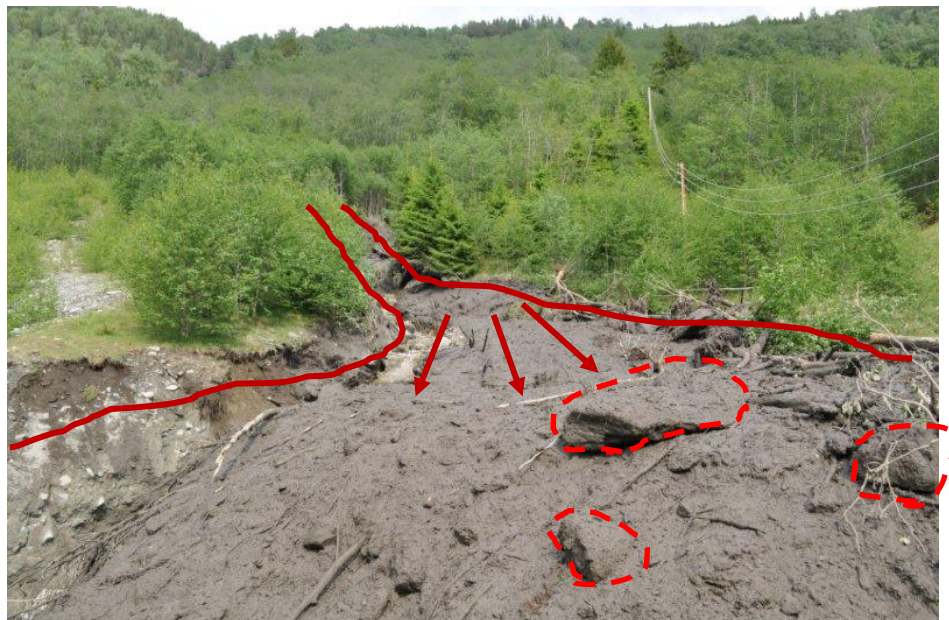
Figure 5.2.2.8 Enlarged depositional fan and huge boulders lay on the fine deposits, taken from Hans Roger.

From the deposits pictures, huge boulders were laying on the fine material and smaller particles. Such the phenomenon has been observed in many events, which named Brazil Nuts Effects. Several explanation including dispersive pressure, kinetic sieving, buoyancy and void filling were presented for such the segregation. When the granular mixture is shaken, voids under the larger boulders, are promptly filled by the small particles, leading to the large grains to rise (De Blasio 2011).

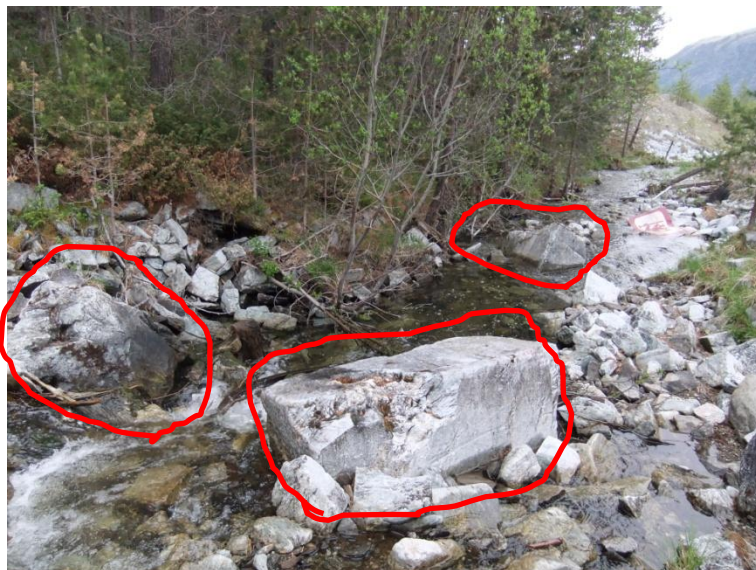
The largest boulder found in Point 147, size over 1.2 m length. With another boulder over 1 m size made up one dam-like structure and narrowed down the channel to 1-2 m wide. Another was 4-5 m away from these two boulders.

Figure 5.3.2.3 The three boulders found in the channel, the largest located in the middle.

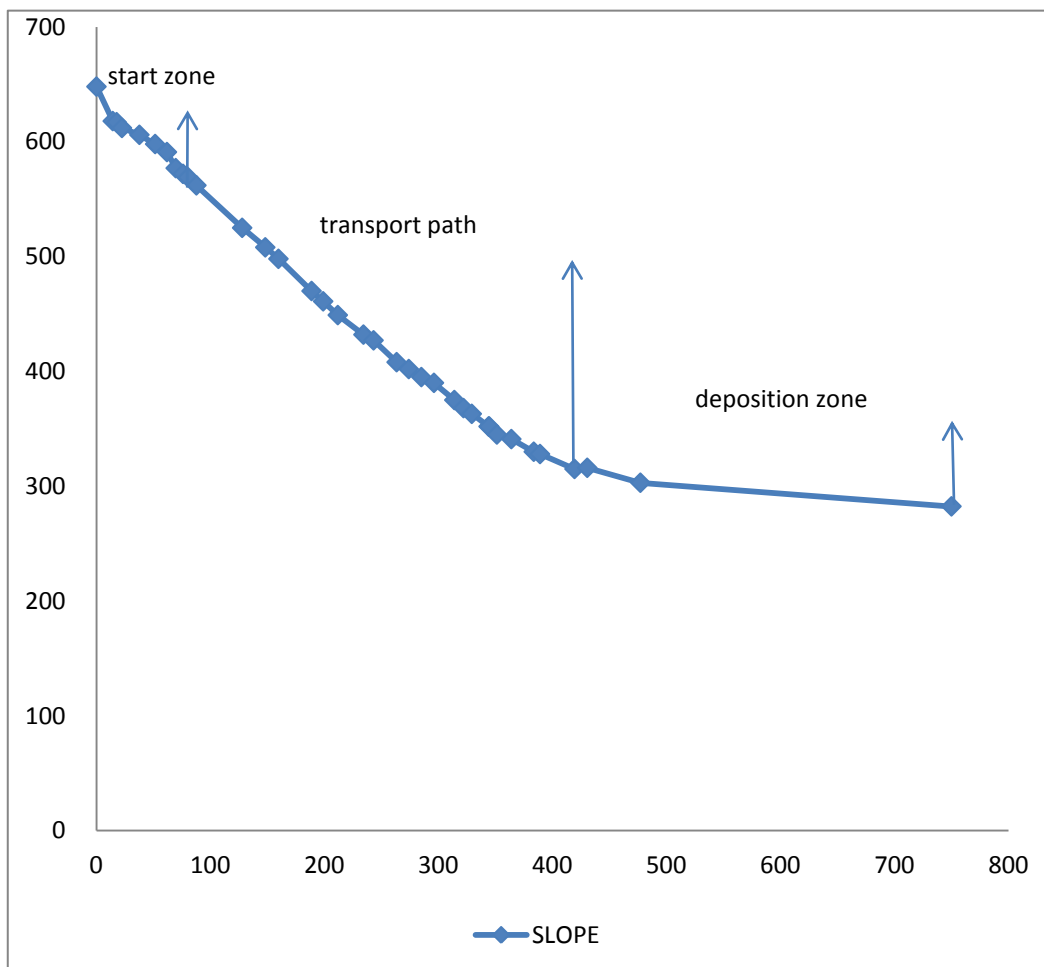
potential terrain for debris flow. The angle of start zone is about  $24.3^\circ$ , while  $36.8^\circ$ 's transport path. The deepest erosion occurred in the area below of the middle in transport path, around Point 129, reflecting the combination of entrainment capacity of the flow and cover's thickness. In upper part, exposed bedrocks were found due to the strong entrainment and thin cover.

Figure 6.1.2 Simple model of the slope cross section in Solhjem, horizontal axis meaning the distance, and the vertical meaning the ASL.

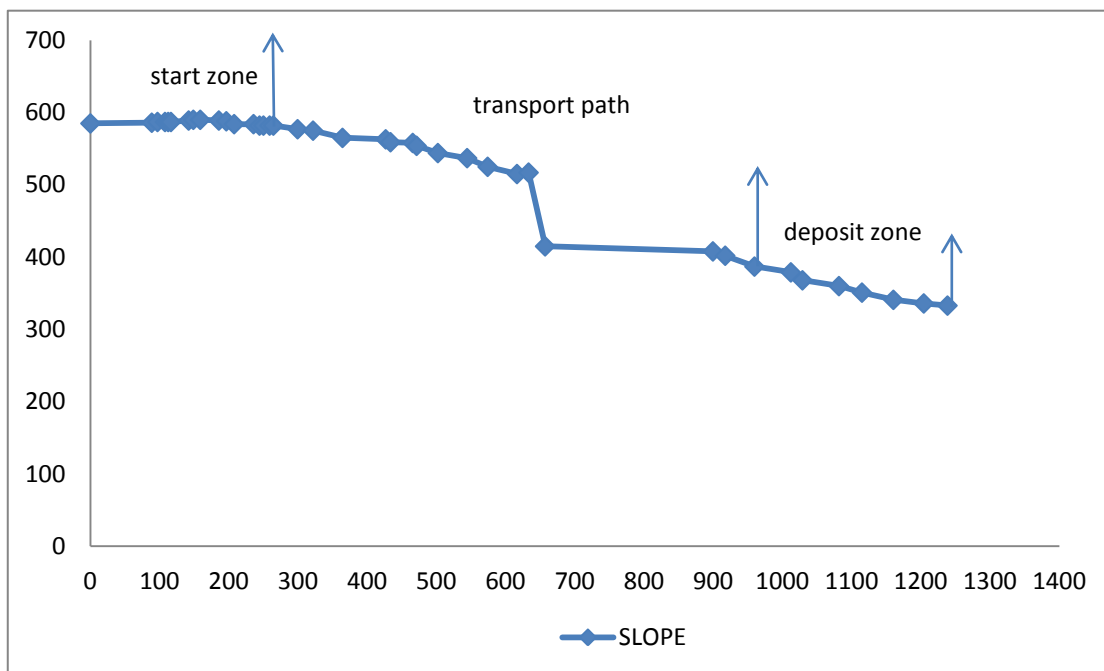
For the terrain of Sagdalen, it is hard to say this area has the potential to trigger one debris flow due to the gentle declination as 12 °. And two destroyed bridges were located in the area of the start zone, where was basically flat area showing through the figure below. However, through the map study of surrounding circumstance, we found out the area was located in the bottom of the catchment area. The gathered surface flow from about 12 km<sup>2</sup> area would merge into the stream. Clarifying the topography of the source location would be especially helpful for us to reveal the mechanism of the event's formation.

Figure 6.1.4 Simple model of the slope cross section in Sagdalen, the horizontal axis meaning the distance and the vertical meaning the ASL.

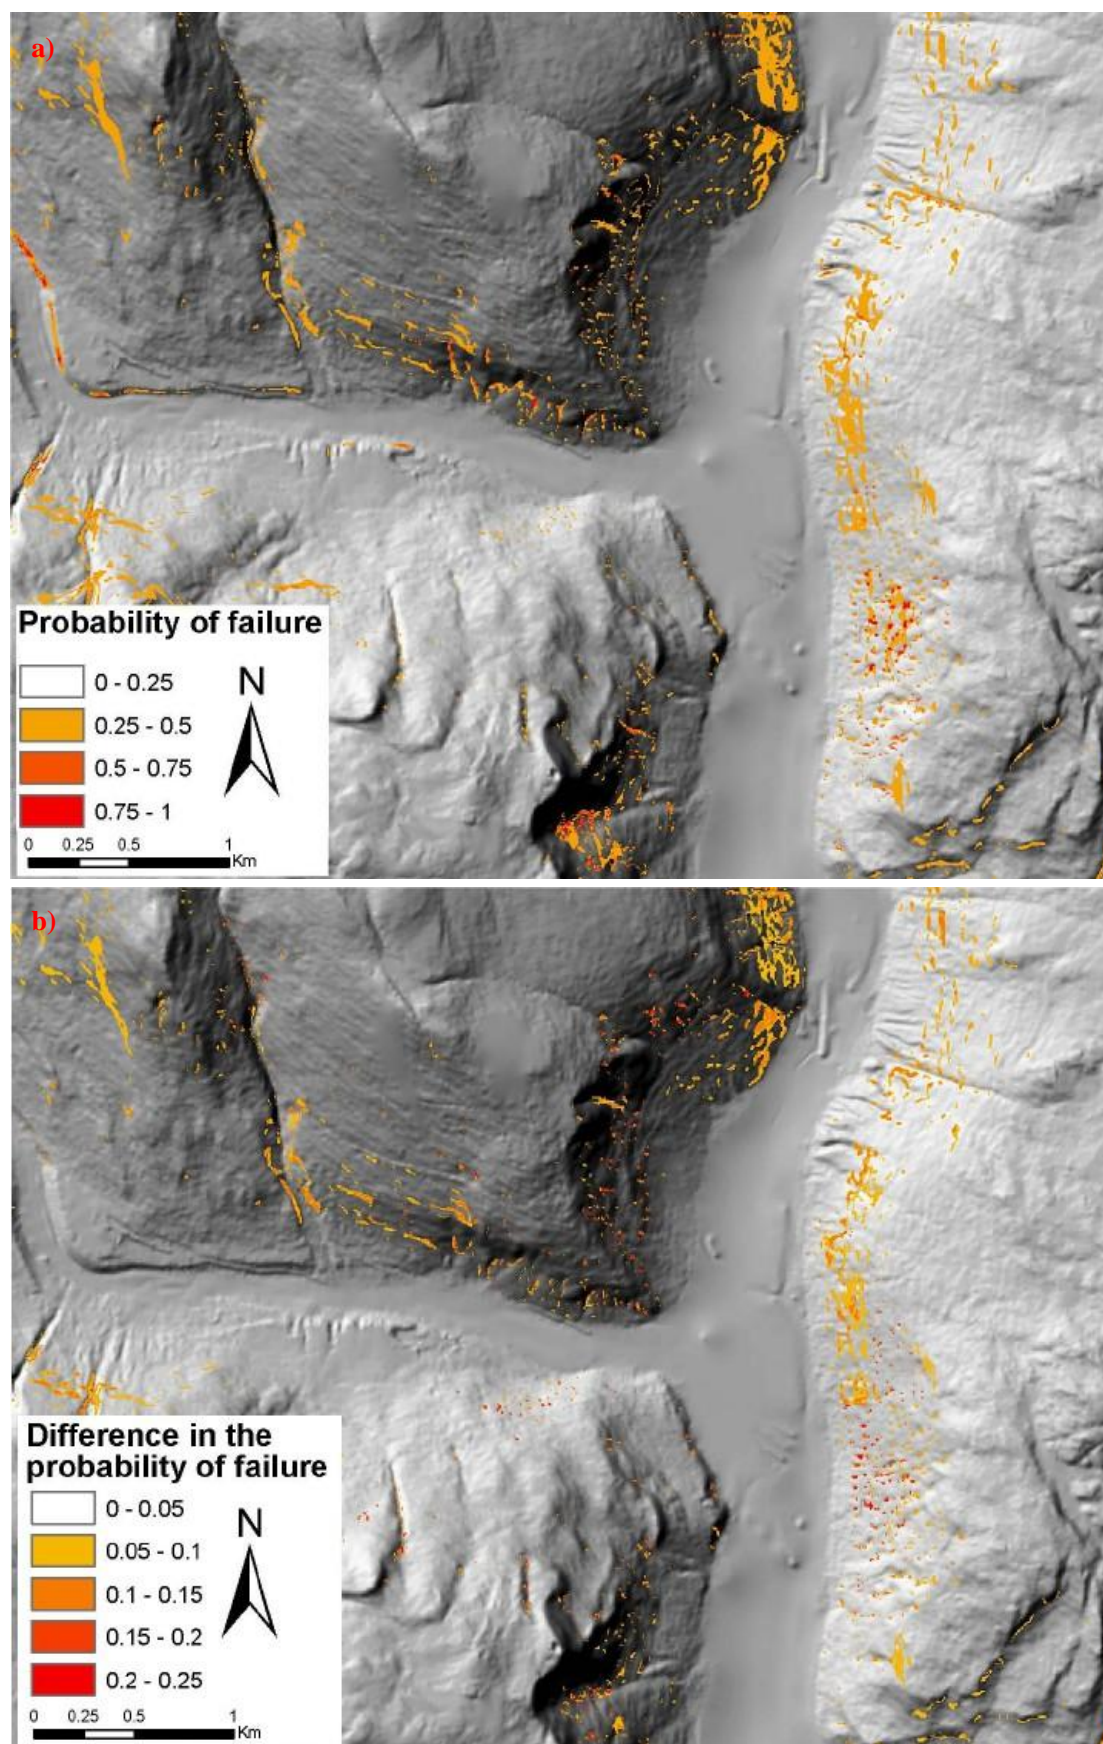
Figure 6.5.3 a) Modelling of the present stability conditions for shallow landslides in Otta area; the probability of

failure is calculated for 69 mm/d precipitation with a return period of 100 years. b) An increase of 20% in the precipitation intensity is assumed. The results are visualized as the difference between the probability of failure at the present precipitation conditions a) and the probability of failure at the modeled future conditions. Areas showing decreased probability of failure were not detected in the study area (Jaedicke 2008).

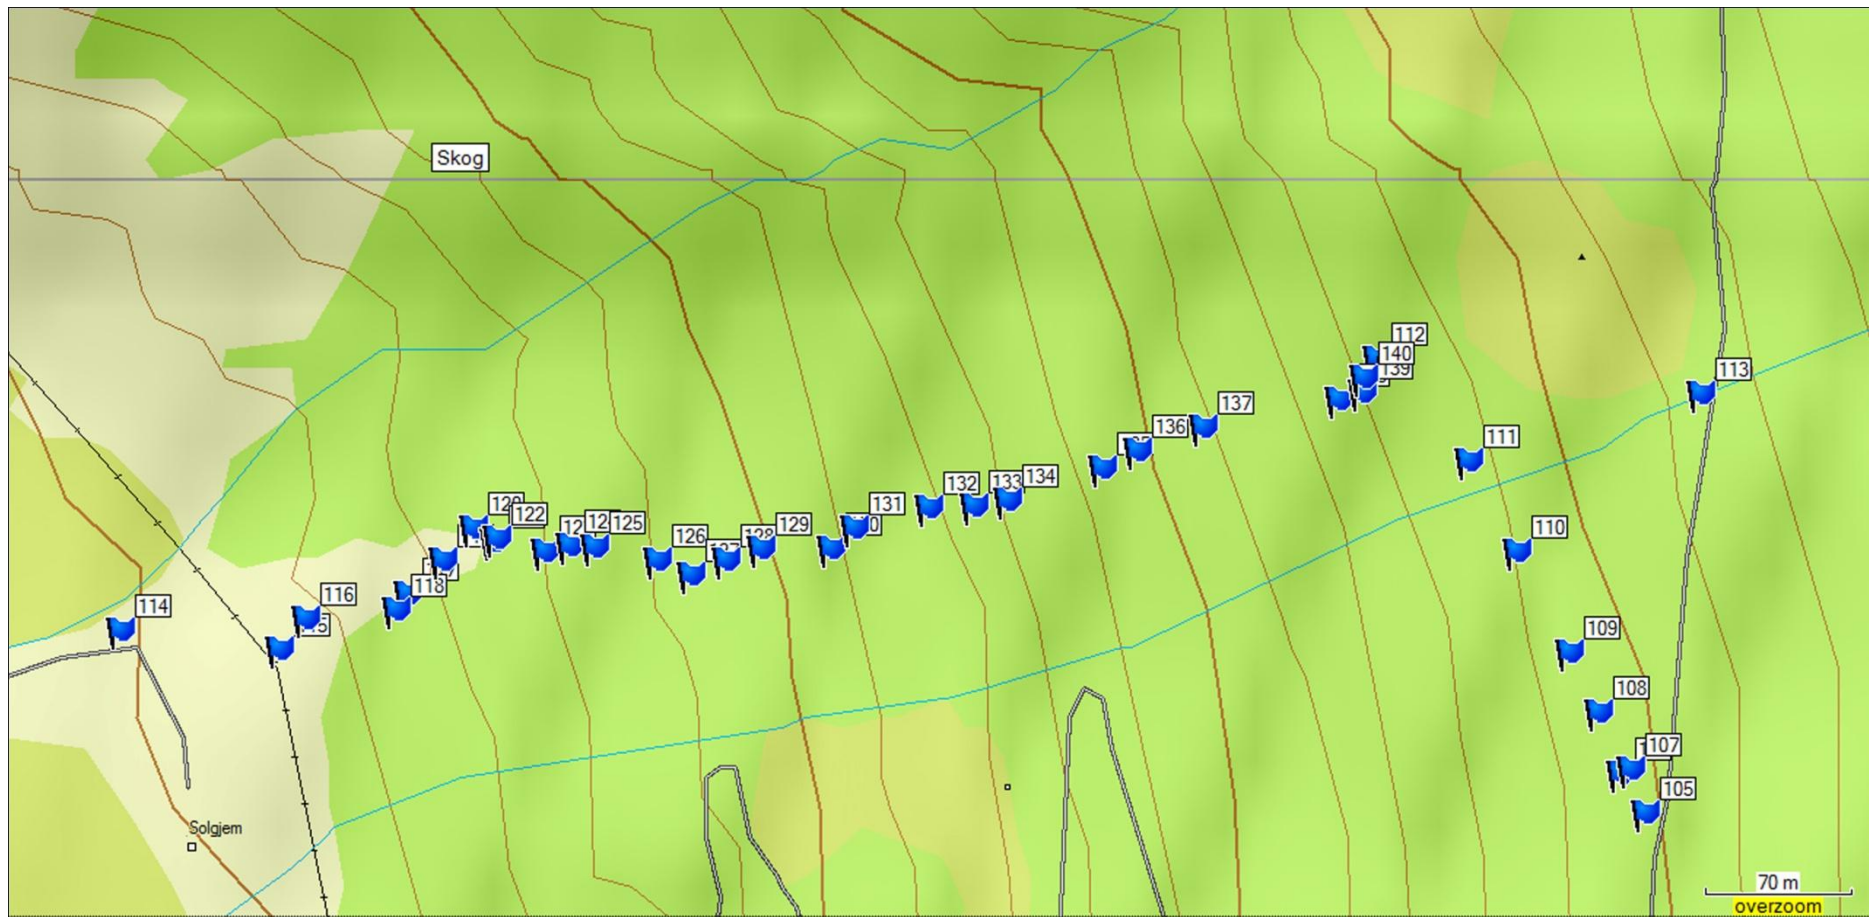
**Appendix B: Field observation records of Solhjem, GPS points map and comments.**

Point No.	GPS N	GPS N degree	GPS E	GPS E degree	ASL (m)	C	Distance (m)	Highness (m)	Slope (degree)	Notes
105	N61 44.811	61.44811	E9 34.381	9.34381	648					Start point. Rainfall flow collected from the up road and turned right to the lower part. Here has one drainage channel. Very fragile sharp flat mineral shall. Flushed channel showing on the old road.
106	N61 44.822	61.44822	E9 34.367	9.34367	618	1	14.32	30	64.5212	Like 10m away from the start point. The flow divided to two parts. Most of the flows follow the track keep running down, some of it turning left fun as the slope.
107	N61 44.823	61.44823	E9 34.373	9.34373	617	1	3.38	1	16.5117	Like 15m lower than the last point. In here, most of the rest running down the slope, less flow keep going this way due to the channel blocked by the debris. However, sign left from overflow showed here.
108	N61 44.838	61.44838	E9 34.356	9.34356	612	1	18.97	5	14.7743

109	N61 44.853	61.44853	E9 34.340	9.34340	606	1	18.72	6	17.7788	
110	N61 44.879	61.44879	E9 34.311	9.34311	598	1	32.76	8	13.7291	Merge point for one cross stream on the right way, which may have flow once or twice a year. Not so much erosion found before this point. the fine material flushed away and vegetation being damaged, still haven't cleaned up.
111	N61 44.902	61.44902	E9 34.285	9.34285	591	1	29.07	7	13.5464	From all the way coming down this point, clearly twice times depth of erosion compared before the merge point, more than 15cm-25cm. Some parts showing two or more than two erosion tracks, till and rock were sediment on the road. The loose materials covered on the road were taken away by the surface flow during the strong rainfall. The inclination gets deeper and deeper. Boulders showing.
112	N61 44.929	61.44929	E9 34.234	9.34234	577	1	40.45	14	19.1020	Turning point at 537m, the end of the old road. Also one joint with another little track of road. The failure of the slope happened exactly here with big

114	N61 44.859	61.44859	E9 33.548	9.33548	303	1	46.62	13	15.5885	The yard of the locals, under the fence, belongs to depositional zone. The inclination is gentle, and next to the other stream channel. When the debris flow occurred, it flushed away the pipe and the bridge built over the stream. The locals were trying to recover it in June 2012.

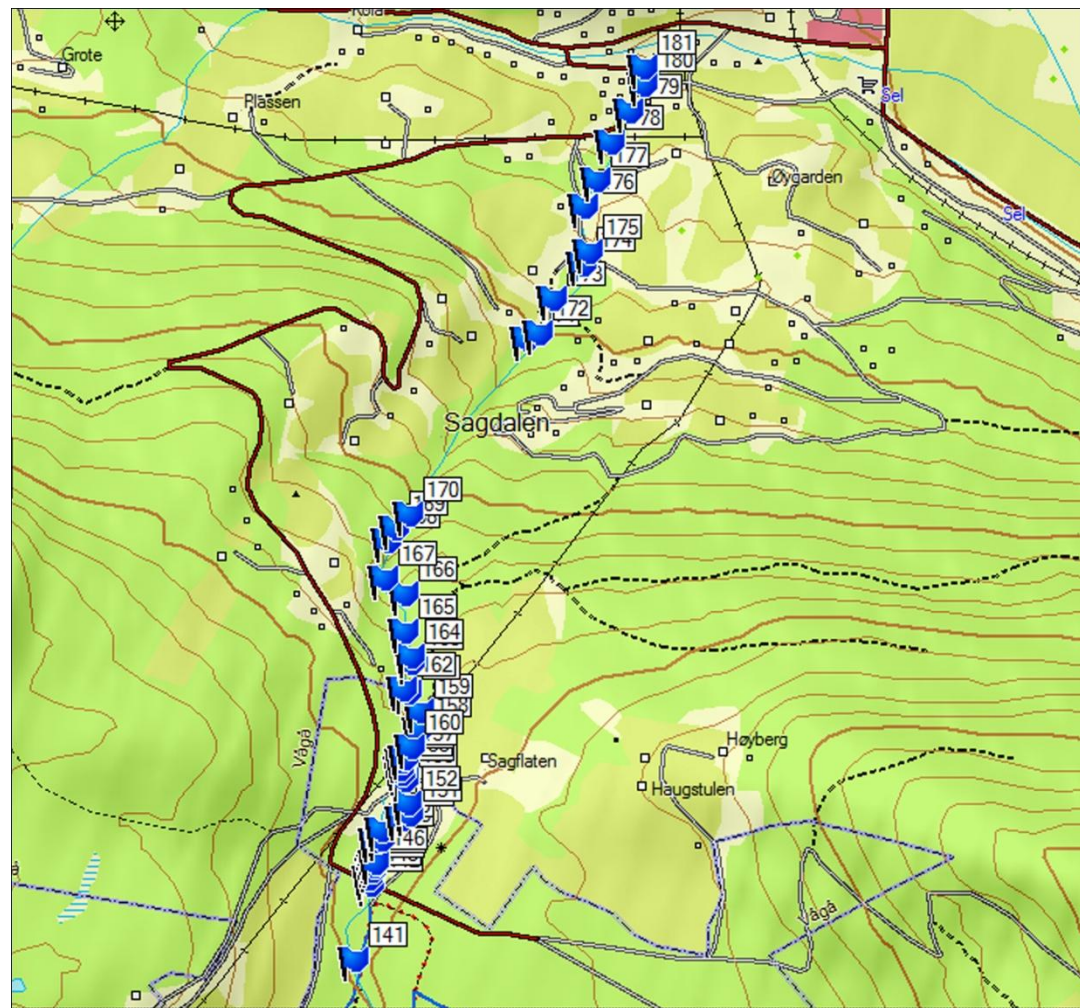
### Appendix C: Field observation records in Sagdalen, GPS map and comments

Point No.	GPS N	GPS N Degree	GPS E	GPS E Degree	ASL(M)	Distance	Highness	Slope (degree)	Notes
141	N61 49.544	61.49544	E9 23.592	9.23592	608				Start point, there is one small woods on the right side of the stream which is heading from south to north. The slope of the area was very gentle; the ground soil was very saturated. The stream located in one catchment. The stream was shallow and narrow, about 1 m width, with lots of boulders saving in the bottom of the river. One wooden made bridge cross over, with 2.5 m high over the water and 2 m width.
142	N61 49.622	61.49622	E9 23.626	9.23626	585	88.69	23	14.54	There was sign showing being flooded.
143	N61 49.629	61.49629	E9 23.621	9.23621	586	8.23	-1	-6.93	The bridge was destroyed. Right now it has already been repaired. The concrete drainage pipes have been replace by iron pipe. And the diameter enlarged from 40cm to 100cm. The old pipe was flushed to the other side with some other debris, including boulders up to 30cm, depositing in the large area. The channel enlarged behind the bridge to 7 m width. however, boulders have already found in the new pipe varying from 20cm- 30cm.

144	N61 49.638	61.49638	E9 23.629	9.23629	587	10.88	-1	-5.25	4 pipes were flushed to the west side of the stream while 1 pipe was flushed to the east side. We could clearly see the debris deposited in this zone, around 5m*8m.
145	N61 49.642	61.49642	E9 23.631	9.23631	587	4.58	0	0.00	tube 2
146	N61 49.645	61.49645	E9 23.635	9.23635	587	3.96	0	0.00	tube 3
