Salt damage around a bat roost at Urnes stave church

Masters Dissertation
December 2019

Urnes stave church is dated to the 1130s and was inscribed on the UNESCO World Heritage List in 1979. In the south west nave corner, the bearing post and adjoining bressummer (sill beam) of original pine wood suffer from salt deterioration. The area is situated near a bat roost, and this has led to the assumption that the salts derive from bat urine. Examinations and different analytical methods were used to verify the source of the salts and examine the condition of the wood. On site investigations included test strips and portable XRF and X-ray. Samples were taken for analyses in ICP-OES, FTIR, SEM-EDX and light microscopy using lignin staining to answer the research questions. A wildlife camera, ultrasound detectors and climate loggers were part of the investigations at site to investigate present bat activity and assess the preservation climate inside the church.

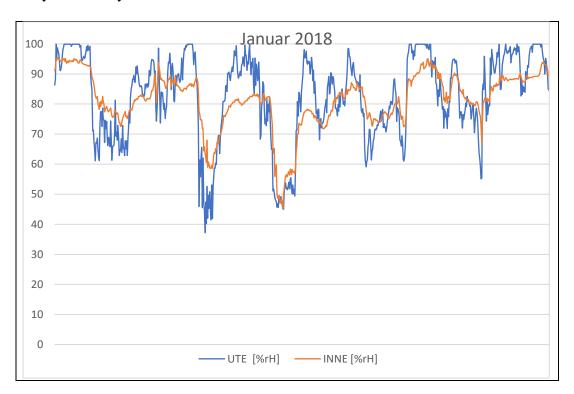
Urnes has a warm temperate climate. The humidity is high, but there is little precipitation. During the one year of logging, the indoor RH exceeded 90% only a few times during November, December and January. The data shows that the indoor climate follows the outdoor climate quite closely, but with a delay for both T and RH during increase and decrease of the values. The indoor values also move on a slightly smaller scale over the year of the logging. When the outdoor logger register rainfall on the 31st of January (=99,9% RH) the indoor logger register a RH of 89%. The minimum and maximum values for the outdoor logger exceed the values from the indoor logger for both temperature and relative humidity, which means that the wooden building buffers the outdoor climate somewhat as expected.

The diagram for relative humidity from January 2018 is an example of this pattern (figure 19). The red curve (indoor humidity) follows the blue curve (outdoor humidity) closely, but with a delay. This delay results in a flatter curve for the indoor environment.

Figure 19. Humidity curves January 2018. Blue curve = outdoors, orange curve = indoors

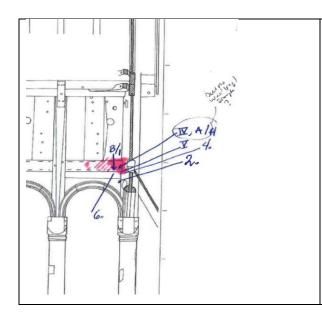
Figure 26. A drawing of the post and bressummer seen from the north, marking the location for tests and samples collected by Leif Anker in 2015. The letters A and B corresponds to pH tests, and the letters H and I corresponds to sulphate test strips. The results show a sulphate content of below 200 ppm – over 800 ppm here. The highest values of sulphates were retrieved on the aisle side, near the join between the post and bressummer where they lied between 800 and 1600 ppm.

The <u>sulphate</u> test strips were put on the salt contaminated surface of the post and bressummer. For location see figure 26 above, and for results see table 6 below.

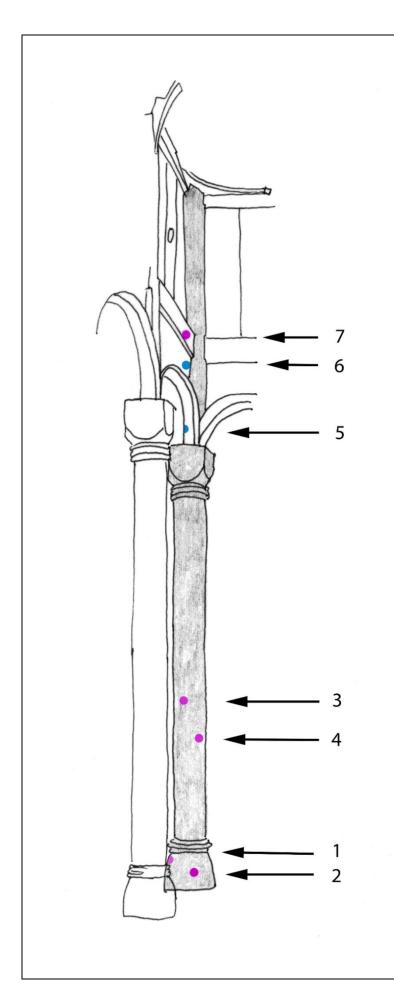
Figure 27, The location of readings of the portable XRF at the base, post and bressummer.

The analysis was conducted using a portable XRF instrument in June 2017. A total of seven readings were made on the post and sill beam (see figure 27). To rule out that the salt contamination derived from ground moisture, readings were made on several heights of the post, from the base to the infested area. The bressummer was also analysed with the pXRF instrument.

Reading 1 and 2 are reference areas at the base of the SW post.

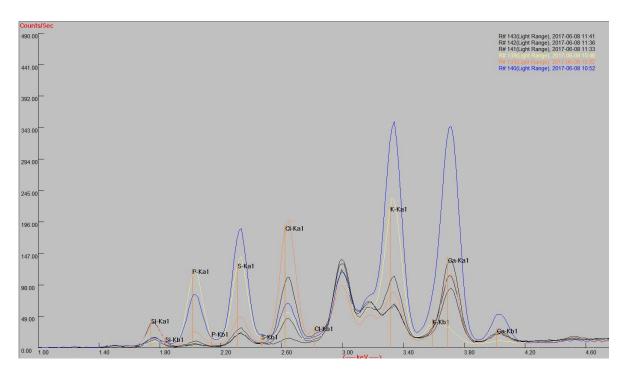
Figure 28. XRF spectra from the pXRF analyses. The three black spectra are from the chancel reference area, the orange spectrum from the base. The blue and yellow spectra are from the contaminated areas; blue from the bressummer and yellow from SW corner post.

Results from four areas will be presented here, one area from the base of the post (reading 2 = R# 133), one reading from in the contaminated area at the post (R# 139), one reading from the bressummer (R# 140) and the three readings from the chancel wall (R# 141-143). The location of all 6 readings are presented in pictures in appendix 2, and also on the drawing on the previous page (figure 27). These areas were chosen because the measurements here gave higher counts per second of elements compared to the reference areas, or they represent reference areas (base and chancel).

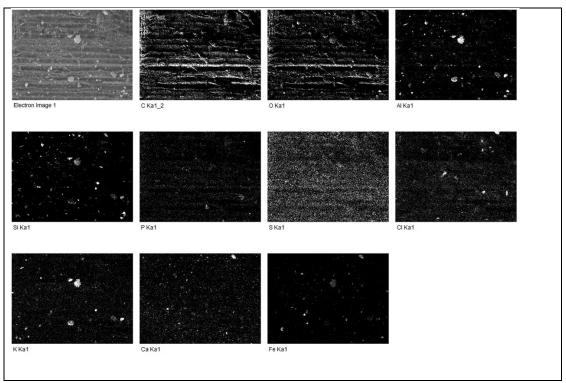
The analyses gave different results from the two sides of the SW corner post. The aisle side of the post gave signals for zinc (figure 34). Zinc was not detected in the samples from the gallery side of the post, nor from the bressummer. The image of the reference sample from the base of the post showed no salt crystals (figure 35)

Figure 35. SEM-EDX analysis of sample 15, a wooden sample from the base of the SW post. The base is not salt degraded and is used as a reference sample to find the elements of normally degraded historic wood. The image and mapping of elements shows no salt crystals.

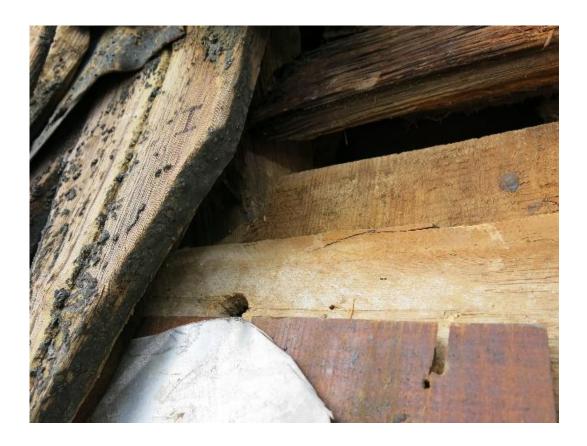
The results from this investigation gave valuable results that were impossible to get using other methods. It gave a good insight into the condition of the wood construction in the SW corner. The dismantling of the cladding and fittings to prepare for the X-ray investigation gave valuable information (figure 39). The extension of the rot damage became clear, and previous repairs visible (wooden repairs and lead fittings). The bressummer has suffered from total material loss in approximately 1 meter in length.

Figure 39. Picture showing the roof area after dismantling of the roof tiles and the lead fitting. The bressummer to the upper right, two layers of cladding and a lead fitting over one of the underlying tiles on the aisle roof. A roof tile to the left.

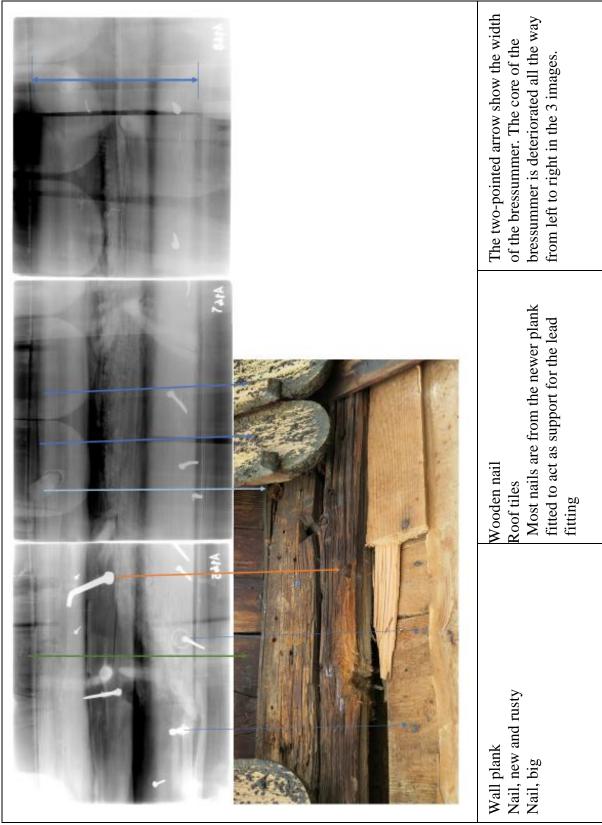
The X-ray images of the bressummer show very clearly that the core of the timber is partly gone and partly highly deteriorated (see figure 40). The exposures show the wooden fibres clearly in the healthy areas of the beam, and a mess of fibres going in all directions in the deteriorated areas. In the deteriorated areas the iron nails are also corroded, which indicates that these areas are contaminated by salts and/ or infested by acidic material.

Knowing the size of the cavity can say something about how many individuals of bats might have used the space. X-ray established that the cavity extended all the way from the SW corner post to the intermediate post towards east. The bressummer was examined by X-ray only between these two posts.

Figure 40. X-ray images seen from the outside. 3 images laid side by side. Photograph of parts of the same area, taken from the aerial lift after dismantling of the roof tiles.

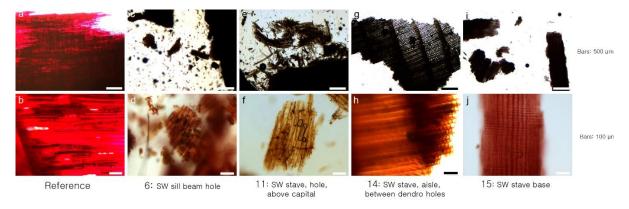
The lignin staining showed a clear difference in the reference sample compared to the samples from the SW corner post (figure 45). The samples tested were the reference sample, (sampled from the raft beam), sample 6, 11 and 14 (sampled from the salt infested area), and sample 15 (sampled from the base of the SW corner post).

Figure 45. Results from the lignin staining. All samples are photographed in two different magnifications. Upper panel shows lower magnification and lower panel shows higher magnification. Under the low magnification, it was not easy to identify the lignin degradation, but it was distinct in the higher magnification. The sample to the left is the reference sample, and it shows a deeper red colour than the other samples. All samples were coloured using 10% phloroglucinol in ethanol.

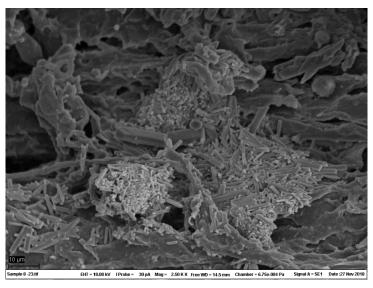
Figure 47. The finer crystals contain more sulphur and potassium.

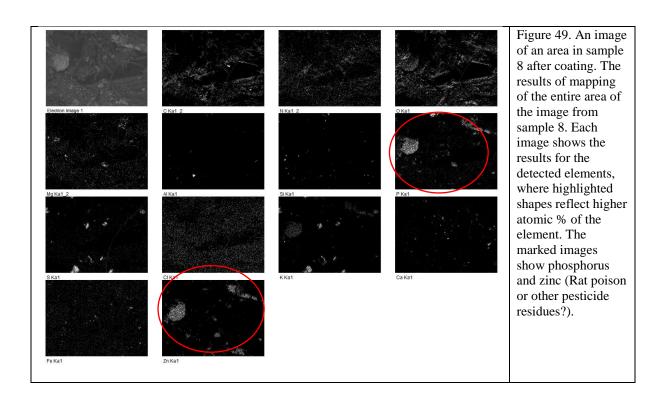
Figure 50. Sample 8 was taken from the area around the bat entrance hole.

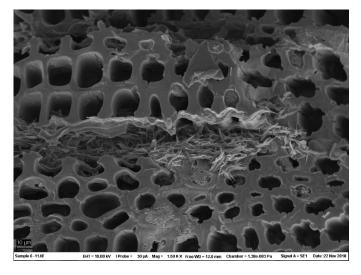
Figure 55. An image of sample 6.

The image shows tracheid separation, similar to what is reported from the research project of Tampa Bay, and others.

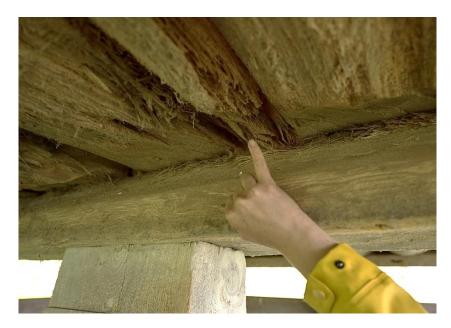
Figure 56. The floor in this old building is heavily affected by salt degradation. The building lies in an area with dry climate, and the salts will cross their saturation point more often than in a humid climate. The photograph is taken from under the floor seen from the outside. Åsheim farm, Seljord Norway. Photo: Anders Amlo, Riksantikvaren.

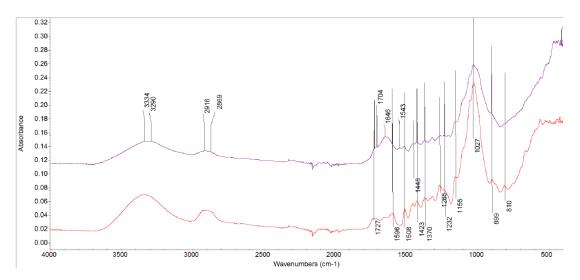
The *No urine content* sample 8 compared well with sound pine (Figure 2). Bands are typical signals from wood. Sample 8 shows signs of slight degradation due to natural aging, seen in the region of spectra containing carbonyl functional groups (C=O), at 1543 cm⁻¹ and in region ca 1650-1710 cm⁻¹.

Figure 2. No urine content spectra exemplified by sample 8 (purple) and by the sound pine reference (red).

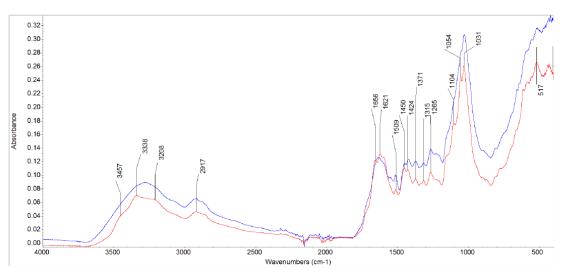
Slight urine content spectra are represented by samples 3, 7 in Figure 3. Compared to the previous figure, here different bands are visible at 3457, 3338, 3208, 1656, 1621 and 1450 cm⁻¹, which are associated with urine [7, 8]. Although there is still an overlap due to sulfates or phosphates (at 1054 cm⁻¹) and ammonium (at 1450 cm⁻¹), most other signals associated with wood in the region 1400-700 cm⁻¹ are visible, such as the band for pure lignin (1509 cm⁻¹).

Figure 3. Slight urine content spectra, illustrated by sample 3 (red) and sample 7 (blue).

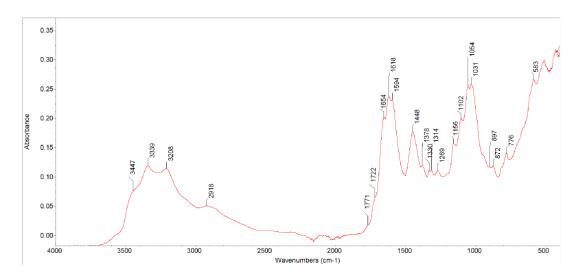
High urine content spectra included samples 1, 4, 5, 6, 9, and 10. Figure 4 shows a typical spectrum (sample 5) where the bands at 3447, 3339, 3208 cm⁻¹ are more defined and where bands at 1654, 1618, 1448 cm⁻¹ are very intense. The pure lignin band at 1505 cm⁻¹ is hidden due to interference from urine compounds. The fingerprint region of sample 5 is shown in Figure 5 where it is compared against a urine spectrum found in the literature [7].

Figure 4. High urine content spectrum illustrated by sample 5.

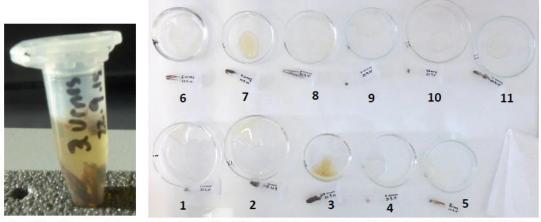
The extract after pH measurements is shown in Figure 7 after transfer into petri dishes. Samples 3 and 7, both sorted into the *Slight urine content* group (based on infrared spectra) had the strongest extract colour. For these samples, the spectra may have been dominated by a different salt composition relative to other spectra, but this is only a hypothesis, as their residues were not analyzed.

Figure 7. After pH measurements, the supernatant was transferred to petri dishes. Note the strong yellow colouring of the extract in samples 3 and 7, both of which had only 'Slight' urine content according to interpretation of infrared spectra.

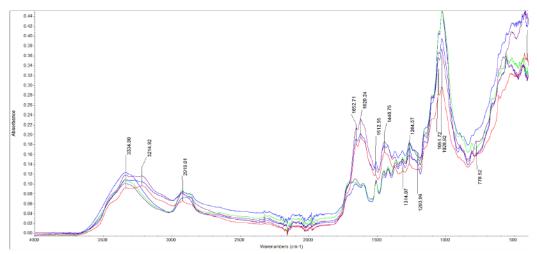
Generally rinsing removed signals attributed to urine (1652, 1620, 1450 cm⁻¹) as well as sulfates /phosphates (1054 cm⁻¹) from samples 2, 3, 4 and 6. Even after rinsing, strong bands remained in 1530-1820 cm⁻¹ region, slightly higher than in sample 8 (see Figure 12), indicating either a higher degree of oxidation of salt-infused wood compounds or remains of insoluble urine-derived compounds.

Figure 8. Effect of rinsing sample 2 Rinsed spectra have lower intensities in the 1500-2000 cm⁻¹ region.

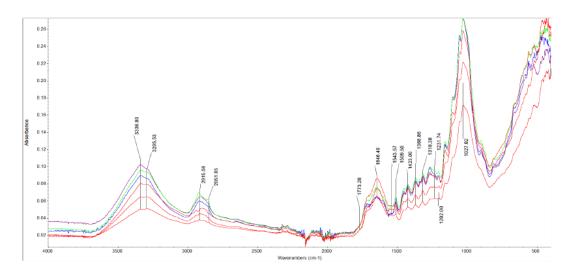
Figure 12. Effect of rinsing sample 8 (red spectra are before rinsing).

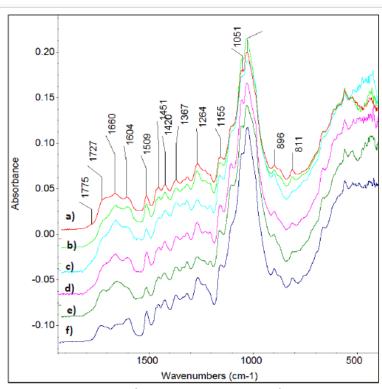
After rinsing, all Urnes samples (2, 3, 4, 6, 8) had high signals in the region spanning 1550-1820 cm⁻¹ compared with sound pine (Figure 13). These signals are due to functional groups containing oxygen. Sample 8 illustrates what may be expected during natural aging, as it originates away from the saltinfused region and thus may represent a 'typically' aged Urnes pine sample. Sample 8 also shows slightly reduced band area ratios relative to sound pine, indicating that the holocellulose fraction has been preferentially degraded over that of lignin.

Figure 13. Rinsed samples together (1 spectrum from each sample was chosen) showing fingerprint region only. a) sample 2, b) sample 3, c) sample 4, d) sample 6, e) sample 8, f) Sound pine reference.

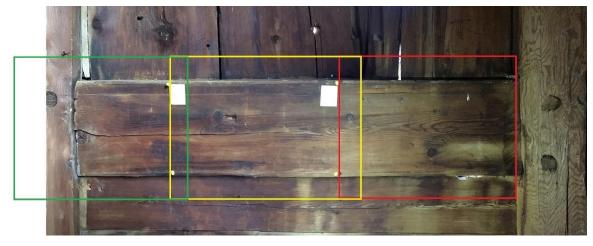
Figur 5. Firkantene markerer røntgenfilmenes plassering på midtromssvilla inne i kirken. Hjørnestav mot sørvest på høyre kant i bildet; en av fire mellomstaver på sørsiden ses på venstre kant i bildet. Foto: NIKU

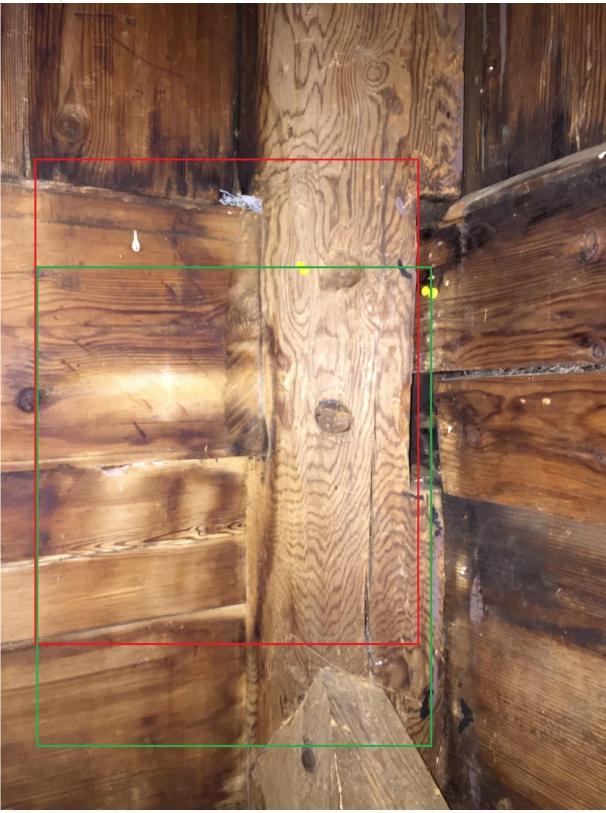
Figur 10. SV stav med inntappede midtromssviller. Firkantene markerer røntgenfilmenes plassering på staven, rød svarer til figur 12, grønn til figur 13 (de gule prikkene er NIKUs tegnestifter, brukt til å feste røntgenfilmen til veggen.) Foto: NIKU

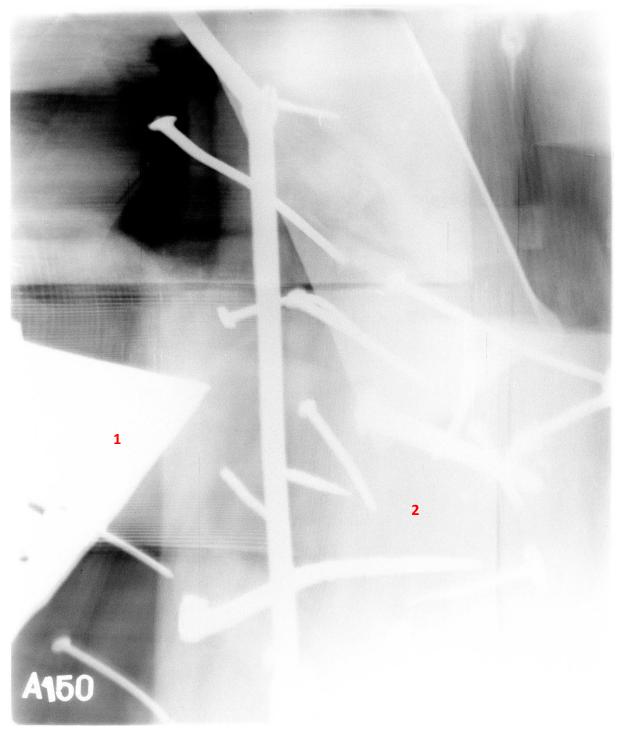
Figur 13. Røntgenopptak SV stav, se grønn firkant i figur 10. Røntgenopptak SV stav. 1) Man kan se mer av blydekket enn i Figur 9. 2) Årringene i staven fremtrer ikke tydelig, men dette kan skyldes opptakssituasjon. Foto: NIKU

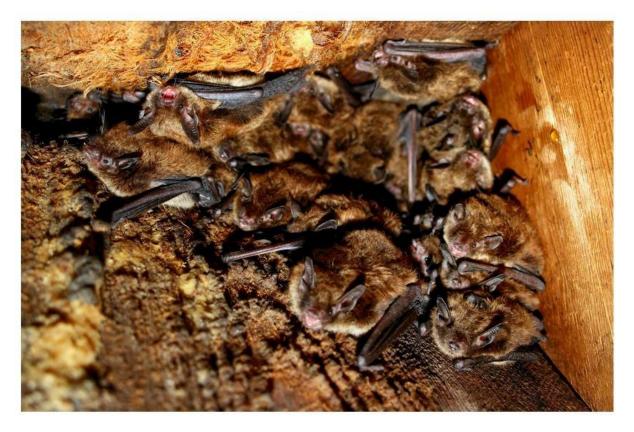
Figur 16. Foto av flaggermus i trekonstruksjon. I nedre del av bildet vises klumpete forsteininger som dannes av urin og avføring fra flaggermus. Øverst til venstre i bildet: svært flusset treoverflate. Viser dette nedbrytning av treverk som kan skyldes flaggermus-urin? Hentet fra nettside https://www.mass.gov/news/study-on-little-brown-bats-continues.
